**MINERALS PROGRAM INSPECTION REPORT****PHONE: (303) 866-3567**

<b>MINE NAME:</b> Colorado Red Rose Stone Resource	<b>MINE/PROSPECTING ID#:</b> M-2013-068	<b>MINERAL:</b> Granite, granite gneiss	<b>COUNTY:</b> Larimer
<b>INSPECTION TYPE:</b> Monitoring	<b>INSPECTOR(S):</b> Jared L. Ebert	<b>INSP. DATE:</b> May 15, 2017	<b>INSP. TIME:</b> 10:30
<b>OPERATOR:</b> Colorado Rose Red Inc.	<b>OPERATOR REPRESENTATIVE:</b> Caleb Liesveld	<b>TYPE OF OPERATION:</b> 111 - Construction by Government Agency

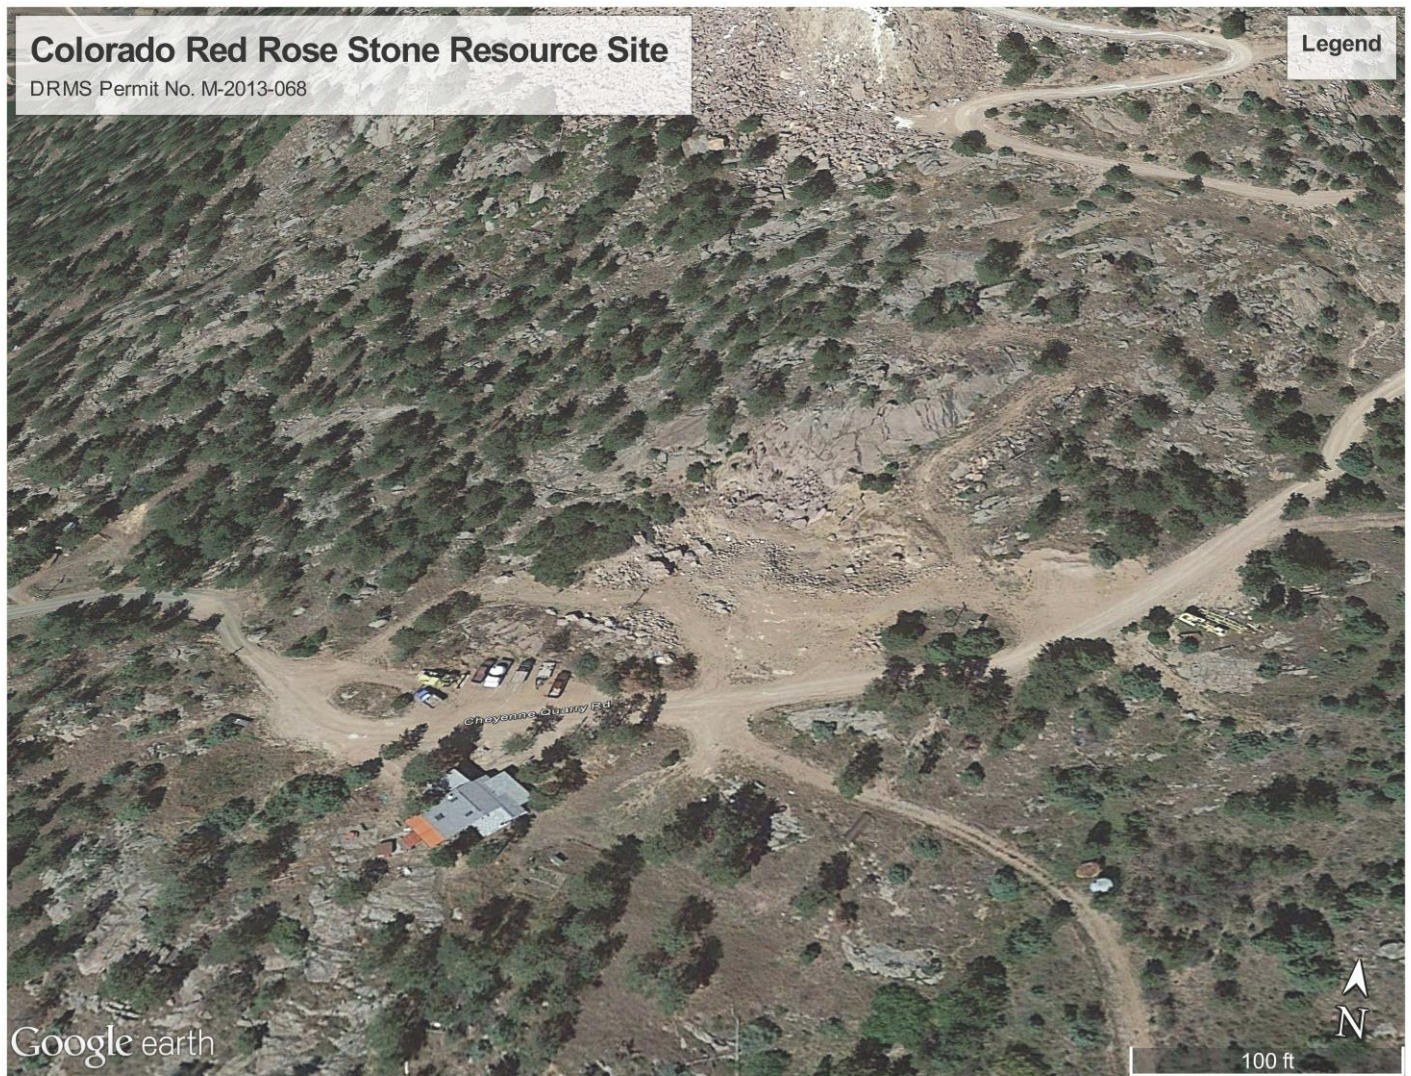
**Figure 1. Photograph dated 9/7/2016**

The affected area was not completely marked with boundary markers. However, based on a recent Google Earth© photograph of the site, the Division estimates about .85 acres have been affected by the mining operation and this area is likely within the approved permit boundary.

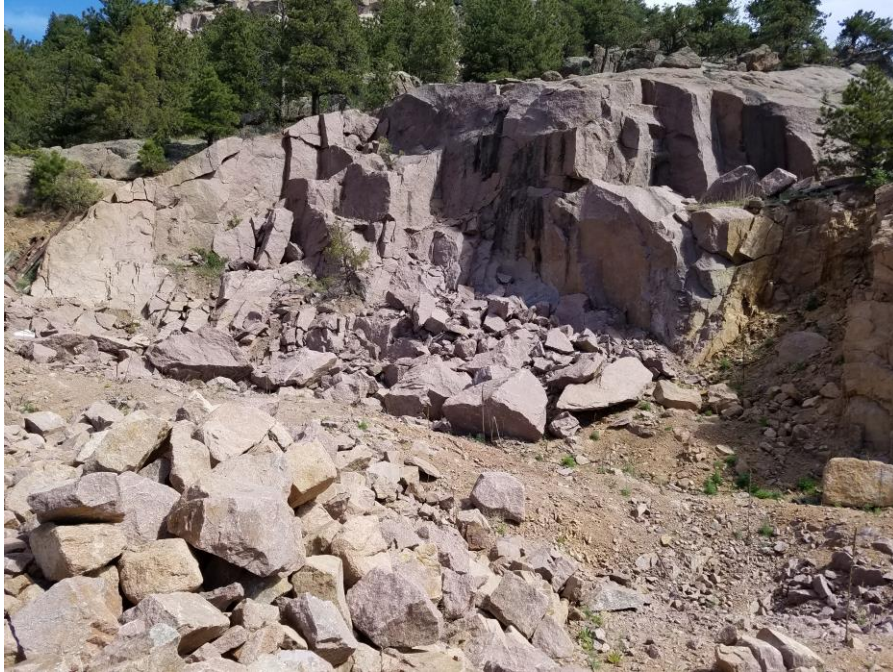
The approved plan calls for excavating the toe of the highwall about 12 feet to a level consistent with the roadway on the south side of the site. The Operator has excavated an area at the base of the existing highwall as discussed in the approved mine plan. The excavated area is above the level of the roadway on the south side of the site.

Figure 2. View of highwall from above the road looking north.

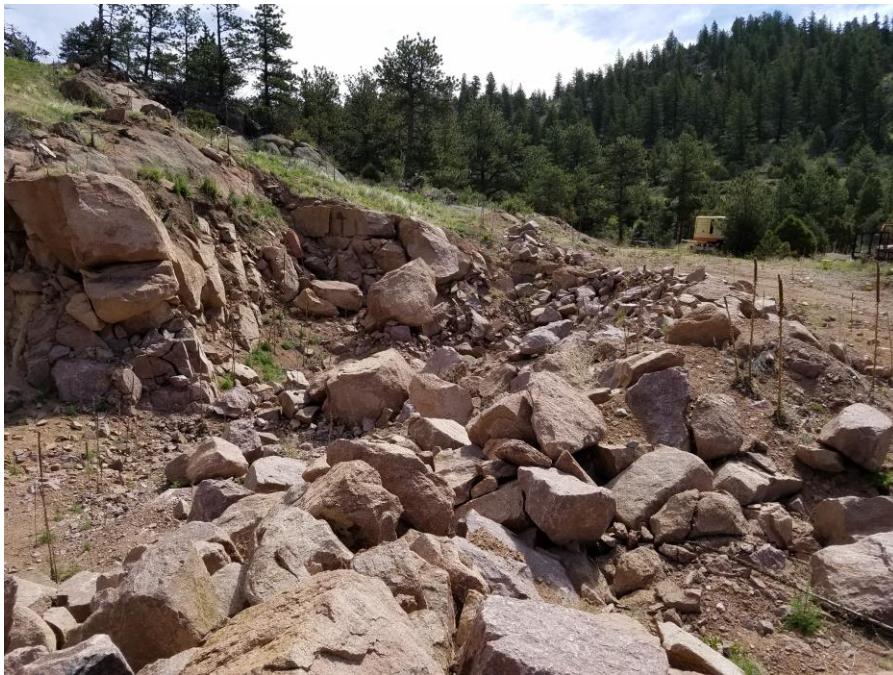
Figure 3. From above the road looking east.

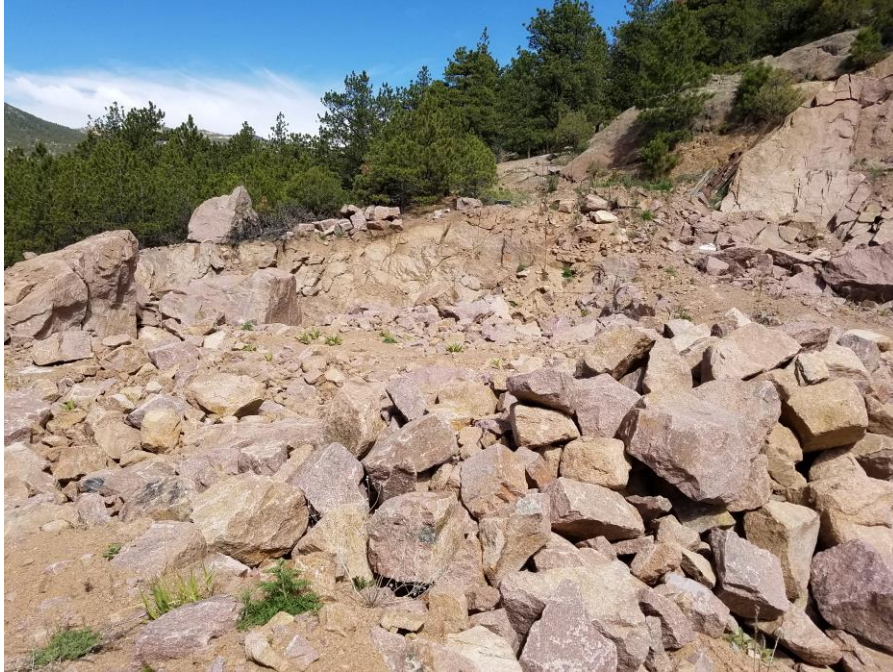
Figure 4. From above the road looking west.

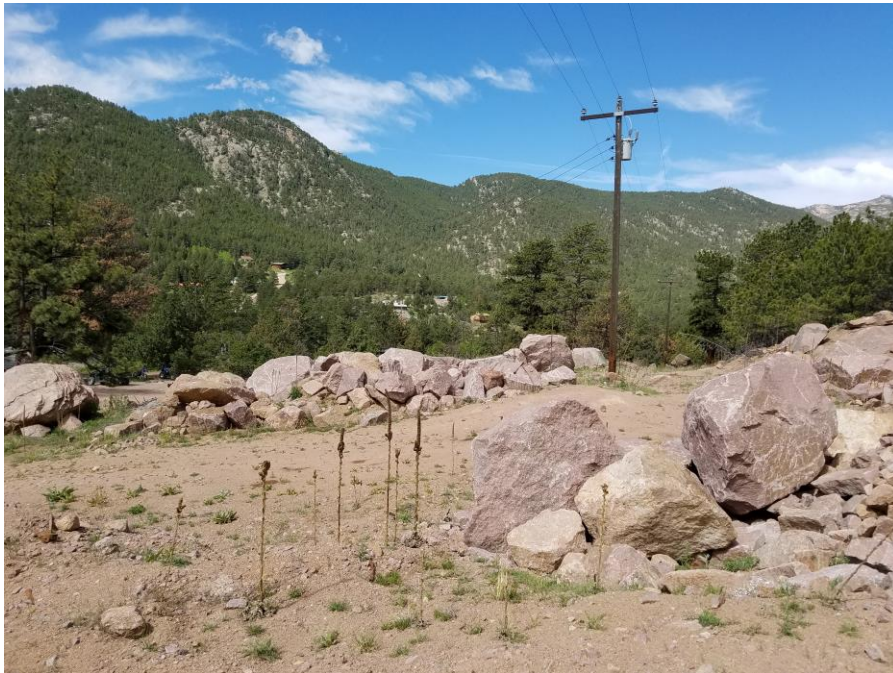
Figure 5. From above the road looking southwest.
