MINERALS PROGRAM INSPECTION REPORT

MINE NAME: Proctor Pit	MINE/PROSPECTING ID#: M-2009-054	MINERAL: Gravel and sand	COUNTY: Otero
INSPECTION TYPE: Surety Release Inspection	INSPECTOR(S): Amy Eschberger	INSP. DATE: May 11, 2017	INSP. TIME: 10:30
OPERATOR: All-Rite Paving & Redi-Mix, Inc.	OPERATOR REPRESENTATIVE: Jodi Schreiber, Herb Pearson	TYPE OF OPERATION: 112c - Construction Regular Operation	
REASON FOR INSPECTION: Surety Release Requested	BOND CALCULATION TYPE: Partial Bond	BOND AMOUNT: \$72,550.00	
DATE OF COMPLAINT: NA	POST INSP. CONTACTS: None	JOINT INSP. AGENCY: None	
WEATHER: Cloudy	INSPECTOR'S SIGNATURE:

M2009-054 / Proctor Pit / All-Rite Paving & Redi-Mix, Inc.

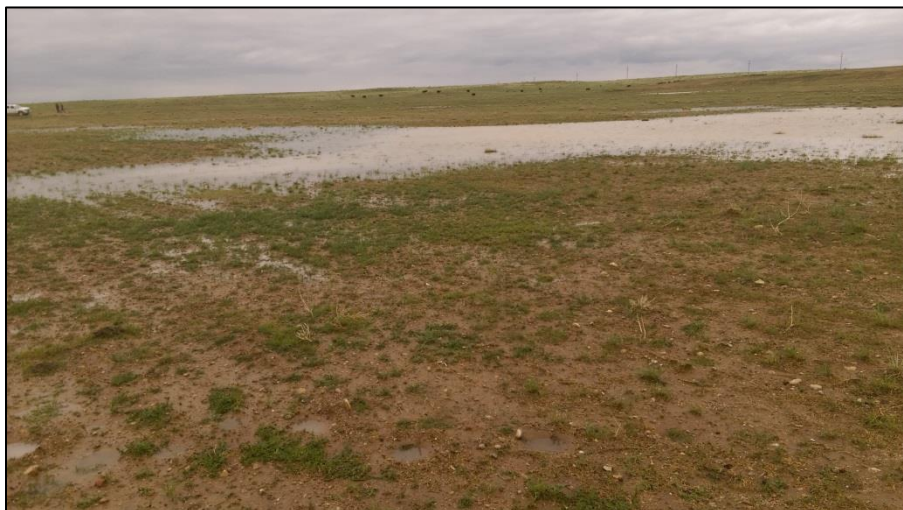
At the time of the inspection, it was cloudy and the ground was very wet from a recent rainstorm. The Division observed standing water and minor flooding throughout the region. The Division believes the water retained in the reclaimed pit during the inspection can be attributed to the storm event that had just ended the morning of the inspection. A permit sign was posted at the main site entrance, and the permit boundary was delineated with white posts. The site was not active at the time of the inspection, as it has been in reclamation since 2014 (**Photos 1-21 and 27-30**). In the Division's last inspection report from February 18, 2015, it was noted that much of the required earthwork had been completed except for some minor grading along the edges of the pit and topsoil replacement. During the current inspection, the Division observed that all disturbed slopes had been graded to 4H:1V or flatter. According to the operator, topsoil was replaced at a depth of 6 inches or more, 2 tons per acre of straw mulch was applied and crimped into the soil, and the disturbed land was drill-seeded. The seeding took place in Fall of 2016. The Division observed a fairly good vegetative cover across the site, including native grasses, forbs, and some nuisance weeds (mainly Russian thistle). There were some portions of the site, mainly along the edges of the pit, that exhibited sparser vegetative cover. Depending on how much of the planted grass seed germinates this spring, the operator may need to reseed these areas.

Photo 21. View looking southeast from northwestern edge of reclaimed pit.
Note water pooled up on pit floor due to recent storm event.

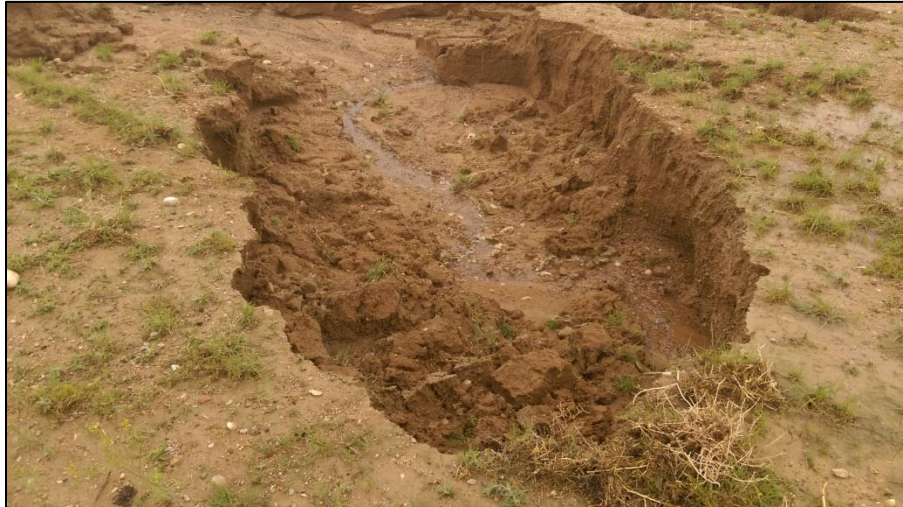
Overall, the site appeared to be stable, except for an erosion feature that was observed at the northwestern edge of the pit. In this area, it appeared that the recent storm had created a large gully along the edge of the pit (**Photos 22-26**), where the pit floor is higher in elevation than the adjacent land. The gully was approximately 2-3 feet in depth, and had a small sediment fan at its base. Per Rule 3.1.6(3), all surface areas of the affected land, including spoil piles, shall be stabilized and protected so as to effectively control erosion. Therefore, the operator will need to repair the erosion damage, stabilize the slope, and work to revegetate this area in accordance with the approved reclamation plan.

Photo 22. View of large gully present at northwestern edge of reclaimed pit.

The reclamation work completed at the site is commendable. However, the Division is unable to approve a full release of the site at this time, and must deny Revision No. SL-1. The Division recommends the operator repair the erosion damage as described above, and continue to monitor revegetation results to determine whether additional seeding will be needed.

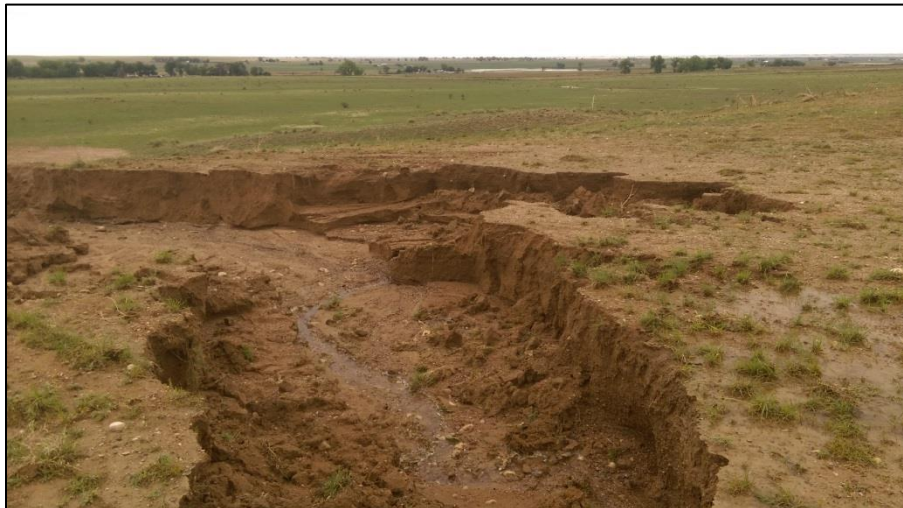
Photo 23. View of large gully present at northwestern edge of reclaimed pit.

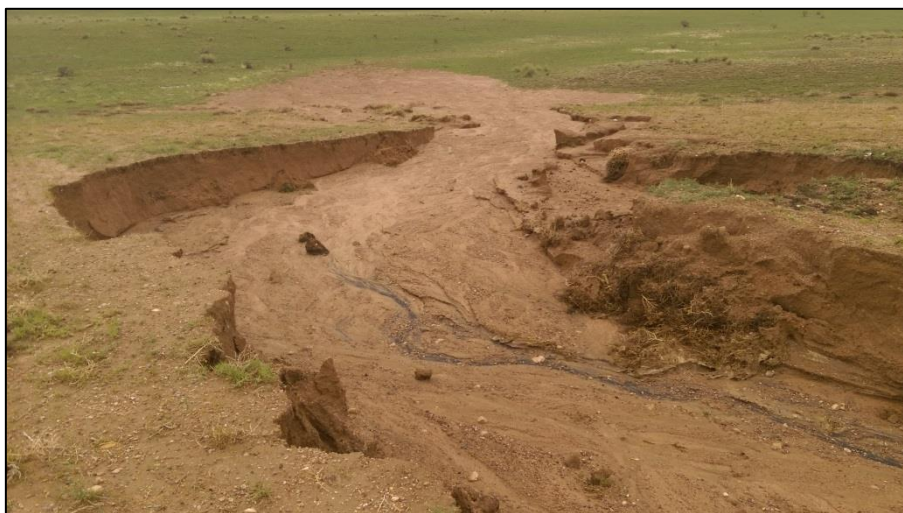
Photo 24. View of large gully present at northwestern edge of reclaimed pit.
Note sediment fan formed at base of gully.

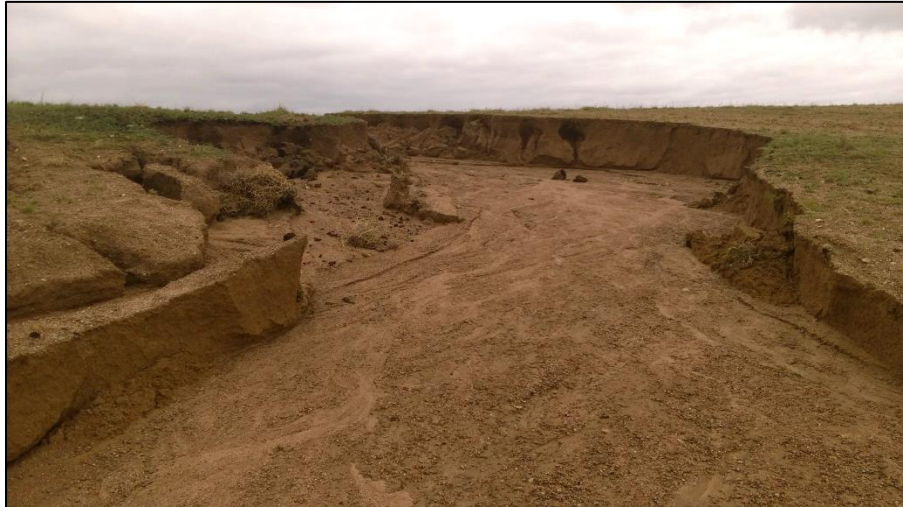
Photo 25. View of large gully present at northwestern edge of reclaimed pit.

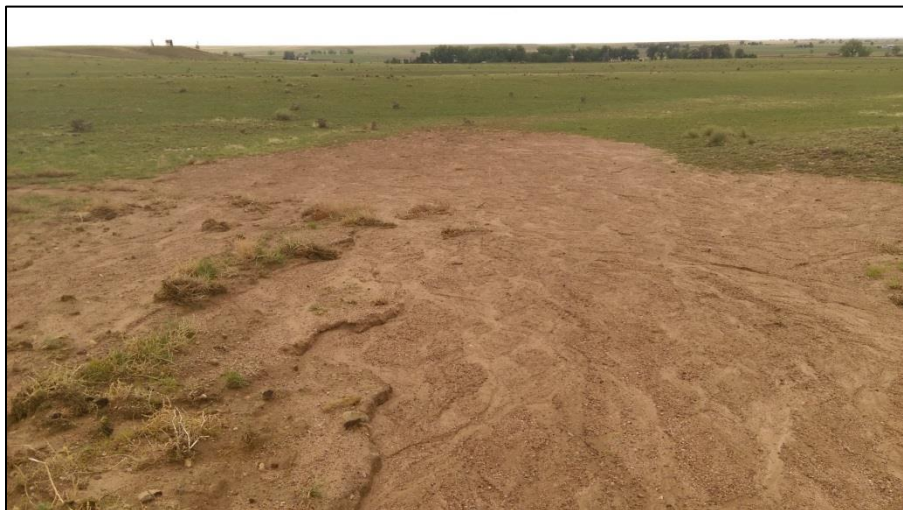
Photo 26. Closer view of sediment fan formed at base of gully present at northwestern edge of reclaimed pit.
