## MINERALS PROGRAM INSPECTION REPORT

<b>MINE NAME:</b> Cresson Project	<b>MINE/PROSPECTING ID#:</b> M-1980-244	<b>MINERAL:</b> Gold	<b>COUNTY:</b> Teller
<b>INSPECTION TYPE:</b> Monitoring	<b>INSPECTOR(S):</b> Timothy A. Cazier	<b>INSP. DATE:</b> March 28, 2017	<b>INSP. TIME:</b> 10:15
<b>OPERATOR:</b> Cripple Creek & Victor Gold Mining Company	<b>OPERATOR REPRESENTATIVE:</b> Cheyne Mann	<b>TYPE OF OPERATION:</b> 112d-3 - Designated Mining Operation

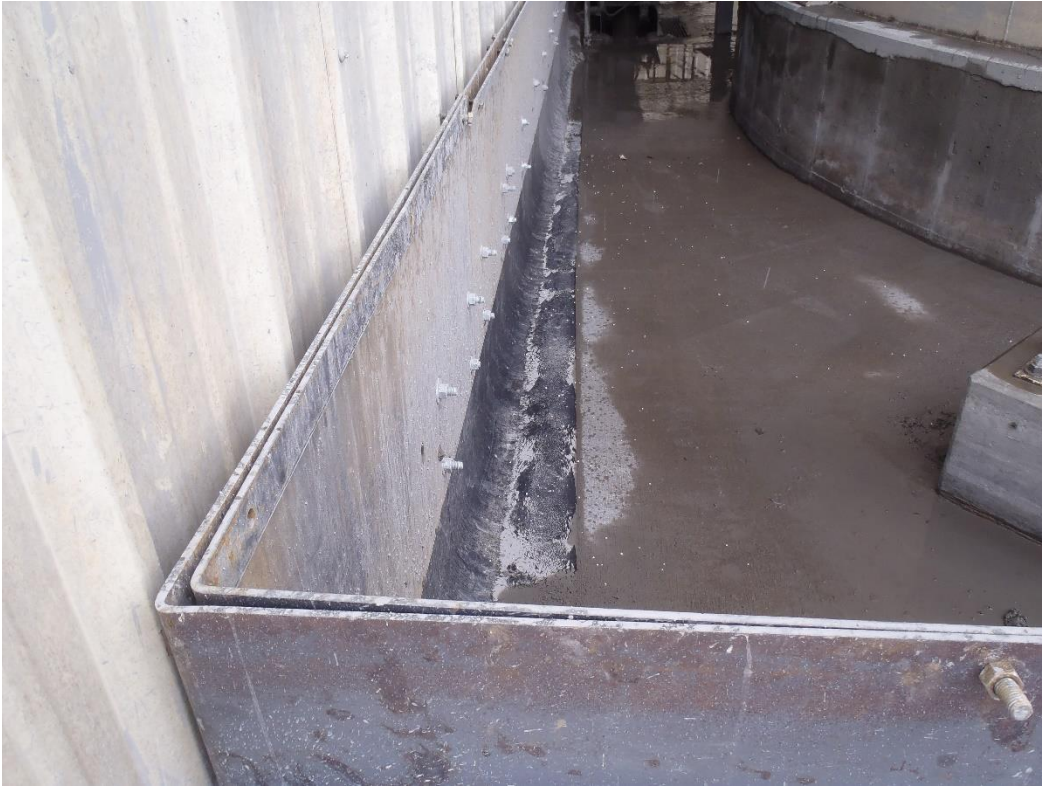
Photo 1. Vat leach tank secondary containment construction (steel plate & rubber membrane).

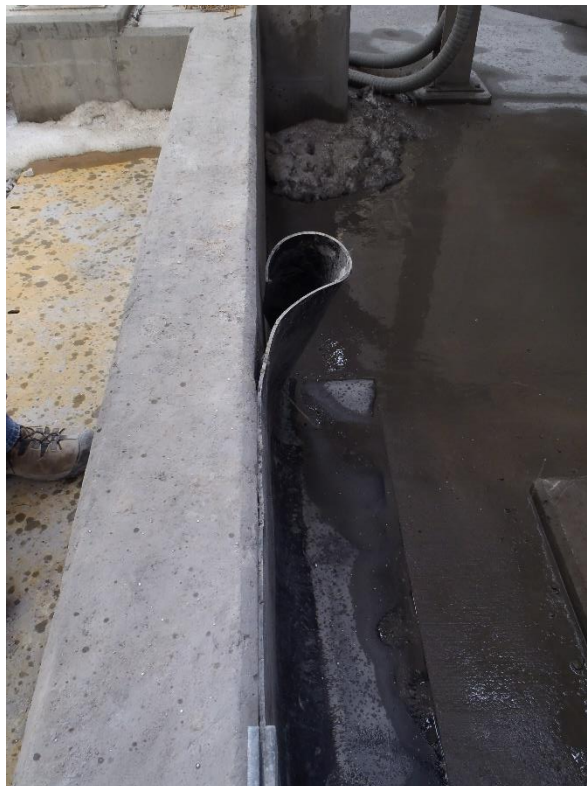
Photo 2. Vat leach tank secondary containment construction (rubber membrane).

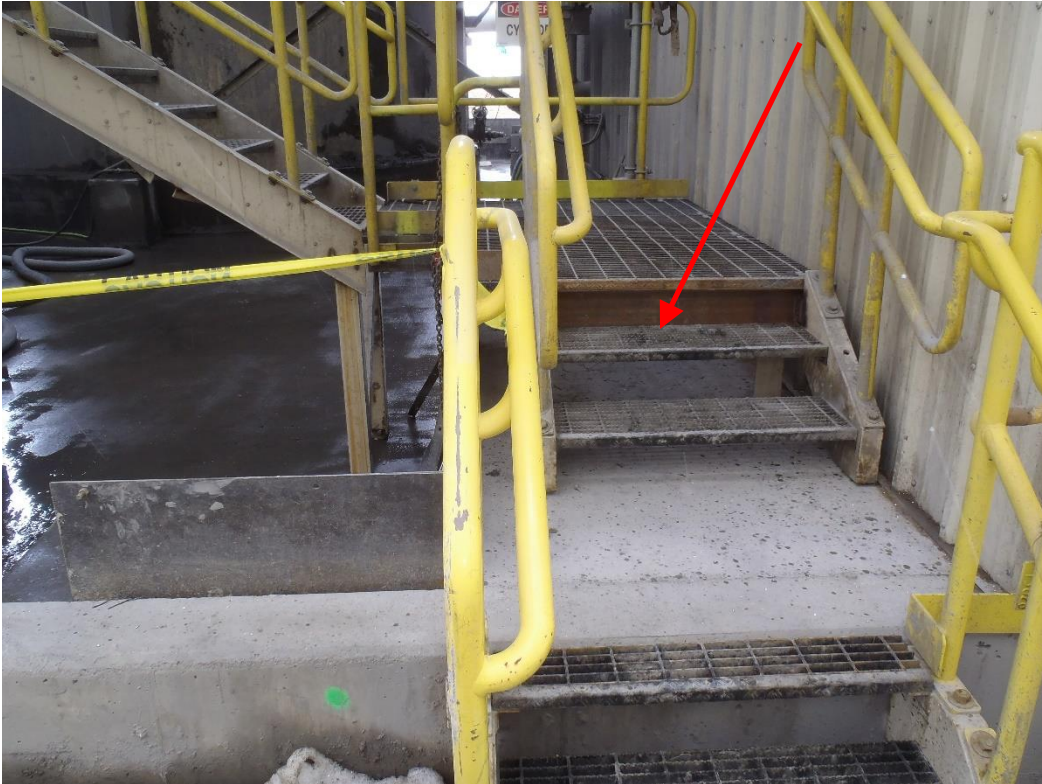
Photo 3. Southeast stairway been modified to accommodate the containment extension.

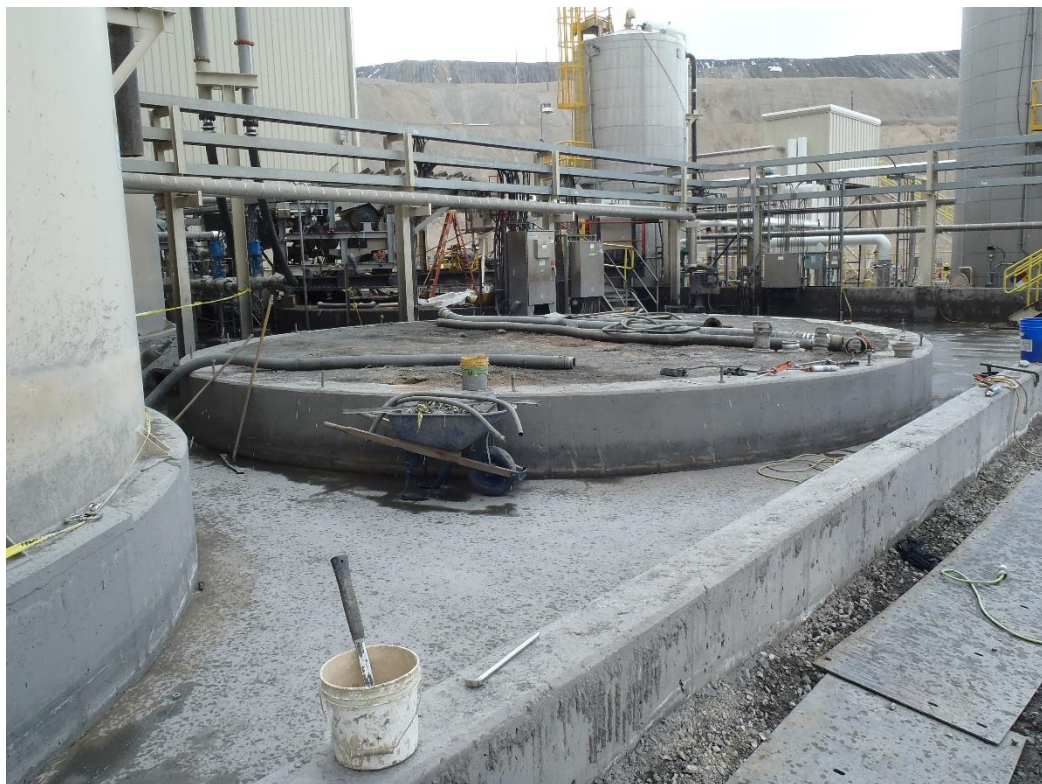
High Grade Mill: The Division was accompanied by Gary Horton and Steve Blaskovitch at the HGM to perform an exterior walk-around inspection. The primary focus was to observe the method and status of the construction project underway to increase the secondary containment capacity in the vat leach area. The Division observed installation of both the rubber membrane and steel plate (**Photos 1 and 2**). A little over half the steel plate and rubber membrane had been installed. The southeast stairway had been modified to accommodate the containment extension (**Photo 3**). The Division noted the leach tank secondary containment area (**Photo 4**) had no significant reduction in containment storage.

Photo 4. Clear secondary containment.

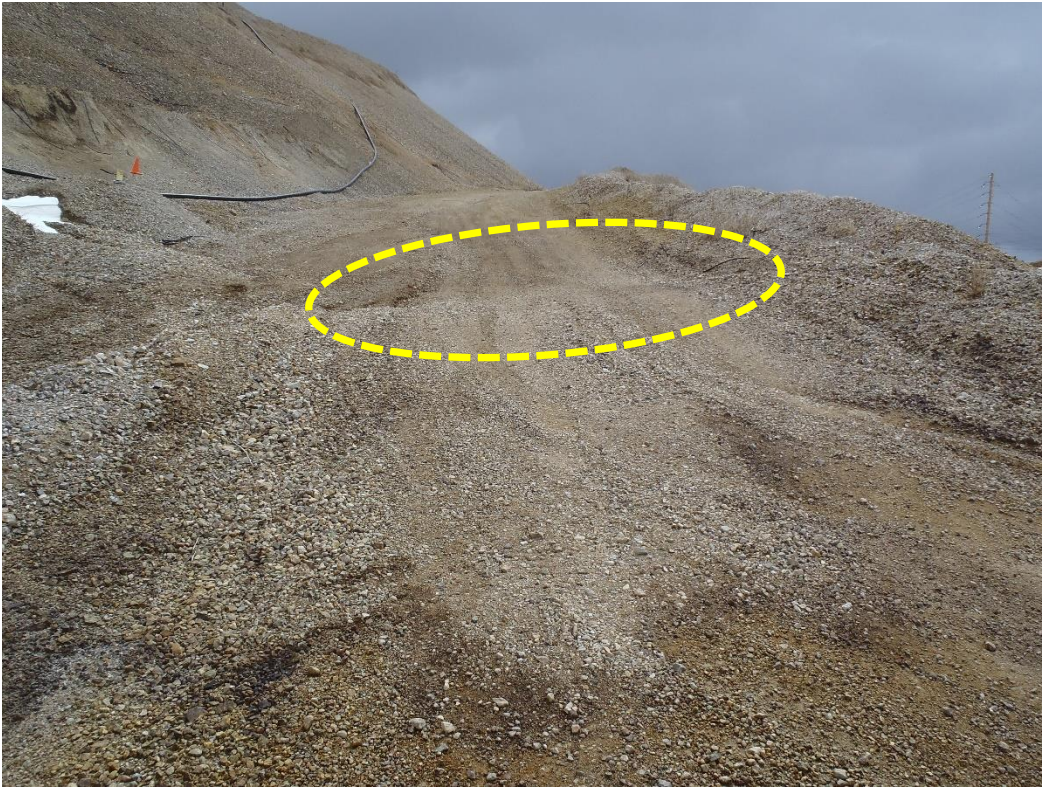
AGVLF: The Division was accompanied by Mr. Mann to inspect the area near the northwest toe of the AGVLF where the Division had observed an area of concern relating to stormwater control where the access road crosses the edge of liner during the October 27, 2016 inspection (*UTM coordinates: Zone 13 S, 485856.96 m E, 4286300.68 m N*). Snow cover had prevented revisiting this area until this inspection. The Division observed what may have been a water bar at one time (**Photo 5**), but the grading was insufficient to prevent stormwater runoff on the upgradient access road from being diverted to the on liner intercept channel (**Photo 6**). Mr. Mann concurred and committed to improving the drainage control in this area. The Division observed no direct evidence of stormwater containment failure, so this was not cited as a problem. However, the Division strongly recommends improvements be completed before the summer storm season begins in order to avoid potential offsite impacts.

Photo 5. NW toe of AGVLF access road Xing – possible, but ineffective water bar (looking SW).

- a) Drainage grading improvements need to be completed on the northwest corner toe of the AGVLF as observed and discussed in the field during this inspection.

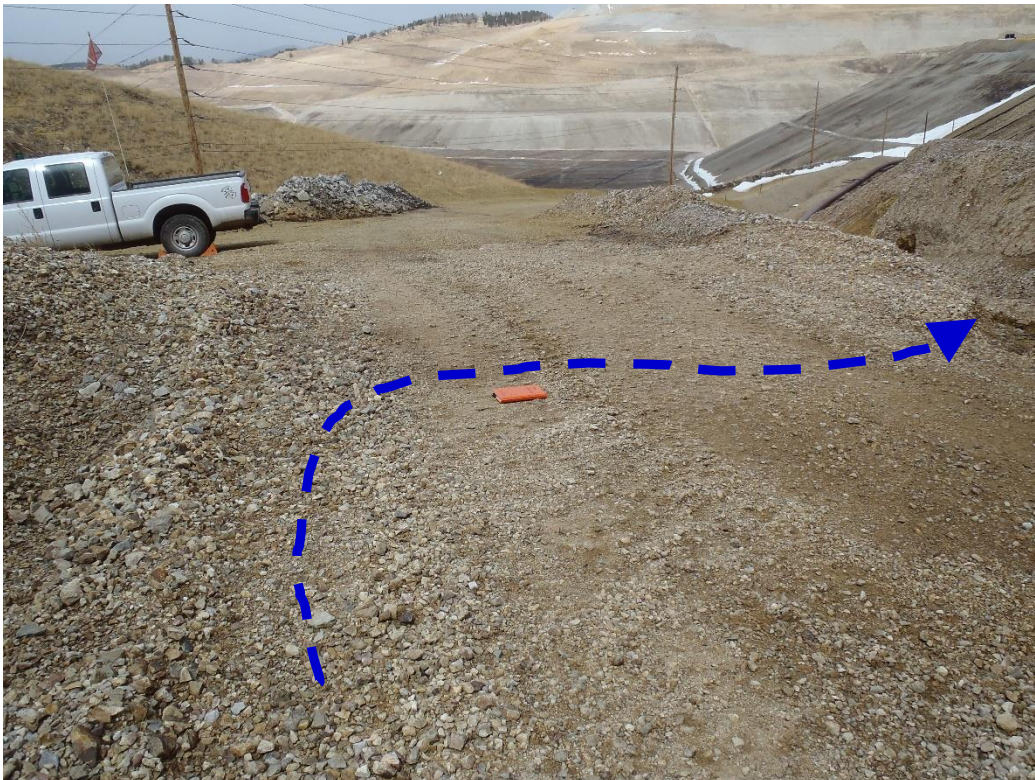
Photo 6. NW toe of AGVLF access road Xing – possible, but ineffective water bar (looking NE).

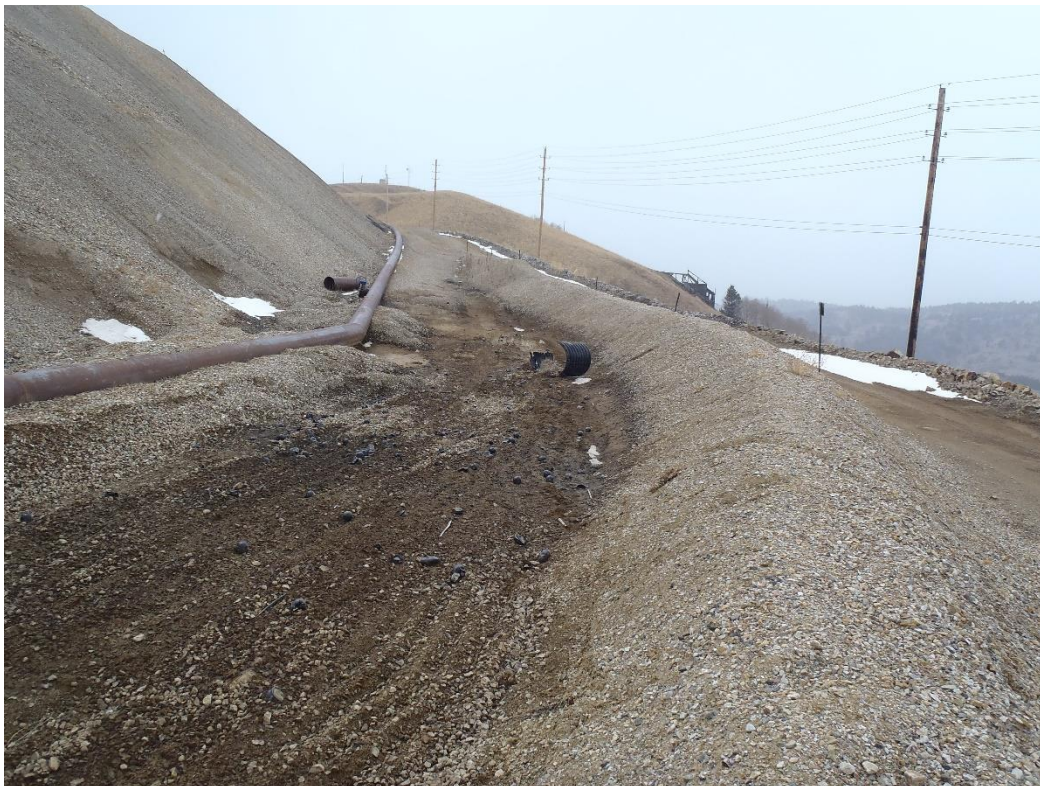
While in the area, Mr. Mann showed this inspector improvements made to the area near the AGVLF water tank cited as a problem in the October 2016 inspection report. These repairs appeared adequate and functioning as intended (**Photo 7**).

Photo 7. Completed repairs to stormwater intercept channel near AGVLF water tank.

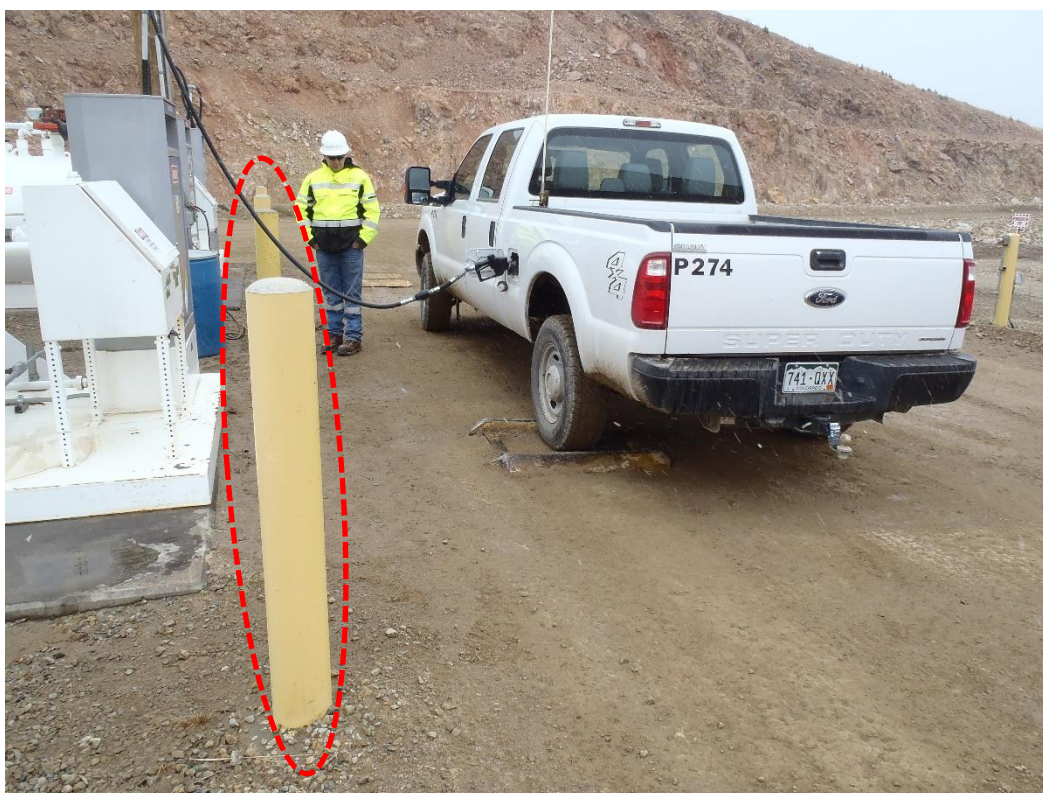
Fuel Island: While waiting for Mr. Mann to refuel the truck used for this inspection, the Division inspected the fueling facility used by both light trucks and the large mining equipment. Bollards were observed for both small and large vehicles to prevent vehicle collisions with fuel tanks (**Photos 8 and 9**). No spills were observed. However, the Division is aware the facility has a subgrade liner. No edge of liner markers were observed. Mr. Mann concurred the edge of the Fuel Island subgrade liner should be marked to prevent damage during potential construction activity and to know whether or not potential petroleum product spills occur over the liner. The Division will revisit the Fuel Island during a future inspection to verify edge of liner markers are

Photo 8. Standard bollards protecting fuel tanks from light trucks.

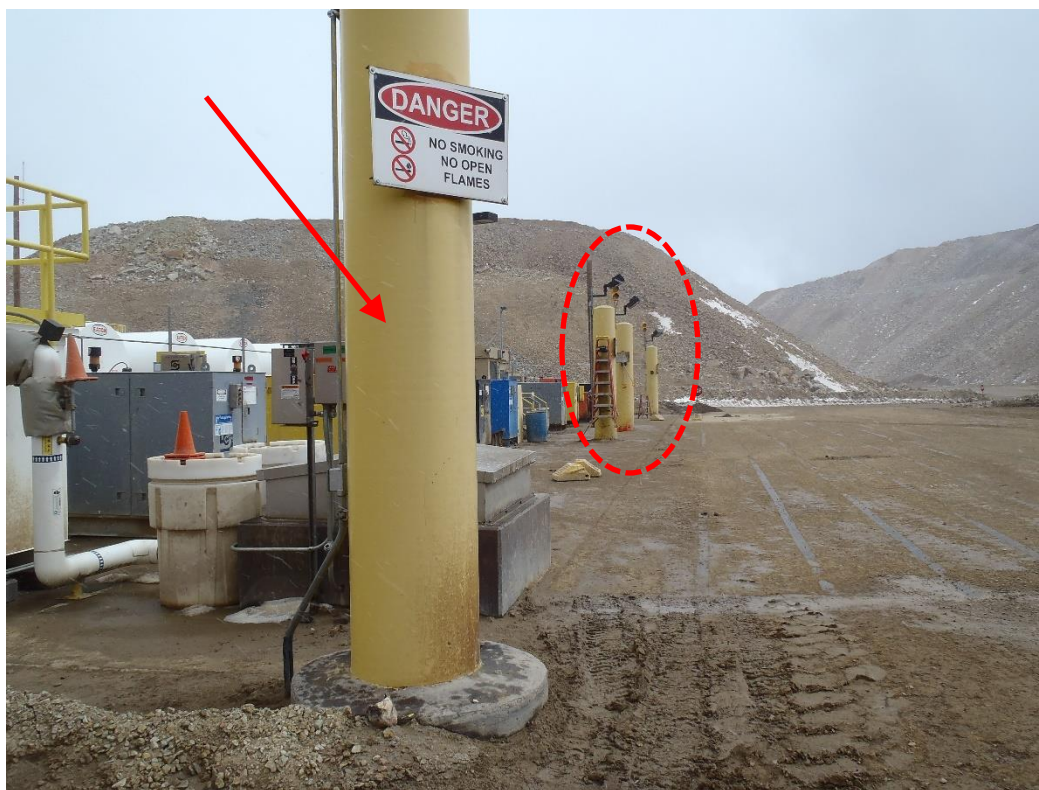
Photo 9. Large bollards protecting fuel tanks from mine equipment.
