**COLORADO**  
Division of Reclamation,  
Mining and Safety  
Department of Natural Resources

<b>Permit Number:</b> C-1981-035 <b>Mine Name:</b> King Coal Mine <b>Operator:</b> GCC Energy, LLC <b>Operator Address:</b> Mr. Tom Bird 6473 County Road 120 Hesperus, CO 81326	<b>County:</b> La Plata <b>Operation Type:</b> Underground <b>Permit Status:</b> Active <b>Ownership:</b> Federal
	<b>Operator Representative Present:</b>  Jordan McCourt
<b>Operator Representative Signature: (Field Issuance Only)</b>

<b>Inspection Start Date:</b> May 24, 2017 <b>Inspection Start Time:</b> 07:30 <b>Inspection End Date:</b> <b>Inspection End Time:</b>		<b>Inspection Type:</b> Coal Complete Inspection <b>Inspection Reason:</b> Normal I&E Program <b>Weather:</b> Clear	
<b>Joint Inspection Agency:</b>  None		<b>Joint Inspection Contacts:</b>  	
<b>Post Inspection Agency:</b>  None		<b>Post Inspection Contacts:</b>  	
<b>Inspector(s):</b>  Robert D. Zuber, P.E.	<b>Inspector's Signature:</b>

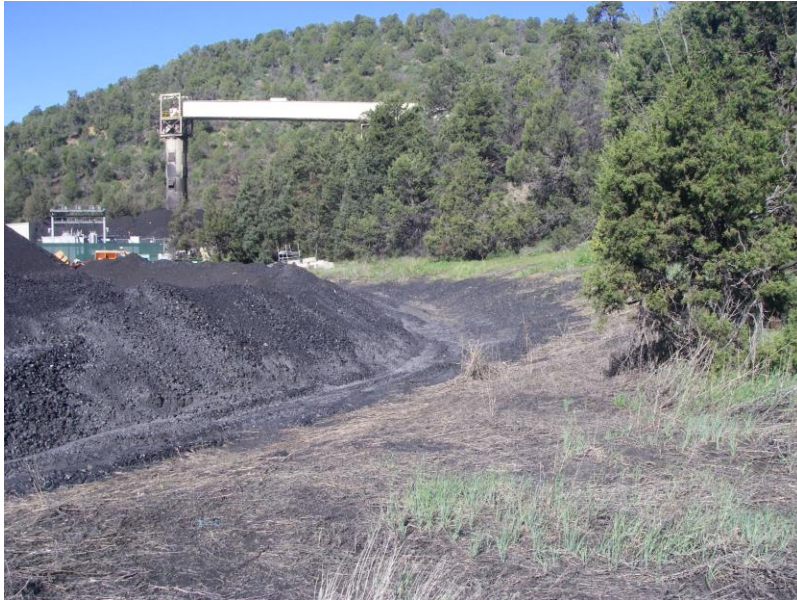
The coal storage pile at Coal Stack Tube #2 was smaller than in past inspections. Jordan McCourt stated that production has been low due to a parting in the seam. No compliance issues were seen with the pile.

**Coal storage area (near Stack Tube #2) and interface with undisturbed area**

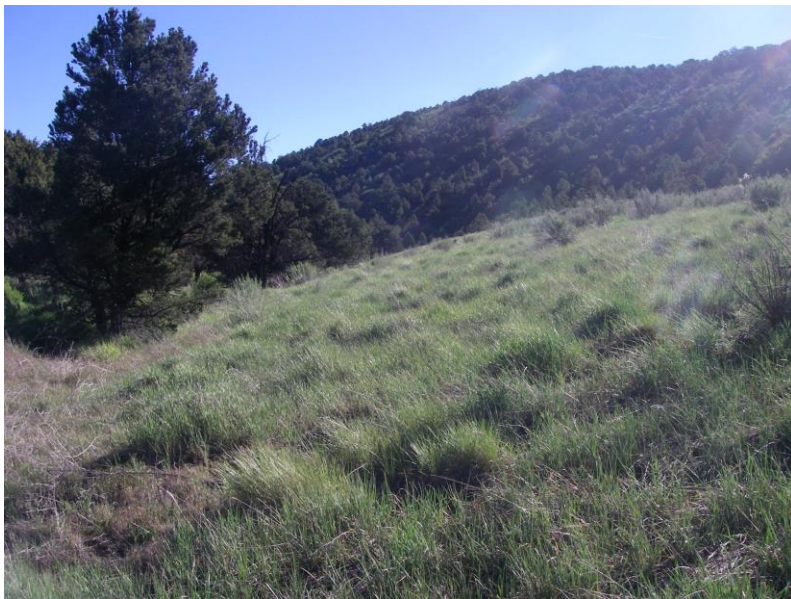
The volume of topsoil stockpile beside Coal Stack Tube #2 was estimated. Cross-sections were estimated with a laser rangefinder in the field, and satellite photography (Google Earth) was used in the office to measure the length of the pile (450 feet). The average cross-sectional area was estimated as follows:

The measured horizontal distances were: 73 feet, 77 feet, 70 feet, and 72 feet on the west side and 41 feet, 56 feet, 74 feet, and 76 feet on the east side. The average of these distances is 67.4 feet. The measured vertical distances were: 14 feet, 19 feet, 20 feet, and 17 feet on the west side and 10 feet, 12.5 feet, 16 feet, and 17 feet on the east side. The average of these distances is 15.7 feet. The estimated cross-sectional area is 1,057 square feet (67.4' x 15.7'), and the estimated volume is 475,625 cubic feet (1,057' x 450') or 17,616 cubic yards. This is significantly less than the volume of topsoil (27,191 cubic yards) that should be in this pile per the PAP (Section 2.05.3). GCC should explain this discrepancy. Is the amount of topsoil less than needed? Or is compaction and/or another factor the explanation?

**Topsoil stockpile (northeast of Stack Tube #2)**

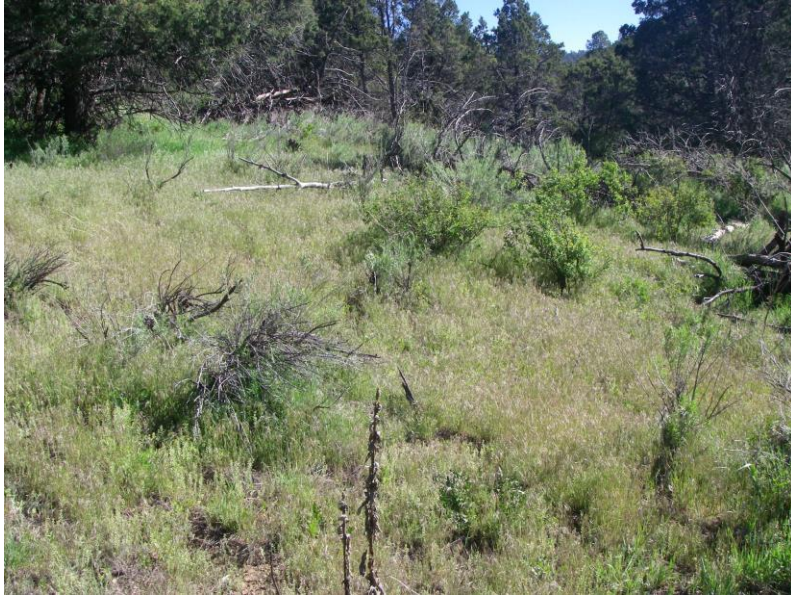
The vegetation reference area at King II was inspected. None of the following were identified: erosion problems, large weed patches, or signs of cattle use. It is suggested that markers be added to identify the outline of the area.

**King II vegetation reference area**

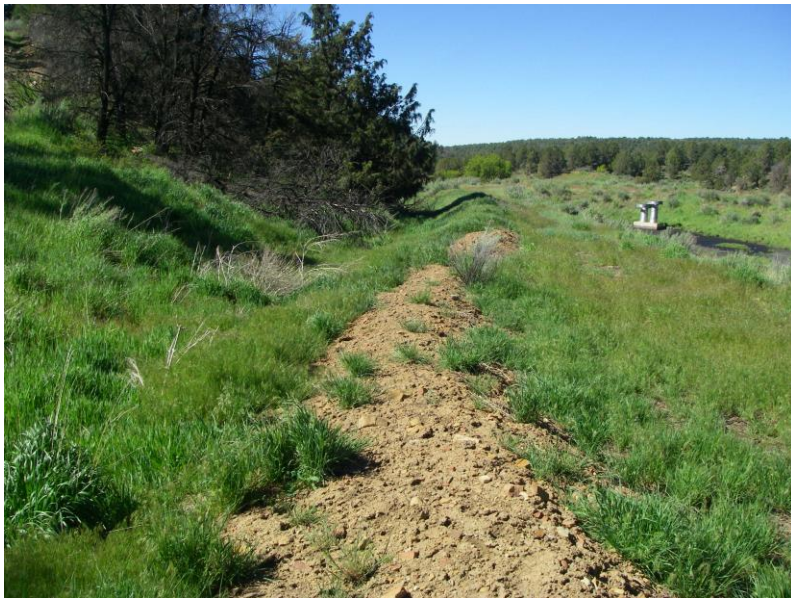
The East Clearwater Ditch at King II (CWD-2) was found to be large enough (per specification in PAP) and generally in good shape, but branch removal and brush cutting is suggested. No water was in the King II pond, and no problems were seen with the structures.

**King II East Clearwater Ditch (CWD-2)**

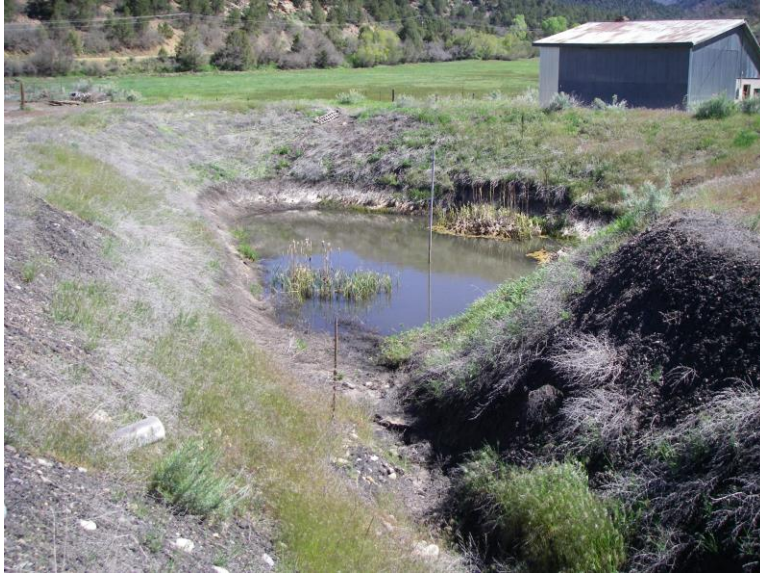
At the King I Mine, the East Pond and the West Pond were inspected. The East Pond was holding water but not discharging. The West Pond was dry. It is not clear why the East Pond often holds water; possible reasons are that there is very little infiltration through the pond bottom, or possibly the pond intercepts the alluvial formation. GCC should investigate this. Also, the East Pond construction does not meet the design, especially the primary spillway; GCC should develop a plan to address this (options include rerunning the model or re-constructing the spillway).

**East Pond at King I**

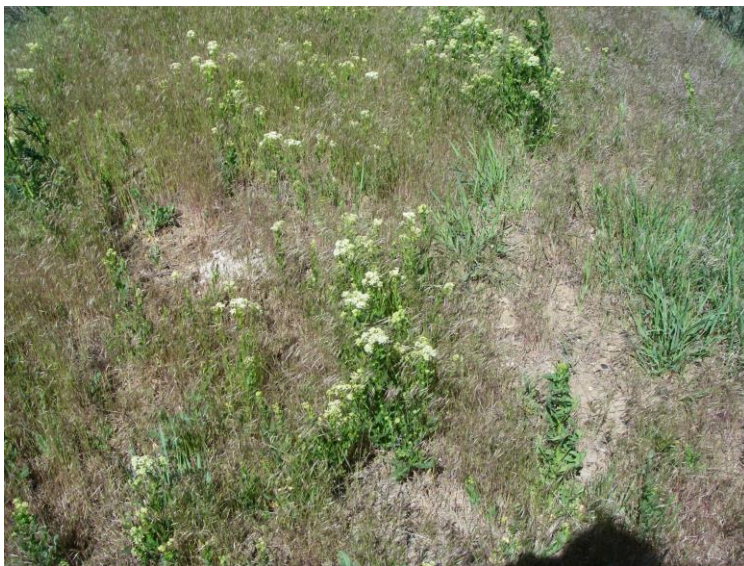
White-flowered plants (possibly white top, aka hoary cress) were seen on the West Pond at King I, and these should be sprayed top prevent spreading. Possible weeds needing control were also seen above the Refuse Pile (to northeast) and below the Refuse Pile (to the west).

**Weeds near West Pond (King I)**

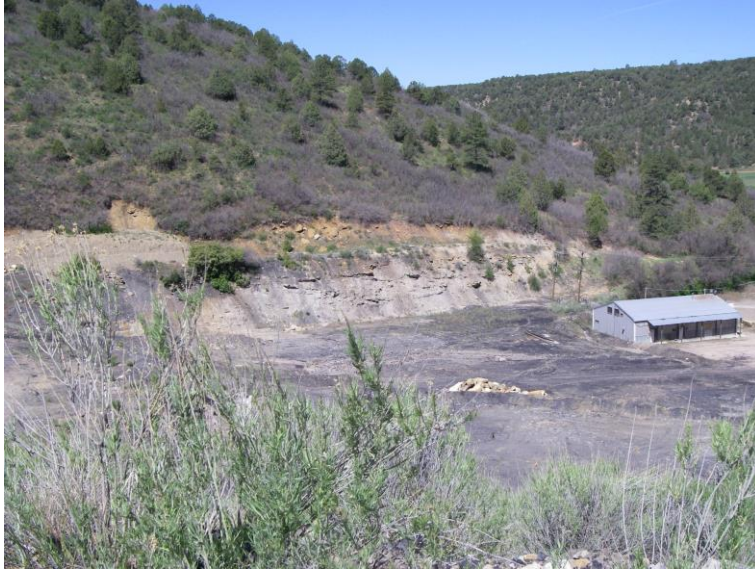
The cut slopes on the west side of King I appear to be stable.

**Cut slope above facilities area**

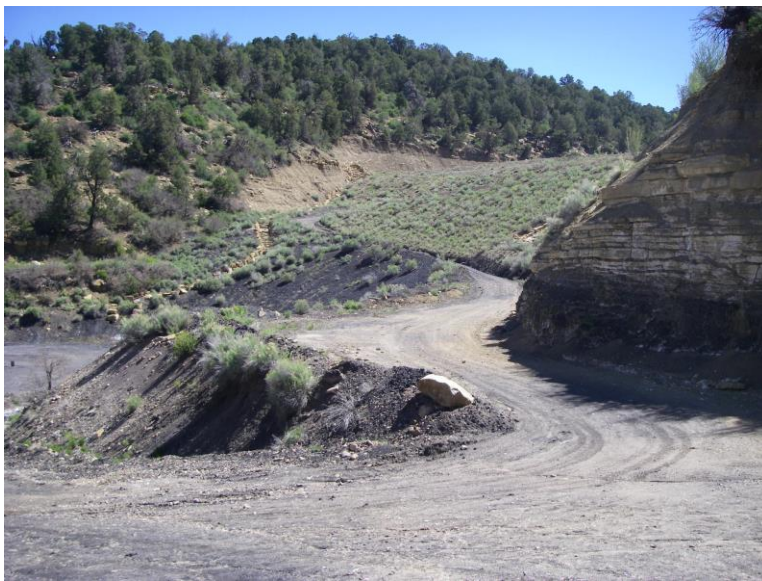
The lower portion of the Refuse Pile was checked with a Rangefinder, and it appears that the slope of the lower portion (2.2:1) is steeper than the design (2.5:1). This appears to be confirmed by surveys by GCC. GCC needs to provide the Division with a plan for a new geotechnical analysis of the pile (and possibly submit a revision application to the PAP) or re-construct the pile to meet the specification.

**Lower portion of Refuse Pile**

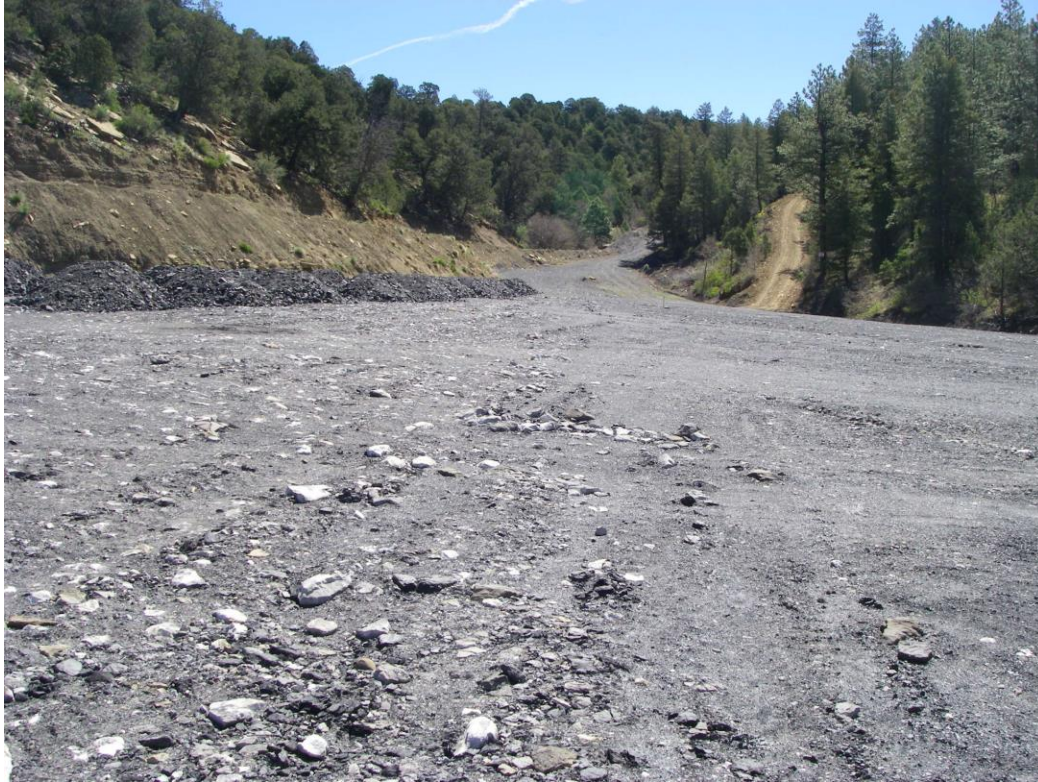
The un-reclaimed portion of the Refuse Pile (upper portion) requires grading to spread the piles of waste rock and insure a two percent slope from north to south across the pile. Some trash was seen in the piles of waste rock material; GCC management needs to insure that operators know to remove this material prior to grading and compaction. No flow was seen from the underdrain of the refuse pile, nor were there signs of recent flows.

**Refuse Pile, looking east up valley**
