**COLORADO**Division of Reclamation,
Mining and Safety

MINERALS PROGRAM INSPECTION REPORT**PHONE: (303) 866-3567**

MINE NAME: Mooney Hills Permit	MINE/PROSPECTING ID#: M-2007-007	MINERAL: Aggregate	COUNTY: Las Animas
INSPECTION TYPE: Monitoring	INSPECTOR(S): Michael A. Cunningham	INSP. DATE: April 11, 2017	INSP. TIME: 13:00
OPERATOR: All-Rite Paving & Redi-Mix, Inc.	OPERATOR REPRESENTATIVE: Jodi Schreiber, Bill Crum	TYPE OF OPERATION: 110c - Construction Limited Impact	
REASON FOR INSPECTION: Normal I&E Program	BOND CALCULATION TYPE: Complete Bond	BOND AMOUNT: \$23,800.00	
DATE OF COMPLAINT: NA	POST INSP. CONTACTS: None	JOINT INSP. AGENCY: None	
WEATHER: Clear	INSPECTOR'S SIGNATURE:

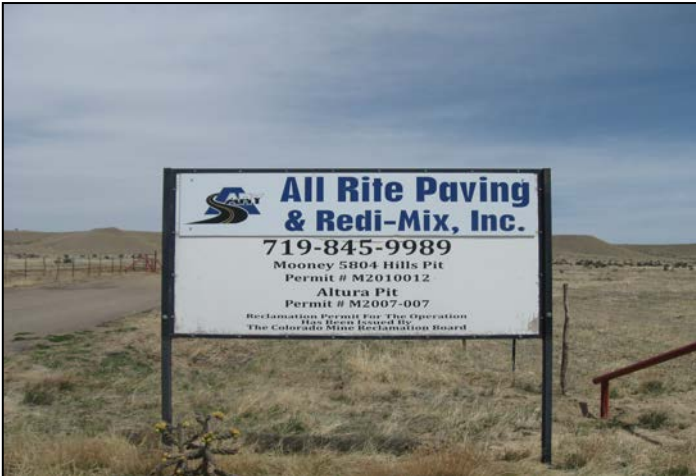
The permit sign was posted at the site entrance and the boundary of the affected lands was clearly marked with monuments.

1. Permit sign at site entrance.

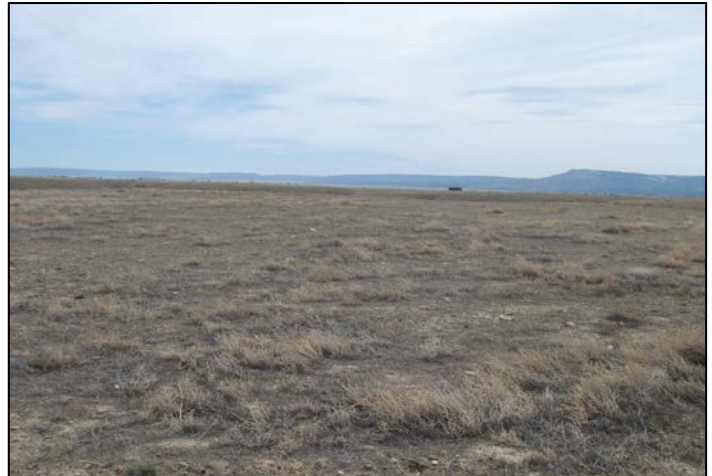
Mining at the Mooney Hills site consists of removing aggregate from the top of the mesa and mining has been conducted in such a way as to create a level area on top of the mesa. The Operator has stockpiled topsoil in a berm along the edge of the mesa. The site was stable and did not show any signs of erosion on the side of the mesa.

2. Overview of the top of the mesa.

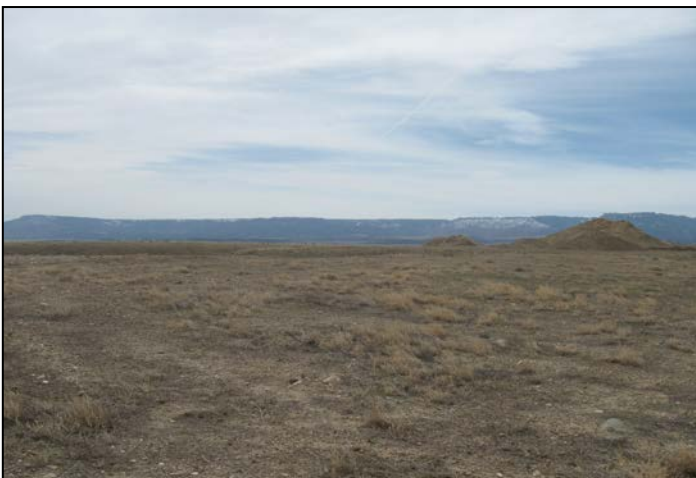
Reclamation at the Mooney Hills site has not commenced. There are several product stockpiles still in place, which will need to be removed prior to final reclamation. Once the product stockpiles have been removed, the remaining reclamation tasks will include replacing topsoil and seeding the affected area.

3. Remaining product stockpiles.
