Permit Number: C-1996-084 Mine Name: Lorencito Canyon Mine Operator: New Elk Coal Company, LLC Operator Address: Mr. Louis Head 12250 Highway 12 Weston, CO 81091	County: Las Animas Operation Type: Surface Permit Status: Permanent Cessation Ownership: Private
	Operator Representative Present: None
Operator Representative Signature: (Field Issuance Only)

Inspection Start Date: May 25, 2017 Inspection Start Time: 15:30 Inspection End Date: Inspection End Time:	Inspection Type: Coal Partial Inspection Inspection Reason: Normal I&E Program Weather: Clear
Joint Inspection Agency: None	Joint Inspection Contacts:
Post Inspection Agency: None	Post Inspection Contacts:
Inspector(s): Robert D. Zuber, P.E.	Inspector's Signature and Signature Date:

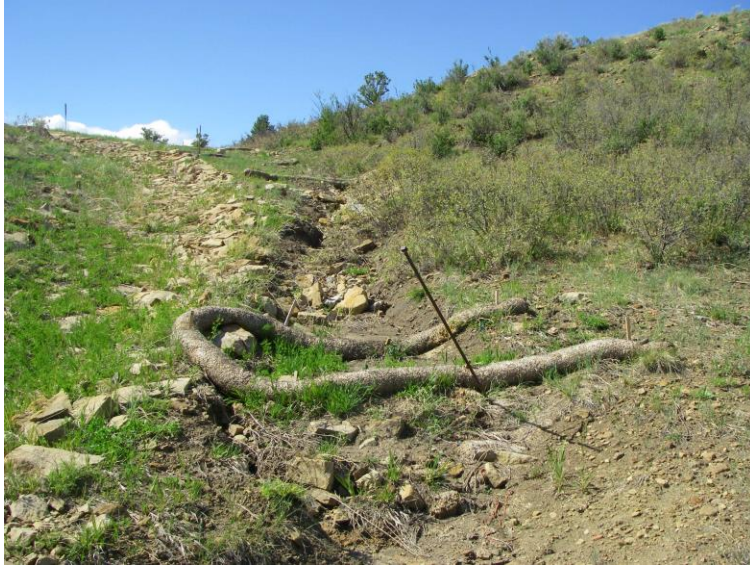
Ditch east of Pond 6

No problems were identified with the ditches and check dams above Pond 6 and the ditch east of this pond. Likewise, the lower contour ditch that drains the smaller portion of Fill 7 (southwest of the main Fill 7) appears to be in good shape.

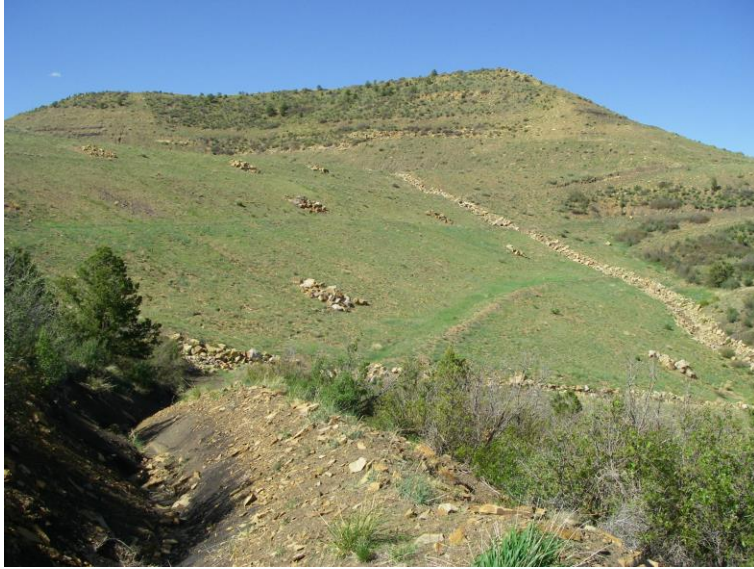
Fills 7, 8, and 9 were inspected; all were in good condition. No large bare areas or weed patches were seen, and there is good vegetation growth on all three fills. There were no signs of instability or erosion on the faces, and the rills on Fill 7 are healing.

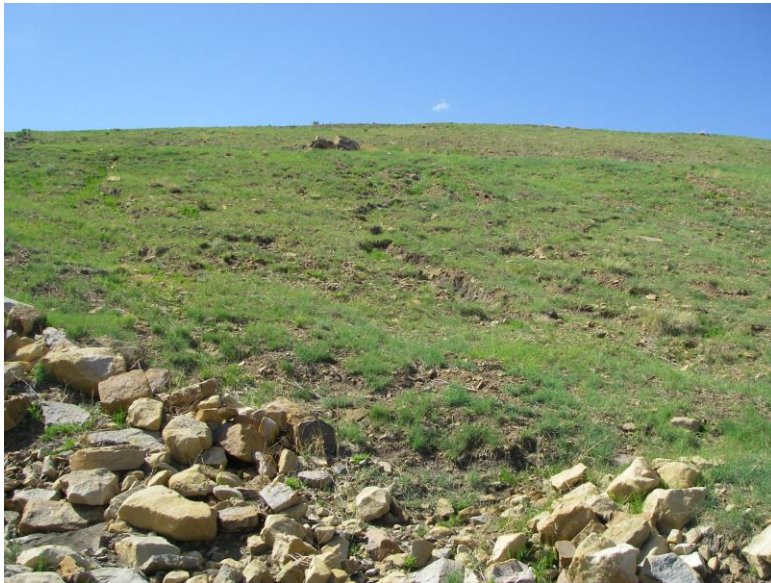
Fill 7 – rills healing

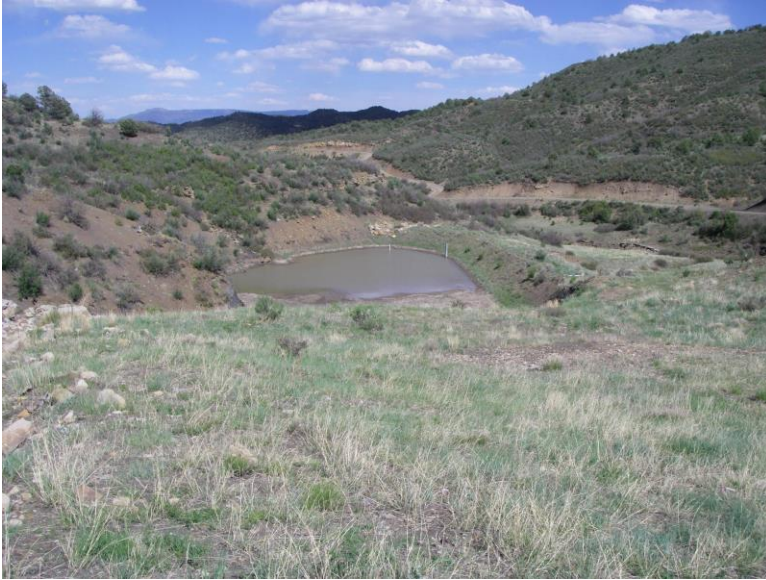
Pond 7

The following ponds were inspected: 6, 7, 8, 9, and 9A. All of them were holding significant amounts of turbid water from recent storms. Ponds 8, 9, and 9A were discharging clear water. Embankments and spillways were generally in good condition. The rills on the downstream side of the Pond 9 embankment appear to be functioning well but could use maintenance.

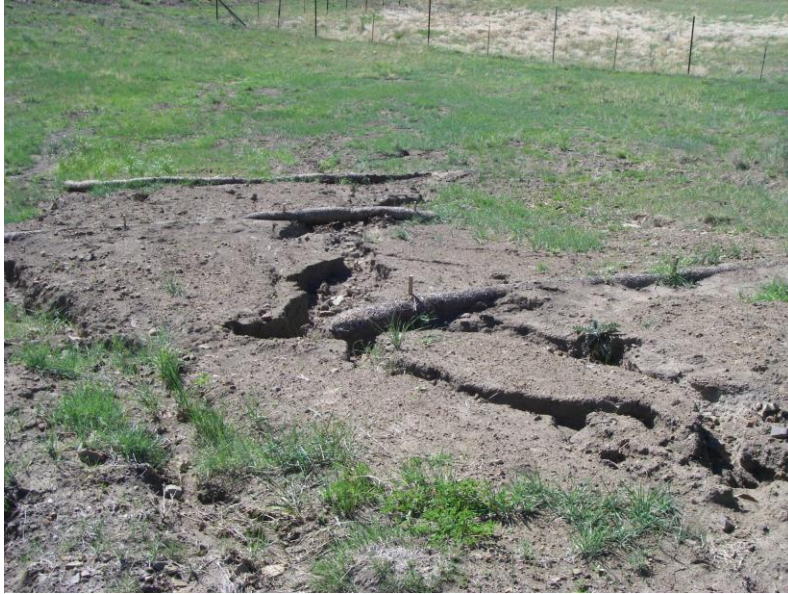
Erosion near shrub plot

Wattle and rill repair are needed in several areas, including (but not limited to):

- *The hill above the pond cleaning dump area.
- *The small drainage southeast of the shrub plot.
- *The hillside northeast of the shrub plot (west side of “the knob”).
- *The hillside above Pond 6 (where Fill 6 was planned).

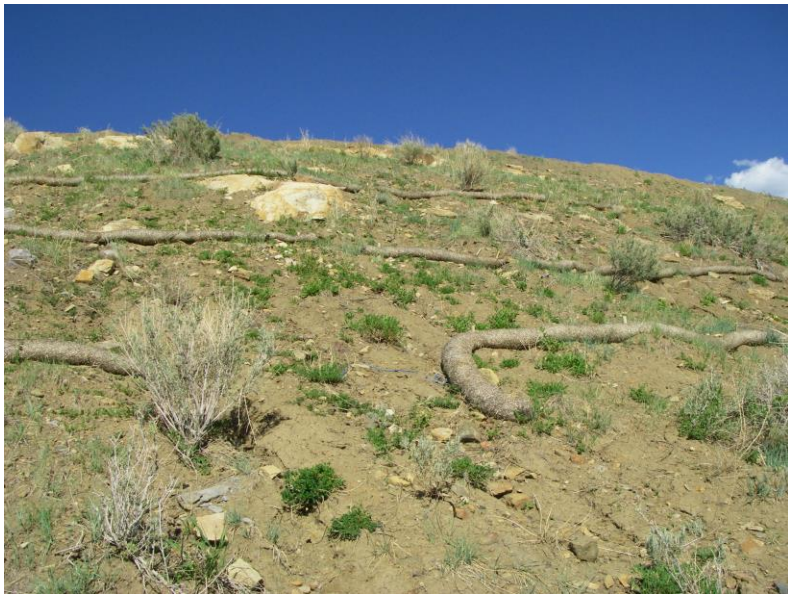
Need for wattle repair on west side of “the knob”

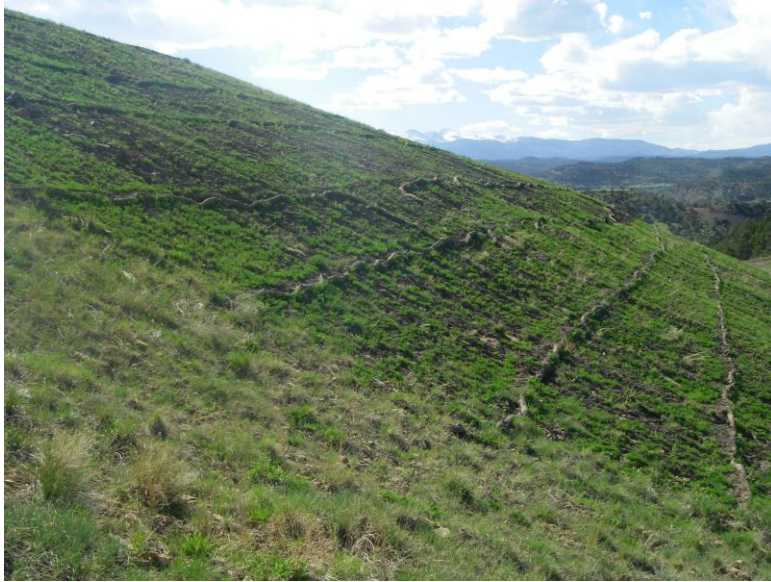
Need for wattle repair on hill west of the shrub plot (above dump area for pond cleanings)
