**COLORADO**Division of Reclamation,
Mining and Safety

MINERALS PROGRAM INSPECTION REPORT**PHONE: (303) 866-3567**

MINE NAME: Dillon Ranch Pit	MINE/PROSPECTING ID#: M-1987-064	MINERAL: Sand and gravel	COUNTY: La Plata
INSPECTION TYPE: Monitoring	INSPECTOR(S): Lucas J. West	INSP. DATE: April 5, 2017	INSP. TIME: 10:40
OPERATOR: Elam Construction, Inc. dba Sandco, Inc.	OPERATOR REPRESENTATIVE: Jodie O'rand	TYPE OF OPERATION: 112c - Construction Regular Operation	
REASON FOR INSPECTION: Normal I&E Program	BOND CALCULATION TYPE: None	BOND AMOUNT: \$31,118.07	
DATE OF COMPLAINT: NA	POST INSP. CONTACTS: None	JOINT INSP. AGENCY: None	
WEATHER: Clear	INSPECTOR'S SIGNATURE:

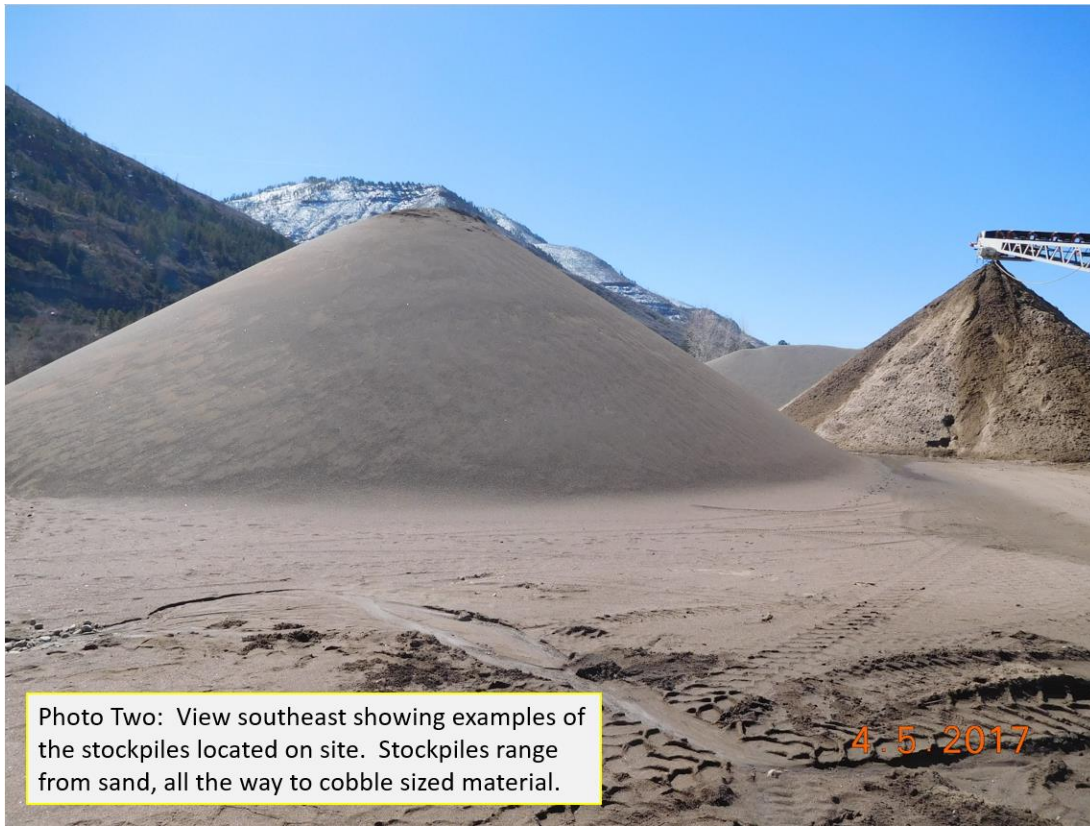
Photo Two: View southeast showing examples of the stockpiles located on site. Stockpiles range from sand, all the way to cobble sized material.

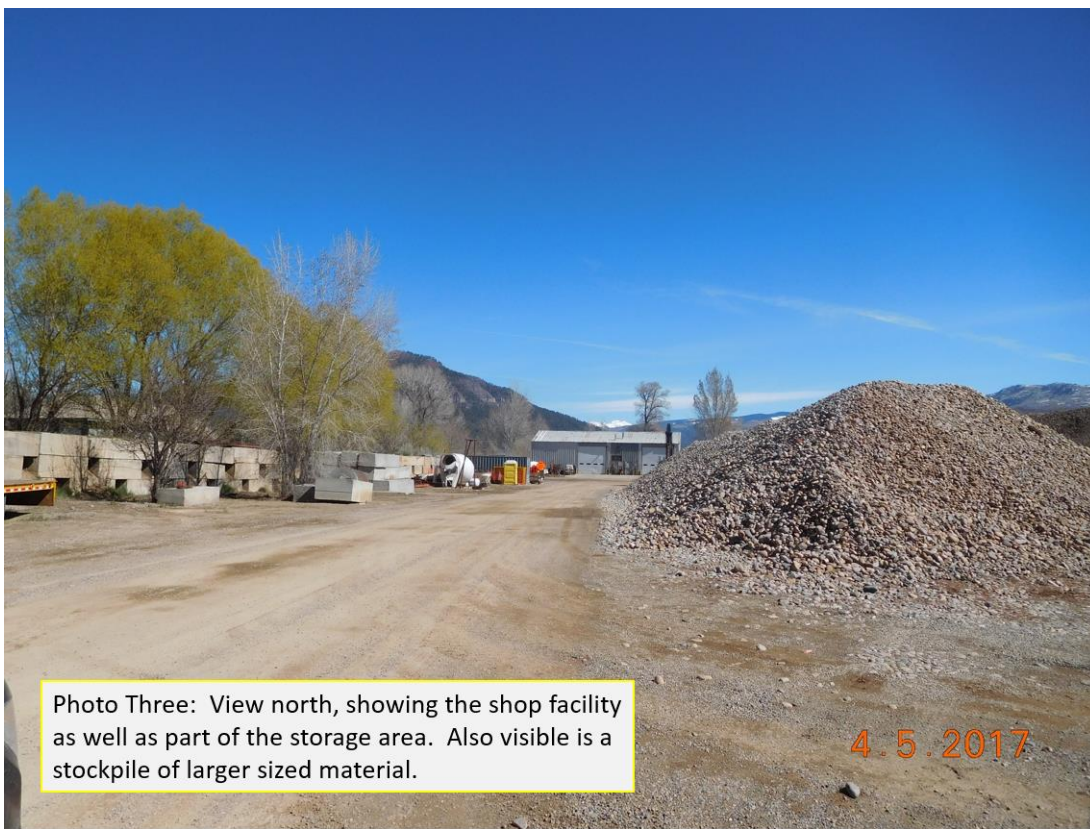
Photo Three: View north, showing the shop facility as well as part of the storage area. Also visible is a stockpile of larger sized material.

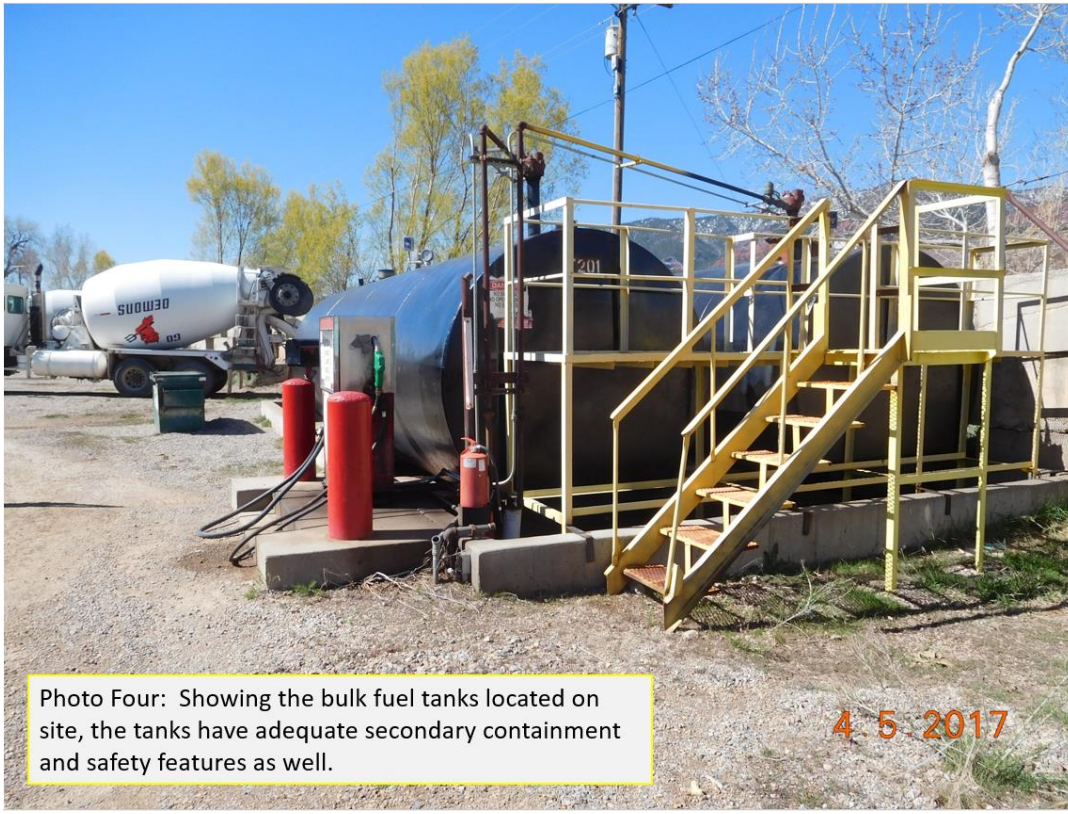
Photo Four: Showing the bulk fuel tanks located on site, the tanks have adequate secondary containment and safety features as well.

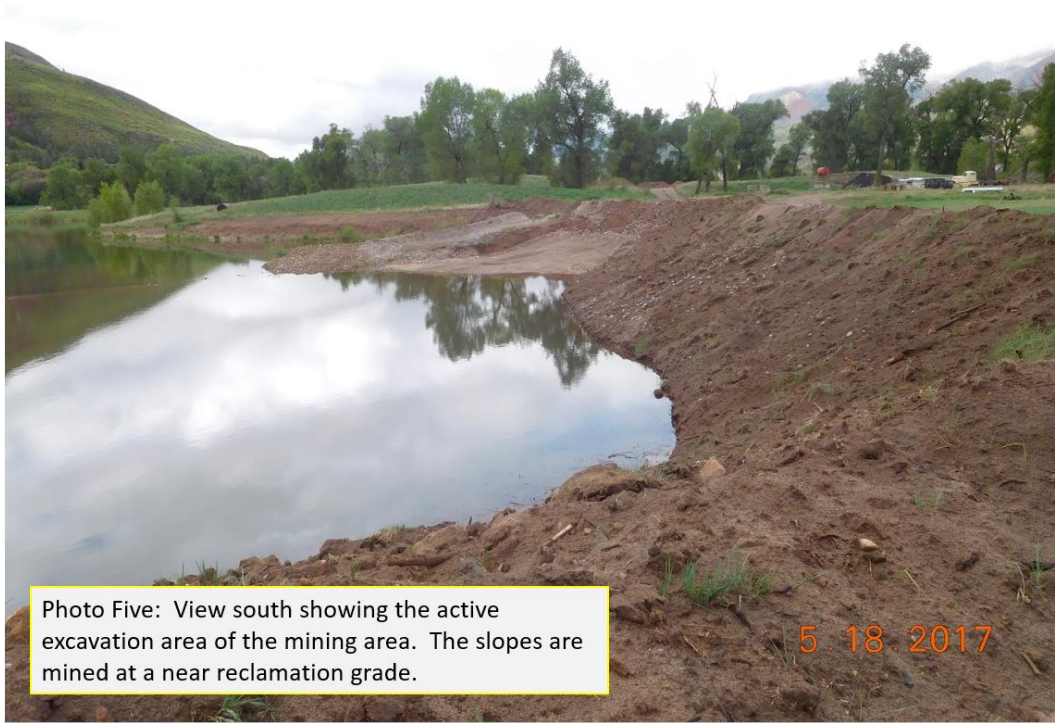
Photo Five: View south showing the active excavation area of the mining area. The slopes are mined at a near reclamation grade.

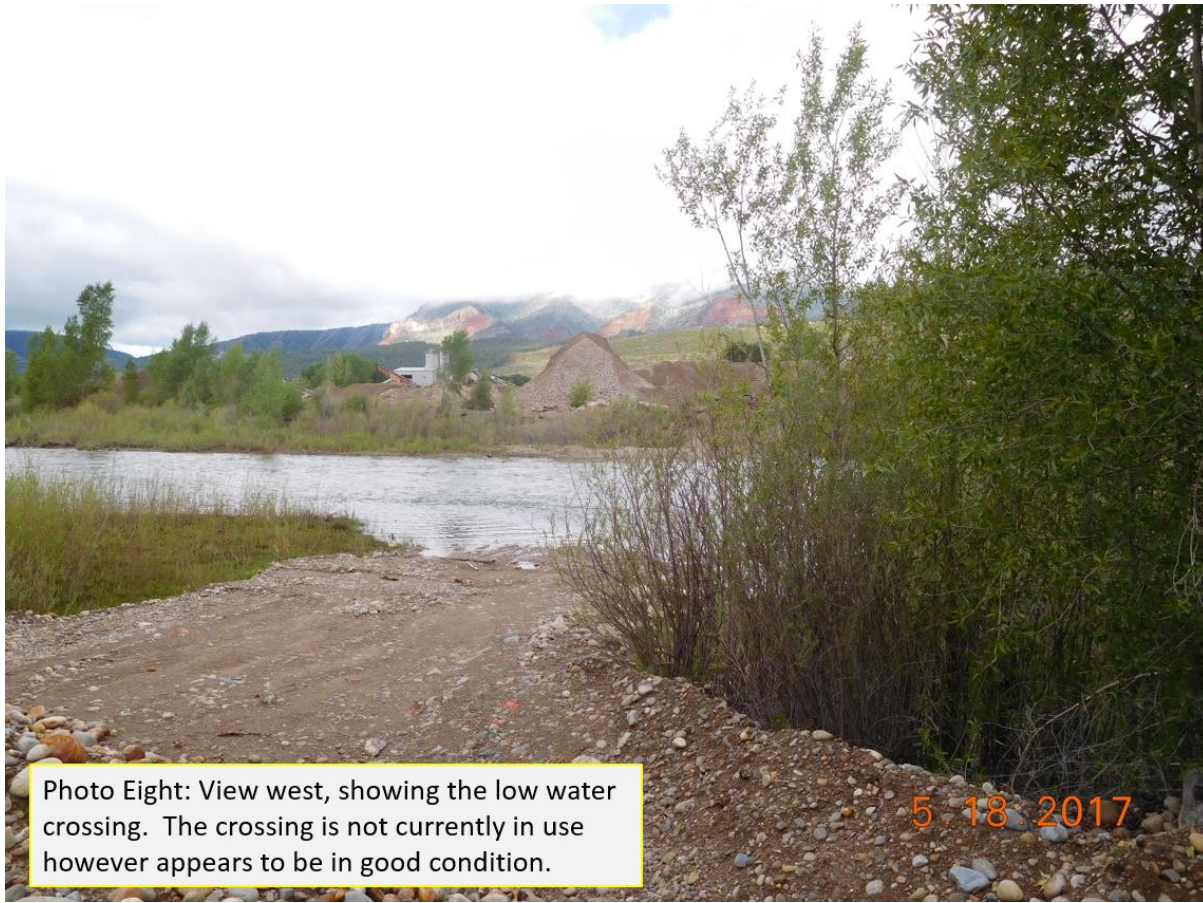
The two sections of the site are connected by a permitted low water crossing across the Animas River. During periods of low water, the flood protection dykes are breached to allow for truck traffic to pass between the two areas. All other times of the year the dykes are restored and truck traffic is routed around to Trimble Lane. Photo Eight shows the low water crossing which was not in use during the inspection but appears to be

stable and in good condition.
