Permit Number: C-1981-013 Mine Name: Golden Eagle Mine Operator: New Elk Coal Company, LLC Operator Address: Mr. Louis Head 12250 Highway 12 Weston, CO 81091	County: Las Animas Operation Type: Underground Permit Status: Permanent Cessation Ownership: Private
	Operator Representative Present:
Operator Representative Signature: (Field Issuance Only)

Inspection Start Date: May 26, 2017 Inspection Start Time: 06:45 Inspection End Date: Inspection End Time:	Inspection Type: Coal Partial Inspection Inspection Reason: Normal I&E Program Weather: Clear
Joint Inspection Agency: None	Joint Inspection Contacts:
Post Inspection Agency: None	Post Inspection Contacts:
Inspector(s): Robert D. Zuber, P.E.	Inspector's Signature and Signature Date:

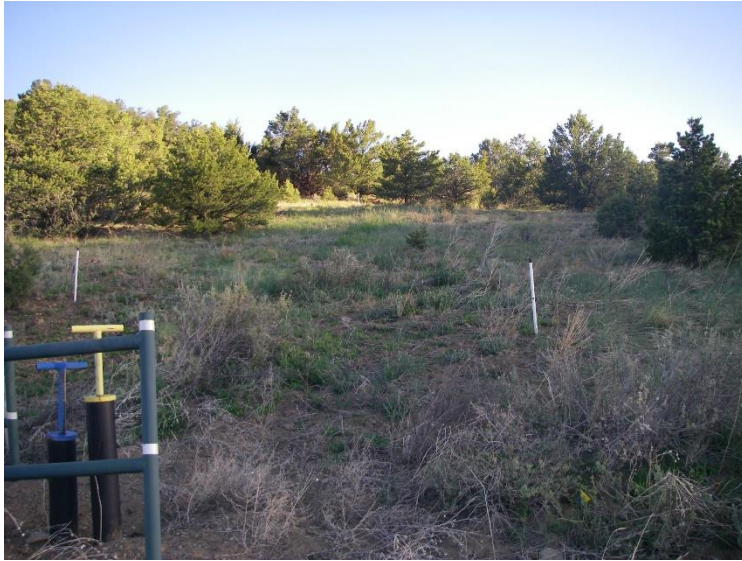
The following reclaimed areas look good, with no large bare areas or weed patches and good vegetative cover:

- The former road (both directions from road to gas production facilities).
- The area that once was a pad for an exhaust shaft.
- The reclaimed area above the ditch segment where repairs were performed in 2016.

Reclaimed road to pad

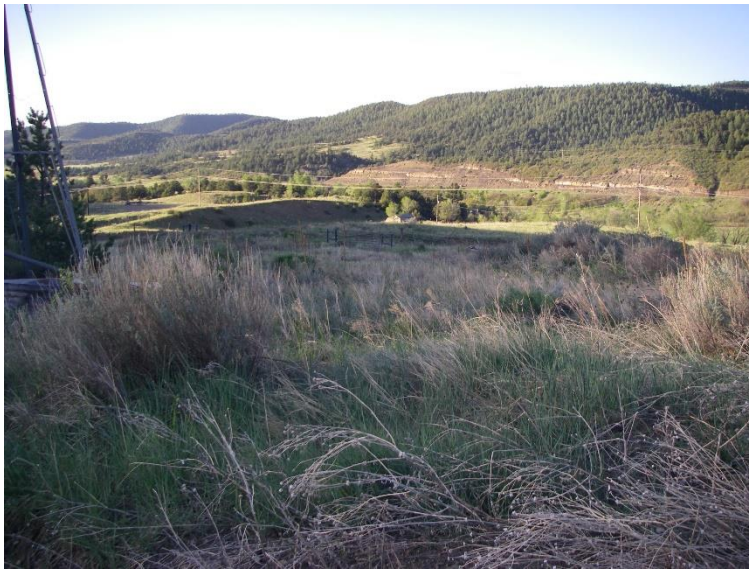
Lower part of reclaimed road

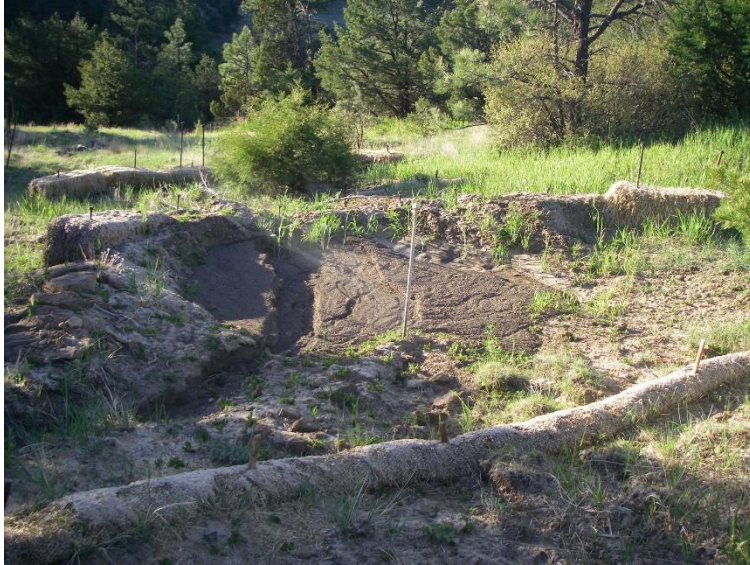
The straw bales on the north side of the site appear to be functioning although maintenance is needed immediately. One row of bales has washed out, and another row is filled with sediment.

Washed out BMPs

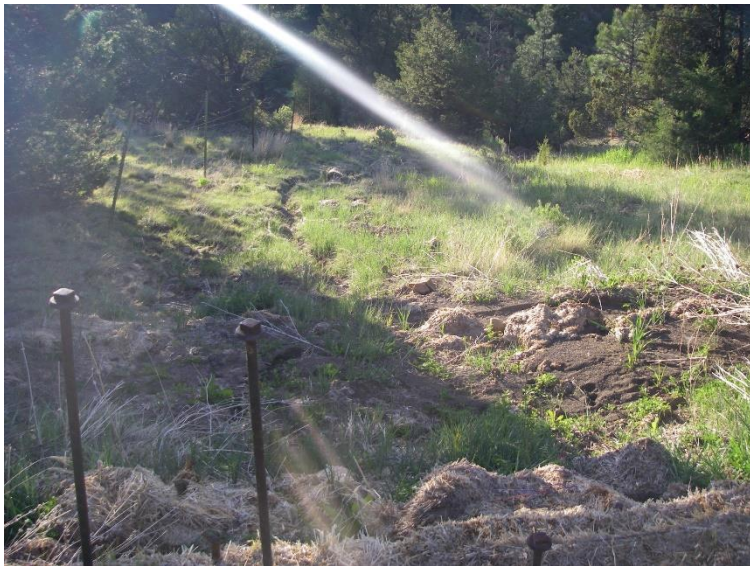
Area below BMPs
