MINERALS PROGRAM INSPECTION REPORT**PHONE: (303) 866-3567**

MINE NAME: Mooney 5804 Altura Pit	MINE/PROSPECTING ID#: M-2010-012	MINERAL: Sand and gravel	COUNTY: Las Animas
INSPECTION TYPE: Monitoring	INSPECTOR(S): Michael A. Cunningham	INSP. DATE: April 11, 2017	INSP. TIME: 13:30
OPERATOR: All-Rite Paving & Redi-Mix, Inc.	OPERATOR REPRESENTATIVE: Jodi Schreiber, Phil Crum	TYPE OF OPERATION: 112c - Construction Regular Operation

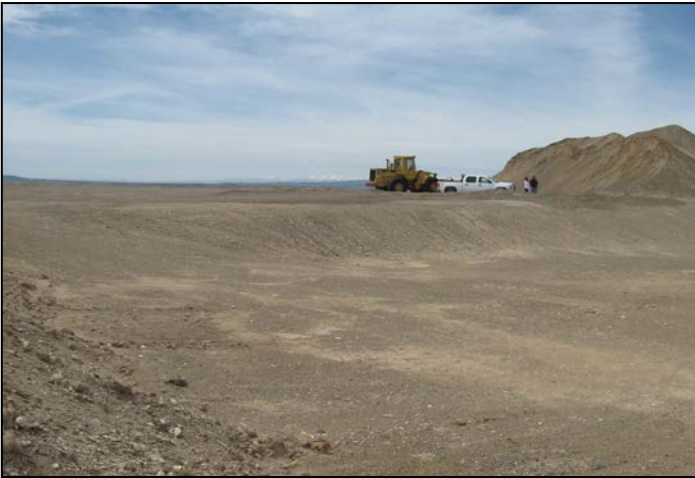
The site was not active at the time of the inspection. The mining operation is comprised of 3 phases. Mining within Phase 1 is complete and the Operator has initiated mining within Phase 2. Mining is occurring on an upland terrace and consists of removing aggregate to create a level platform on top of the mesa. Topsoil has been stripped and stockpiled into berms along the perimeter of the mesa. The natural slopes below the top of the mesa were stable and did not show any signs of erosion. Stormwater runoff from the top of the mesa is managed with the perimeter berms. All mined slopes have been graded to 3H:1V or flatter.

1. Mining slopes graded to 3H:1V.

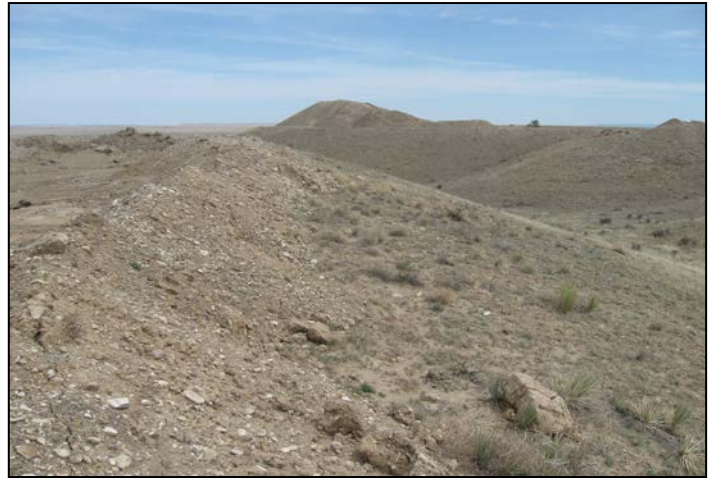
2. Perimeter berms.

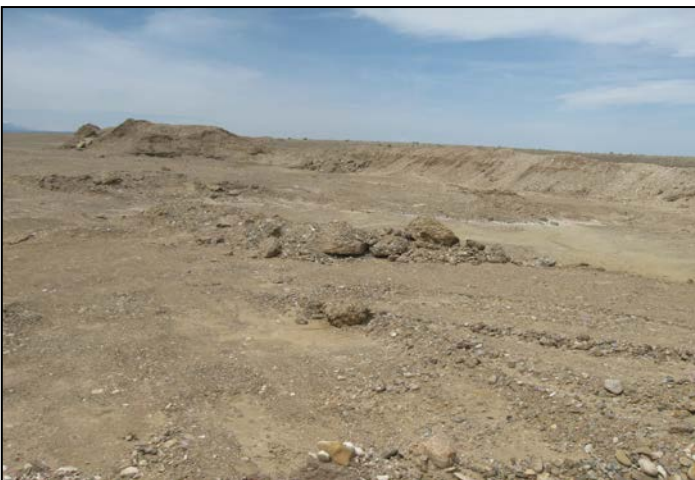
3. Mining area within Phase 3.

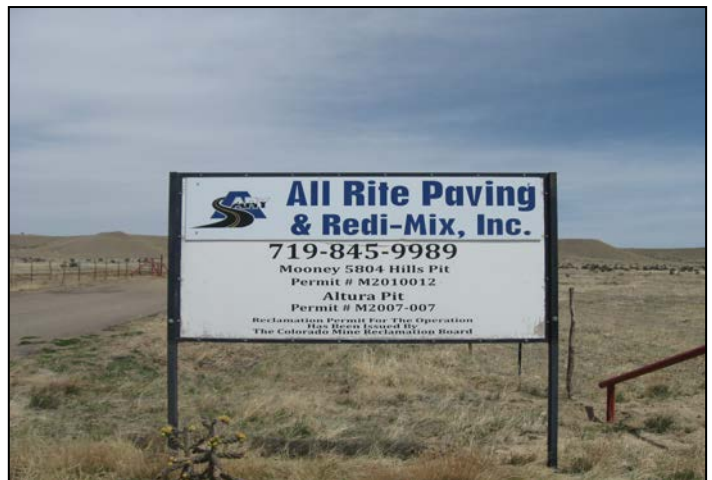
The permit sign was posted at the site entrance and the boundary of the affected area was clearly delineated with monuments.

4. Permit sign at site entrance.
