PERMIT INFORMATION

Permit Number: C-1981-012 Mine Name: New Elk Mine Operator: New Elk Coal Company, LLC Operator Address: Mr. Louis Head 12250 Highway 12 Weston, CO 81091	County: Las Animas Operation Type: Underground Permit Status: Active Ownership: Private
	Operator Representative Present: Jim Begano
Operator Representative Signature: (Field Issuance Only)

INSPECTION INFORMATION

Inspection Start Date: May 26, 2017 Inspection Start Time: 07:00 Inspection End Date: Inspection End Time:		Inspection Type: Coal Partial Inspection Inspection Reason: Normal I&E Program Weather: Clear	
Joint Inspection Agency: None		Joint Inspection Contacts: 	
Post Inspection Agency: None		Post Inspection Contacts: 	
Inspector(s): Robert D. Zuber, P.E.	Inspector's Signature:

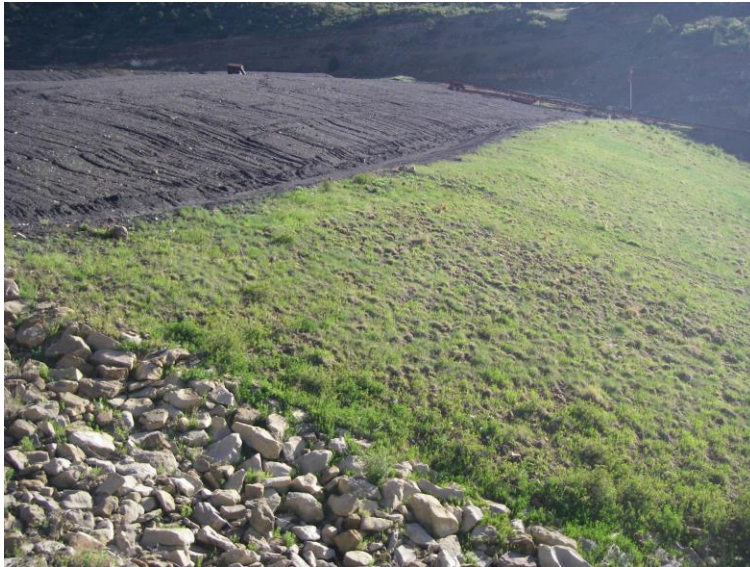
The upper (un-reclaimed) portion of the RDA still requires grading of material. The interface between the upper portion of the RDA and the lower (reclaimed) portion looks good, with the ditch deep enough to prevent flow of runoff over the berm. There is good vegetation cover on the reclaimed portion of the RDA.

RDA – interface between reclamation and un-reclaimed portion

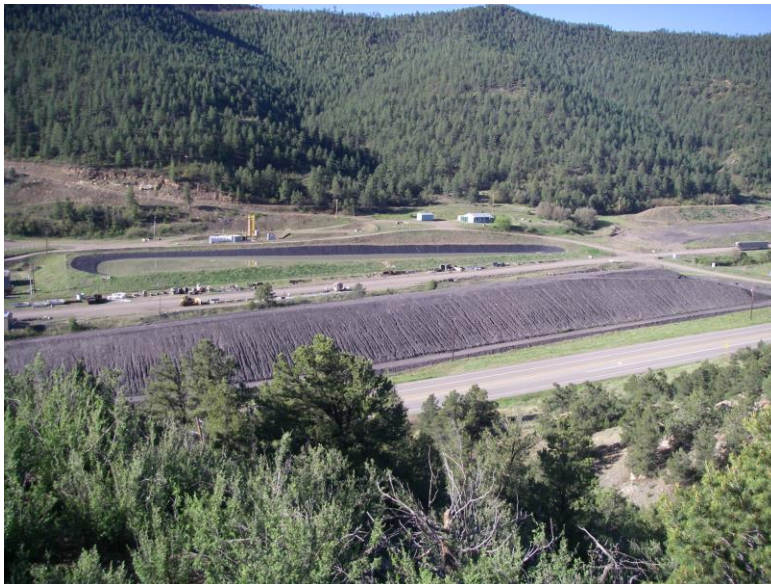
Ponds 001A, 006A, 007A, and 08 were not discharging, and the impounded water was below the spillways in all three ponds. No inflow was seen for any of the ponds. No significant issues were seen with the pond structures.

DWDA#2 and Pond 001A (from RDA road)

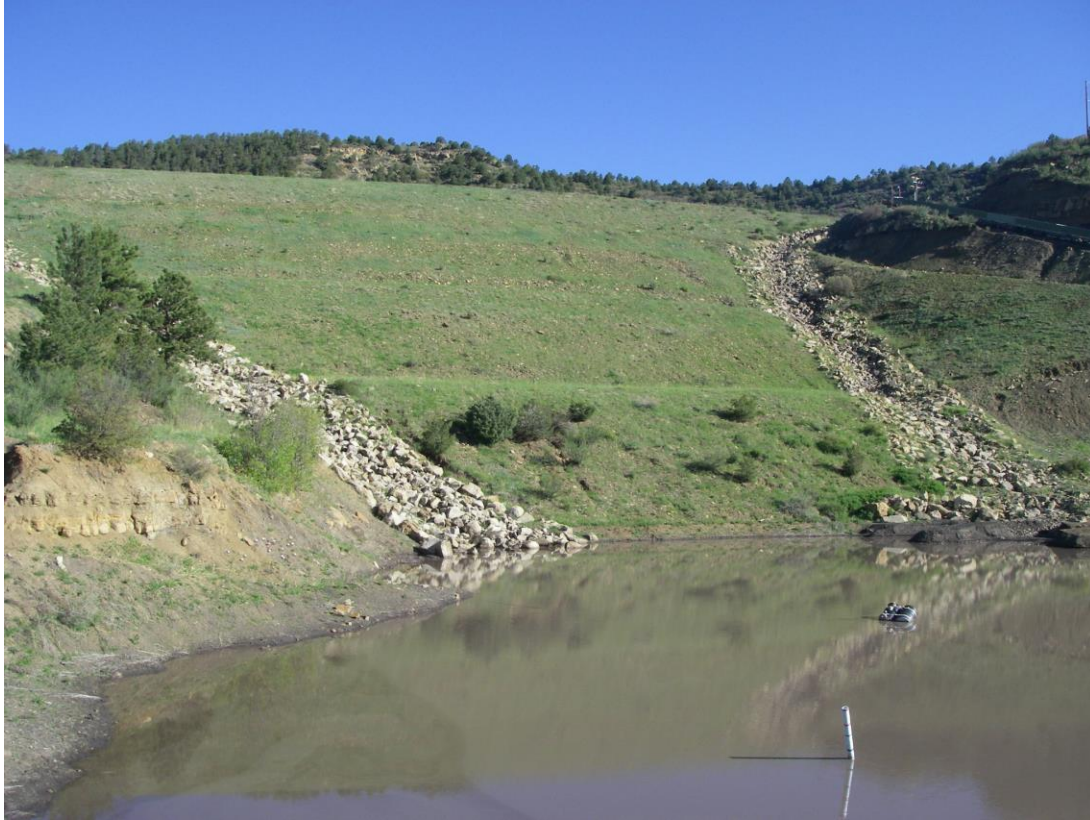
RDA and portion of Pond 08
