MINERALS PROGRAM INSPECTION REPORT
PHONE: (303) 866-3567

MINE NAME: Bulkley Pit No 17	MINE/PROSPECTING ID#: M-1981-138	MINERAL: Sand and gravel	COUNTY: Baca
INSPECTION TYPE: Monitoring	INSPECTOR(S): Michael A. Cunningham	INSP. DATE: April 12, 2017	INSP. TIME: 11:00
OPERATOR: Baca County	OPERATOR REPRESENTATIVE: Norm Shaw, Eric Holcomb	TYPE OF OPERATION: 112c - Construction Regular Operation	
REASON FOR INSPECTION: Normal I&E Program	BOND CALCULATION TYPE: None	BOND AMOUNT: \$0.00	
DATE OF COMPLAINT: NA	POST INSP. CONTACTS: None	JOINT INSP. AGENCY: None	
WEATHER: Clear	INSPECTOR'S SIGNATURE:

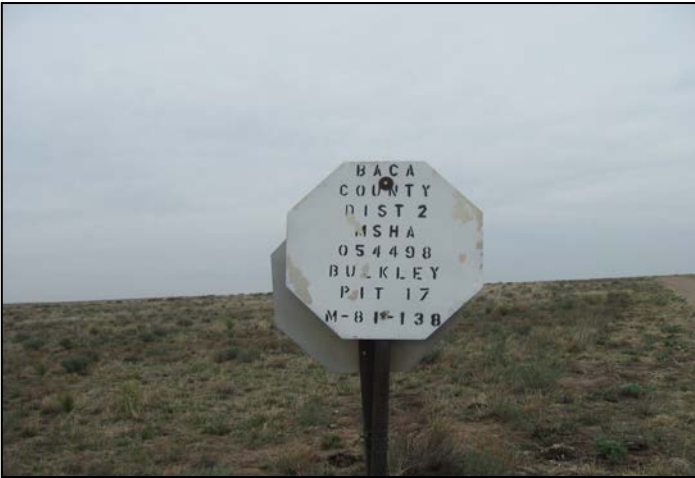
The permit sign was posted at the site entrance and the boundary of the affected area was clearly delineated with monuments.

1. Permit sign at site entrance.

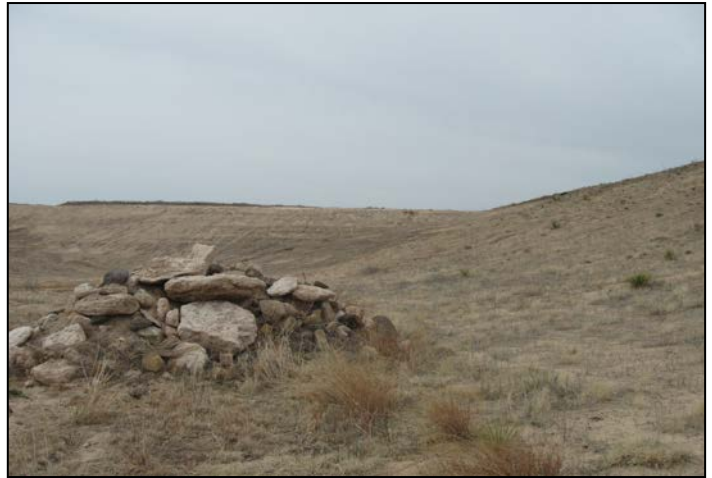
2. Overview of pit floor, facing south.

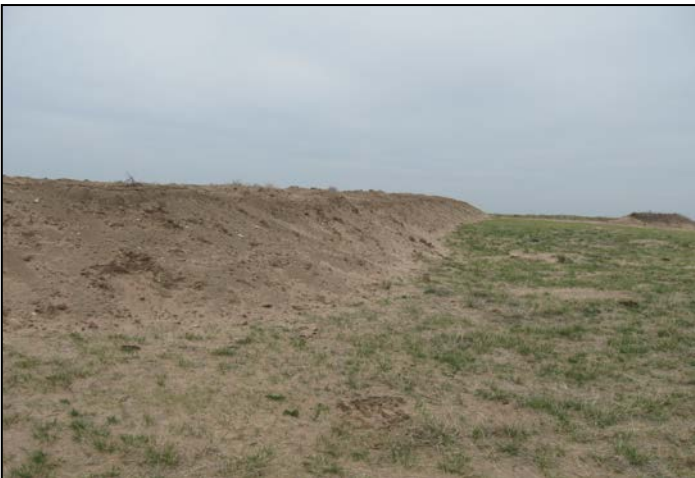
3. Topsoil stockpile.

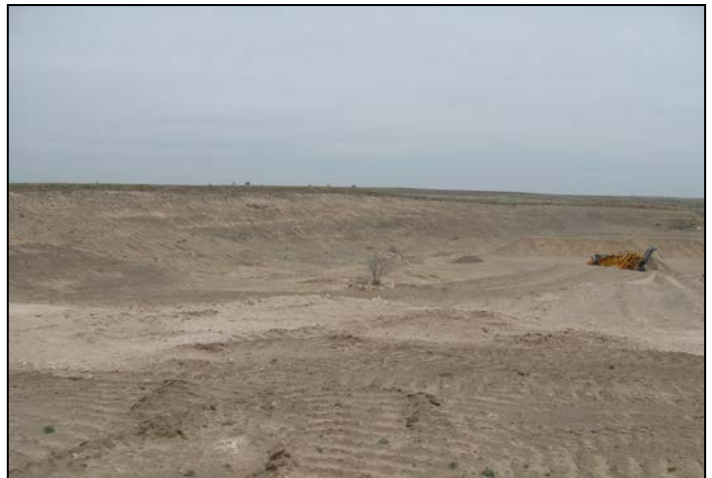
4. Overview of pit, facing north.
