MINERALS PROGRAM INSPECTION REPORT**PHONE: (303) 866-3567**

MINE NAME: Hubbs Pit	MINE/PROSPECTING ID#: M-1987-088	MINERAL: Sand and gravel	COUNTY: La Plata
INSPECTION TYPE: Surety-Related Inspection	INSPECTOR(S): Lucas J. West	INSP. DATE: May 18, 2017	INSP. TIME: 10:08
OPERATOR: Hubbs III, LLC	OPERATOR REPRESENTATIVE: Barbara Hubbs	TYPE OF OPERATION: 112c - Construction Regular Operation	
REASON FOR INSPECTION: Surety Related	BOND CALCULATION TYPE: Complete Bond	BOND AMOUNT: \$59,905.00	
DATE OF COMPLAINT: NA	POST INSP. CONTACTS:	JOINT INSP. AGENCY: None	
WEATHER: Cloudy	INSPECTOR'S SIGNATURE:

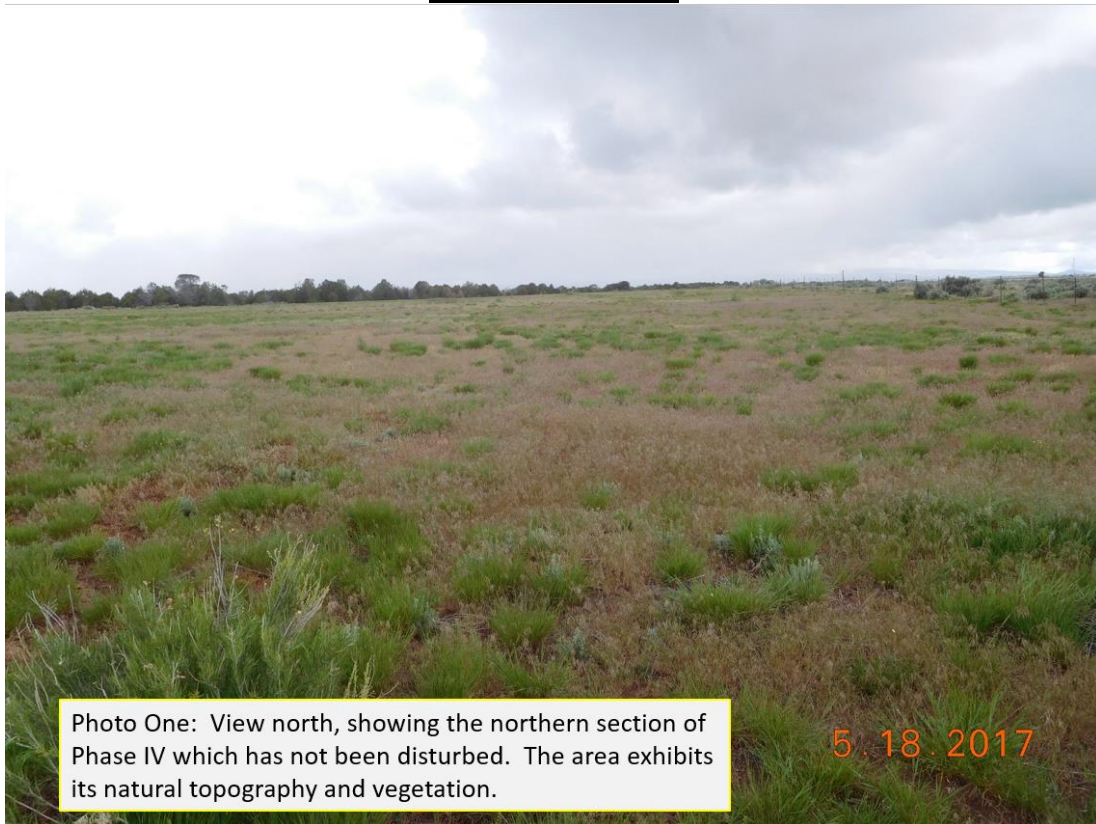
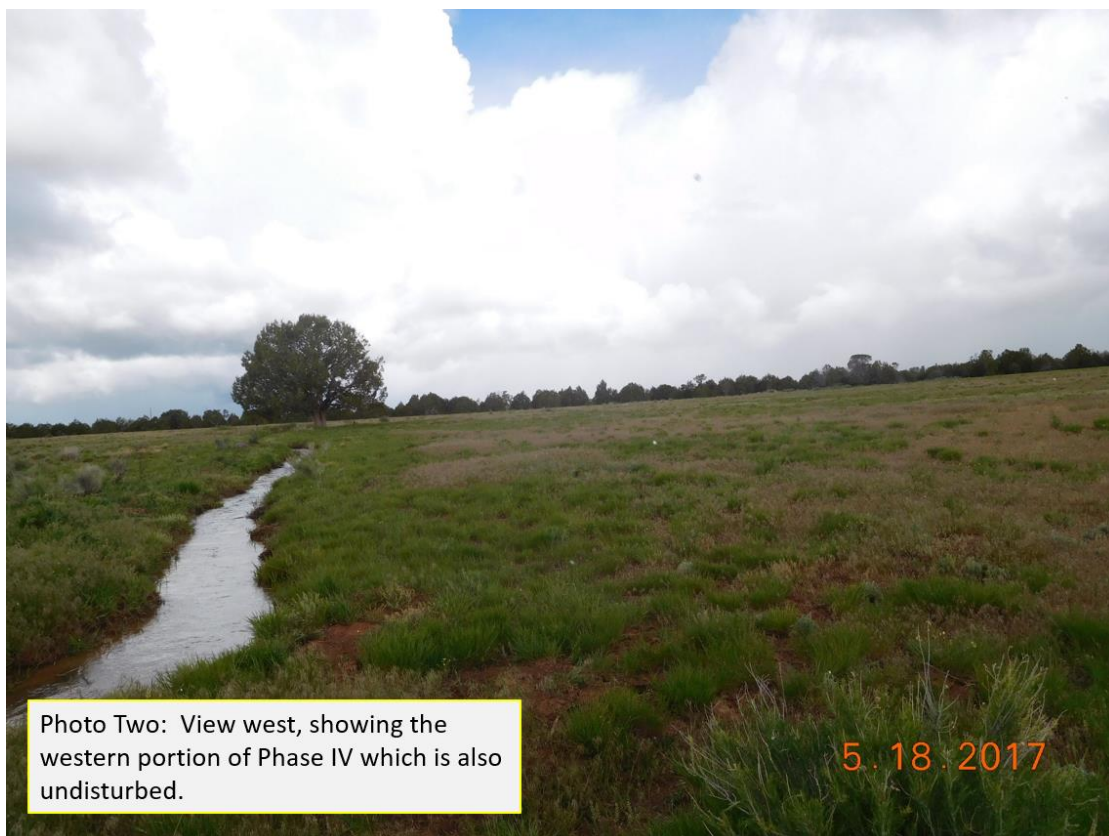
The proper Mine ID signage was posted at the entrance to the site, and mining activities were being conducted in Phase III of the permitted area. The active operations were not inspected at this time. The area to be released is Phase IV, which consists of 10.31 Acres of rangeland that lies just north of County Road 133. This area, which can be seen in Photos One and Two has not been disturbed by mining activities. No equipment was observed in the area, and no signs of activities related to mining of any kind were observed. The area exhibits its natural topography and vegetation. No signs of erosion or noxious weeds were identified during this inspection.
