**MINERALS PROGRAM INSPECTION REPORT**  
**PHONE: (303) 866-3567**

<b>MINE NAME:</b> Shannon Pit	<b>MINE/PROSPECTING ID#:</b> M-1979-163	<b>MINERAL:</b> Sand and gravel	<b>COUNTY:</b> Las Animas
<b>INSPECTION TYPE:</b> Monitoring	<b>INSPECTOR(S):</b> Michael A. Cunningham	<b>INSP. DATE:</b> April 12, 2017	<b>INSP. TIME:</b> 08:30
<b>OPERATOR:</b> Las Animas County	<b>OPERATOR REPRESENTATIVE:</b> Clell Goode	<b>TYPE OF OPERATION:</b> 112c - Construction Regular Operation	
<b>REASON FOR INSPECTION:</b> Normal I&E Program	<b>BOND CALCULATION TYPE:</b> None	<b>BOND AMOUNT:</b> \$0.00	
<b>DATE OF COMPLAINT:</b> NA	<b>POST INSP. CONTACTS:</b> None	<b>JOINT INSP. AGENCY:</b> None	
<b>WEATHER:</b> Clear	<b>INSPECTOR'S SIGNATURE:</b>

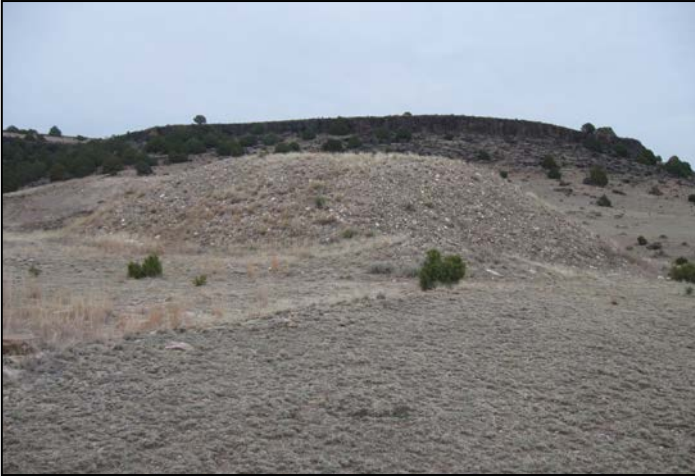
Topsoil has been salvaged and stockpiled along the southern and western permit boundaries.

1. Topsoil stockpile.

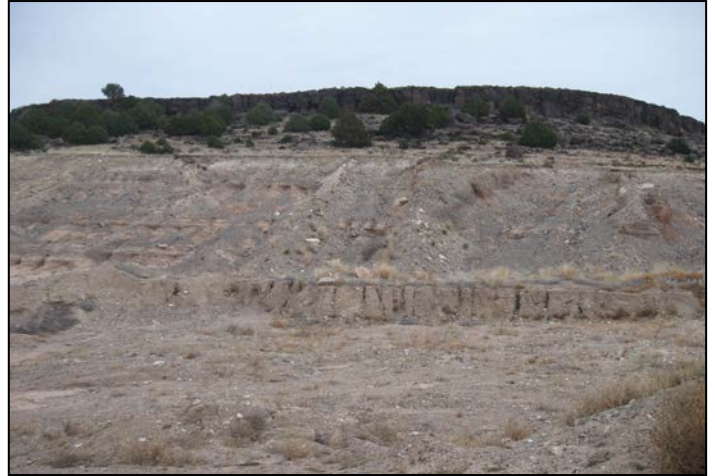
The eastern pit slope has been excavated into the side of the Tecolote Mesa and is approximately 50' in length and is at an angle of 2H:1V. The Operator has run out of room to lay the slope back to a 3H:1V angle. The approved Reclamation Plan calls for excavating slopes along the perimeter of the pit at 3H:1V. The Reclamation Plan also states where 3H:1V slopes are not created, those areas are to be backfilled with waste material to achieve the final grade. The Operator has enough material remaining on site to backfill the eastern slope to 3H:1V. Since the eastern pit slope has reached the limits of the permit boundary and will require backfilling, the Operator should conduct no further mining of this pit slope.

2. Eastern pit wall.

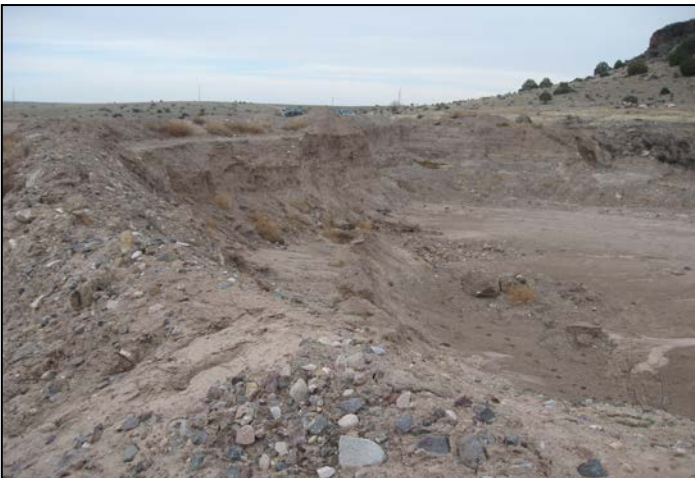
3. Overview of pit, photo taken facing north.

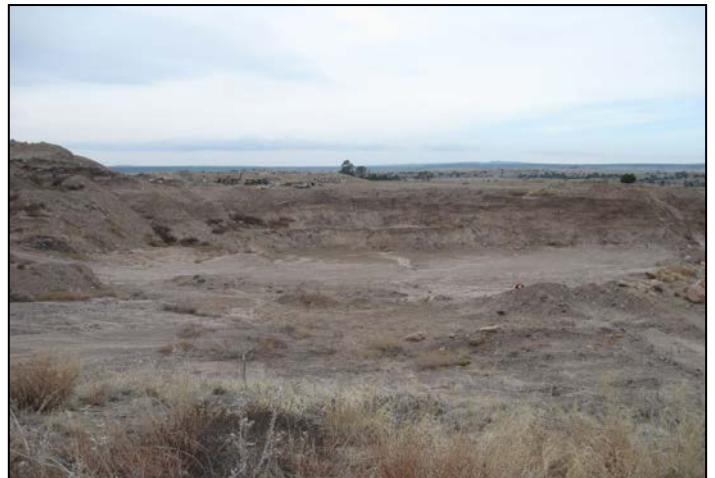
4. Overview of pit, photo taken facing west.
