**MINERALS PROGRAM INSPECTION REPORT****PHONE: (303) 866-3567**

<b>MINE NAME:</b> Garrett Pit	<b>MINE/PROSPECTING ID#:</b> M-1978-271	<b>MINERAL:</b> Gravel	<b>COUNTY:</b> Conejos
<b>INSPECTION TYPE:</b> Monitoring	<b>INSPECTOR(S):</b> Dustin M. Czapla	<b>INSP. DATE:</b> May 15, 2017	<b>INSP. TIME:</b> 13:00
<b>OPERATOR:</b> Asphalt Gravel Products, Inc.	<b>OPERATOR REPRESENTATIVE:</b> Alonzo Salazar	<b>TYPE OF OPERATION:</b> 112c - Construction Regular Operation

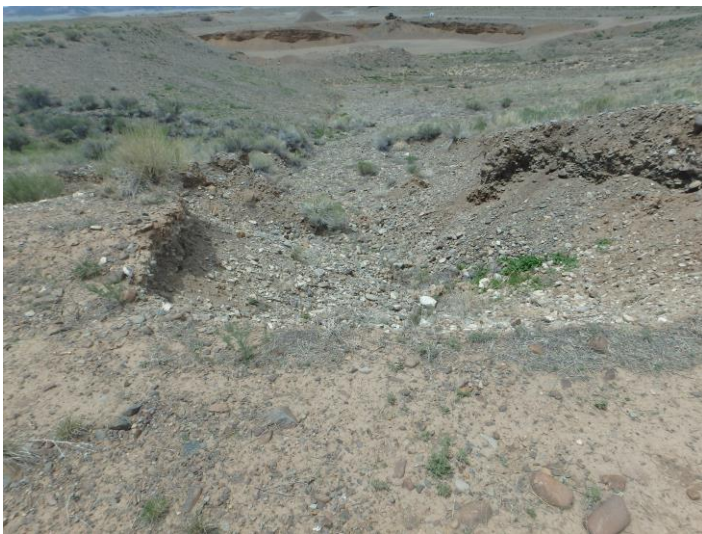
**PROBLEM/POSSIBLE VIOLATION:** Problem: An erosion gully was observed on the east side of the pit. The gully is head-cutting toward the permit boundary. This is a problem at this time for failure to protect the affected land from erosion.

An erosion feature has formed on the east pit wall. The gully is headcutting toward the permit boundary and needs to be repaired. This has been noted as a problem on page one of this report.

Erosion feature on east side

**CORRECTIVE ACTIONS:** Provide photo documentation to the Division verifying the erosion gully has been repaired, and that the site has been reconstructed and stabilized to prevent erosion damage by the corrective action due date.

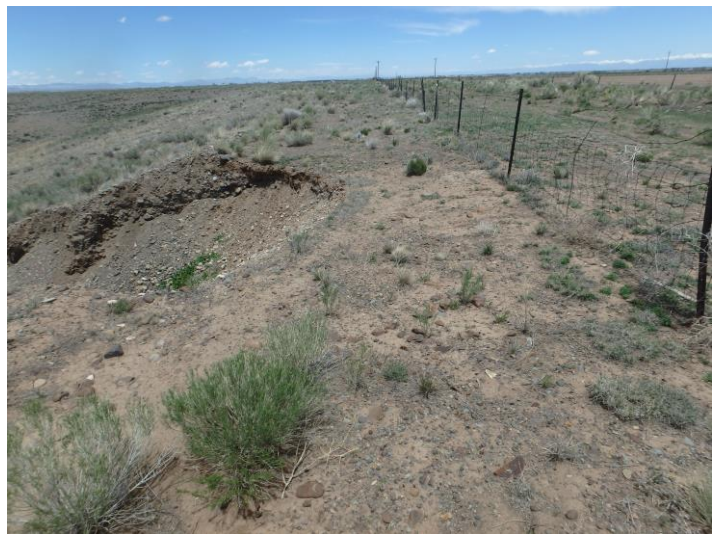
Erosion feature on east side
