MINERALS PROGRAM INSPECTION REPORT
PHONE: (303) 866-3567

MINE NAME: Red Arrow Dome	MINE/PROSPECTING ID#: P-2009-018	MINERAL: Silver, gold and copper	COUNTY: Montezuma
INSPECTION TYPE: Monitoring	INSPECTOR(S): Lucas J. West	INSP. DATE: May 18, 2017	INSP. TIME: 11:00
OPERATOR: Red Arrow Gold Corporation in Receivership	OPERATOR REPRESENTATIVE: None	TYPE OF OPERATION: MP - Mineral Prospecting	
REASON FOR INSPECTION: Normal I&e Program	BOND CALCULATION TYPE: None	BOND AMOUNT: \$2,000.00	
DATE OF COMPLAINT: NA	POST INSP. CONTACTS: None	JOINT INSP. AGENCY: None	
WEATHER: Snowing	INSPECTOR'S SIGNATURE:

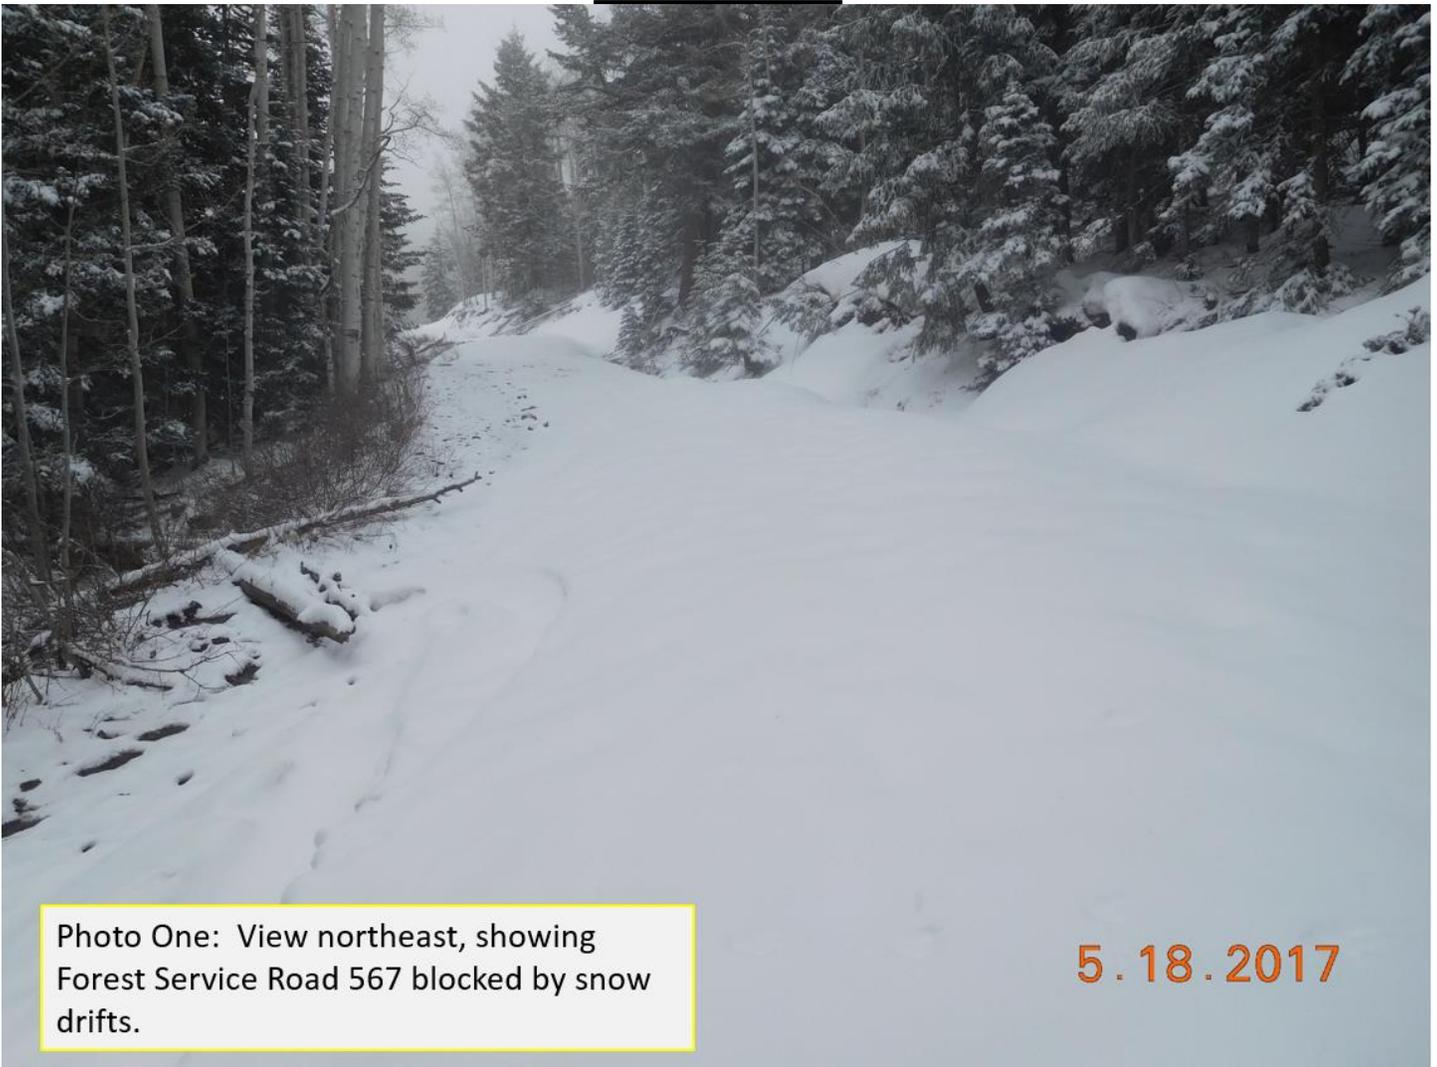
This inspection was attempted as part of the normal monitoring program established by the Colorado Division of Reclamation, Mining and Safety for Hard Rock and Metals Prospecting NOI's. The purpose of this inspection was to determine the status of the above listed NOI as well as NOI No. P-2012-007 which is in the similar area and held by the same Operator. Division Staff attempted to gain access to the site however approximately 3.5 Miles up Forest Service Road 567 the conditions were impassible. Photo One shows the road which was obstructed by 2 to 3 foot snow drifts. Division staff will attempt a follow up inspection at a later date when conditions allow.

Photo One: View northeast, showing Forest Service Road 567 blocked by snow drifts.
