MINERALS PROGRAM INSPECTION REPORT**PHONE: (303) 866-3567**

MINE NAME: Colorado Rose Red Pit	MINE/PROSPECTING ID#: M-1978-332	MINERAL: Granite, granite gneiss	COUNTY: Larimer
INSPECTION TYPE: Monitoring	INSPECTOR(S): Jared L. Ebert	INSP. DATE: May 15, 2017	INSP. TIME: 10:00
OPERATOR: Colorado Rose Red Inc.	OPERATOR REPRESENTATIVE: Caleb Liesveld	TYPE OF OPERATION: 110c - Construction Limited Impact

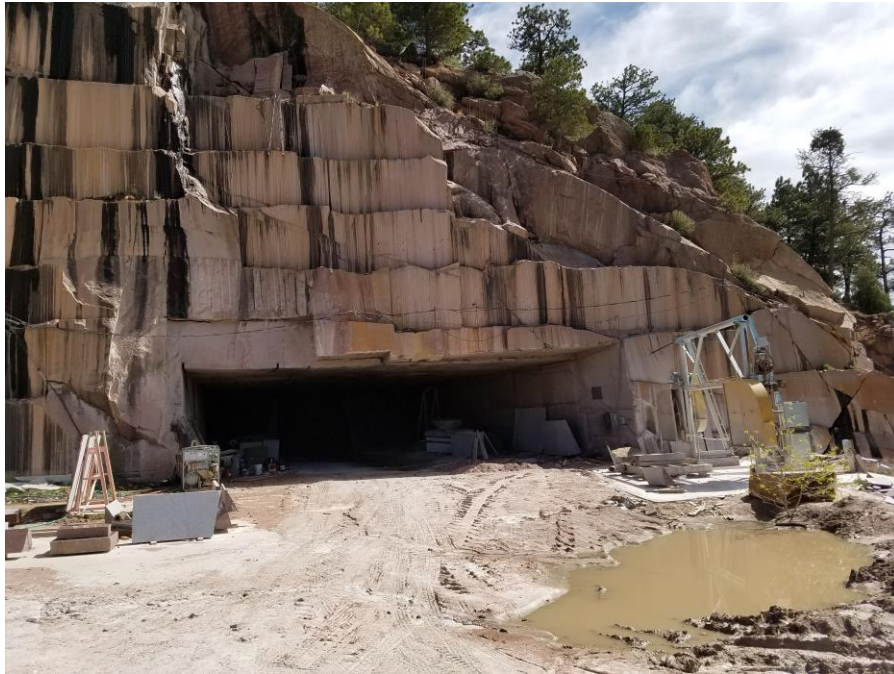
At this time it does not appear the Operator is lowering the existing working deck and have instead quarried underground. The site consists of two benches where the access road enters the site. The lower bench is not very wide and may only accommodate a small vehicle, the upper bench is about 175 feet long and about 120 feet wide. Below these working decks is waste rock and rubble from the historic mining operation at the site. The Operator has created three underground rooms/adits, all of them are about 15 feet in height. The western most room is likely only about 50 feet wide and 20 feet deep, the center room is also about 50 feet

wide and 20 feet deep, the eastern most room is about 50 feet wide and about 160 feet deep. Above the entrance to the rooms, it appears the operator did begin to mine from the surface and mined various sized benches to the level they are currently located at.

The current reclamation plan does not account for the underground openings/adits created. In accordance with Rule 3.1.5(6), adits and shafts must be closed. The current reclamation plan needs to be updated and clarified pursuant to C.R.S. 34-32.5-116(2).

Figure 1. Eastern most room/adit

CORRECTIVE ACTIONS: The Operator shall submit an Amendment, with the required \$827 fee, to update and clarify the current approved reclamation plan to reflect existing and proposed activities by the corrective action date.

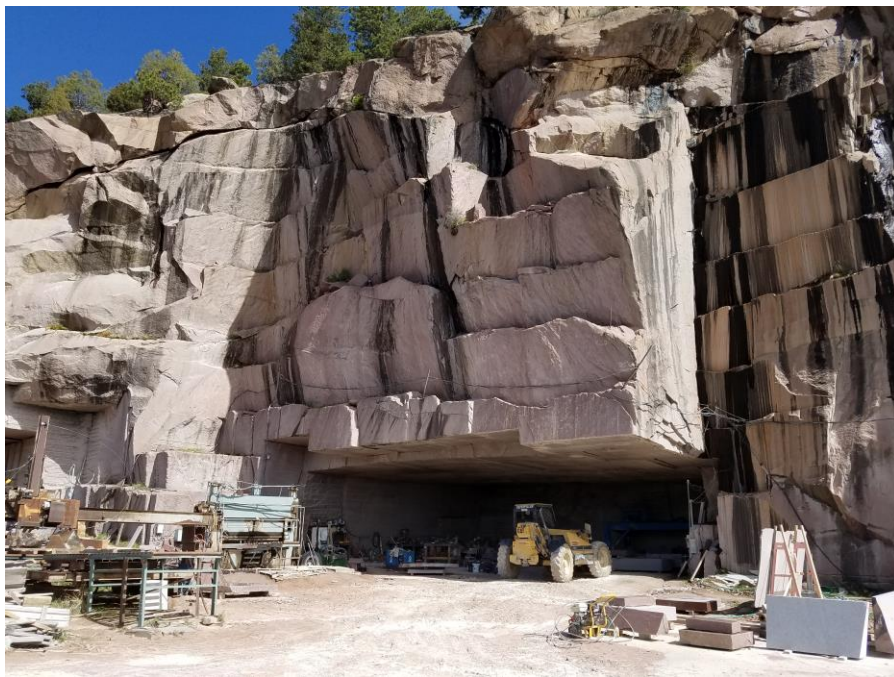
Figure 2. Center Room/adit

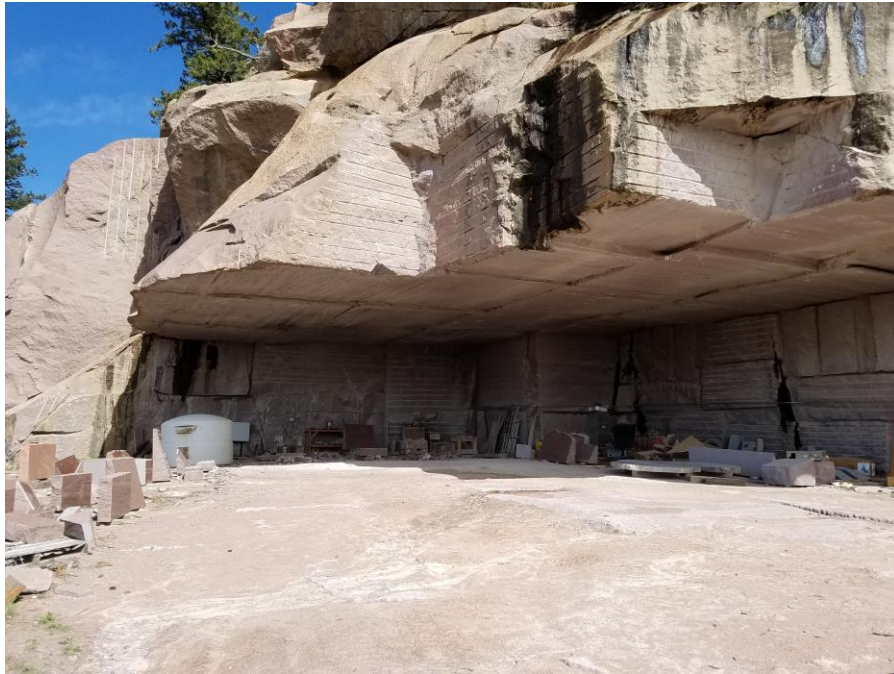
Figure 3. Western most room/adit

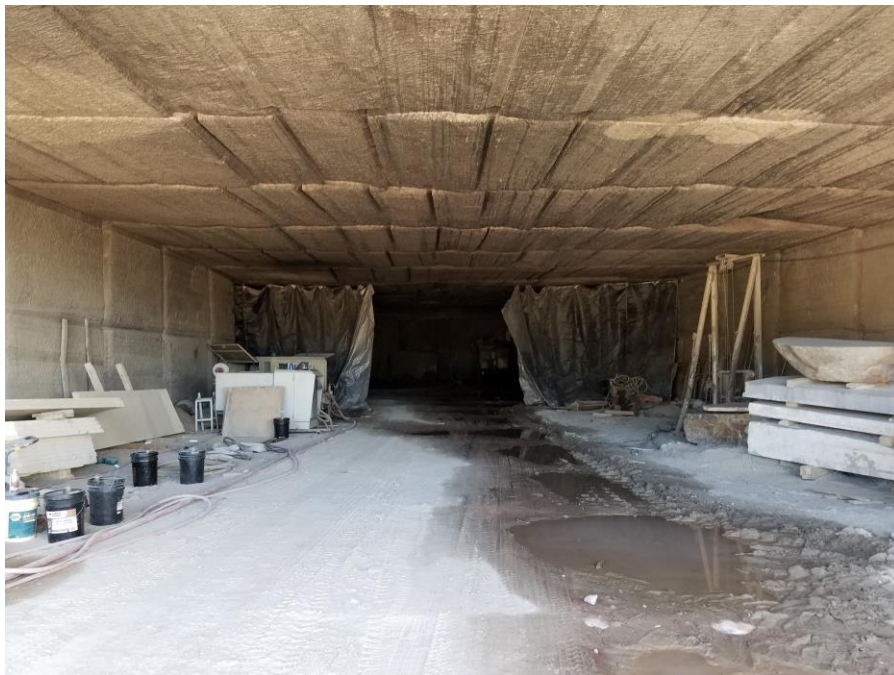
Figure 4. Eastern most room/adit

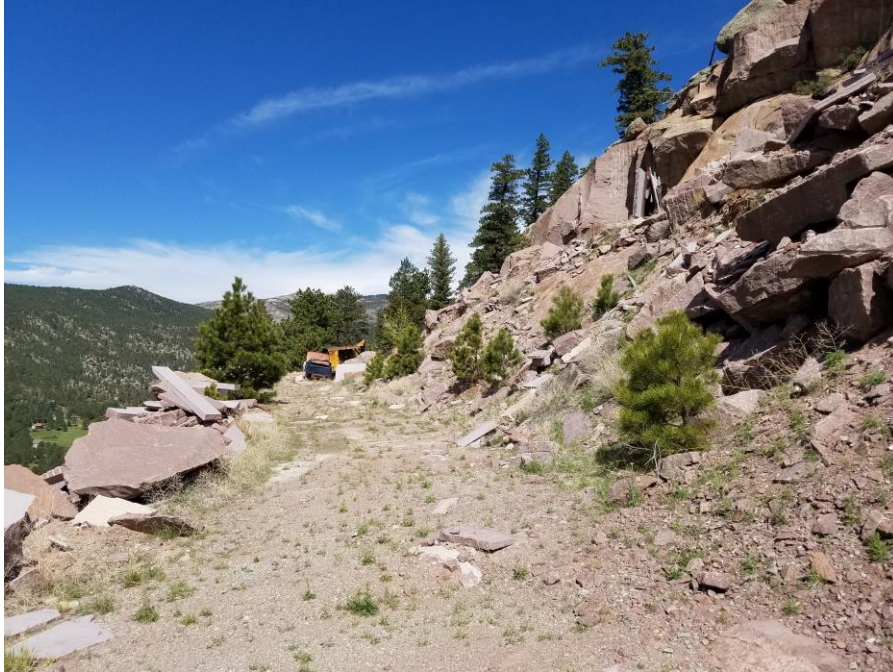
Figure 5. View of the lower bench looking west.
