**MINERALS PROGRAM INSPECTION REPORT****PHONE: (303) 866-3567**

| <b>MINE NAME:</b><br>Vasquez Quarry No 2 | <b>MINE/PROSPECTING ID#:</b><br>M-1994-121 | <b>MINERAL:</b><br>Sandstone (silica, stone, quartzite) | <b>COUNTY:</b><br>Boulder |
| <b>INSPECTION TYPE:</b><br>Monitoring | <b>INSPECTOR(S):</b><br>Amy Eschberger | <b>INSP. DATE:</b><br>April 6, 2017 | <b>INSP. TIME:</b><br>10:35 |

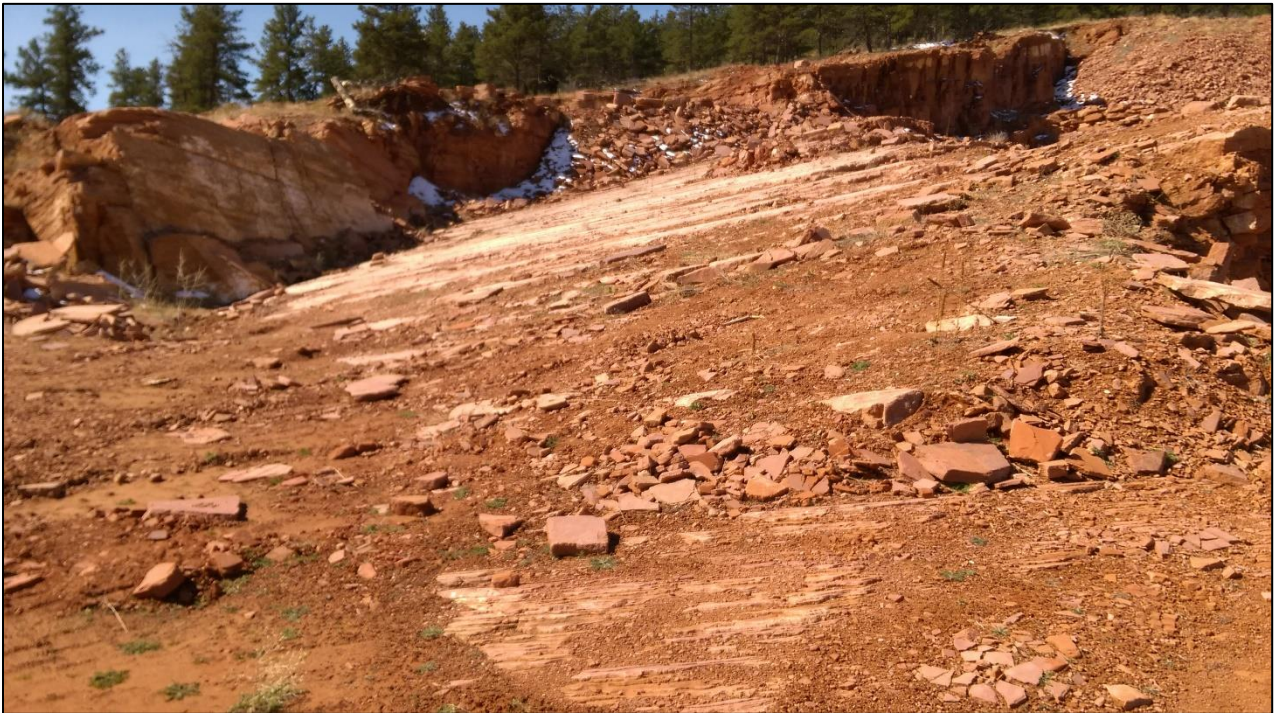
**Photo 1.** View looking southwest at eastern portion of highwall present along southern edge of site.

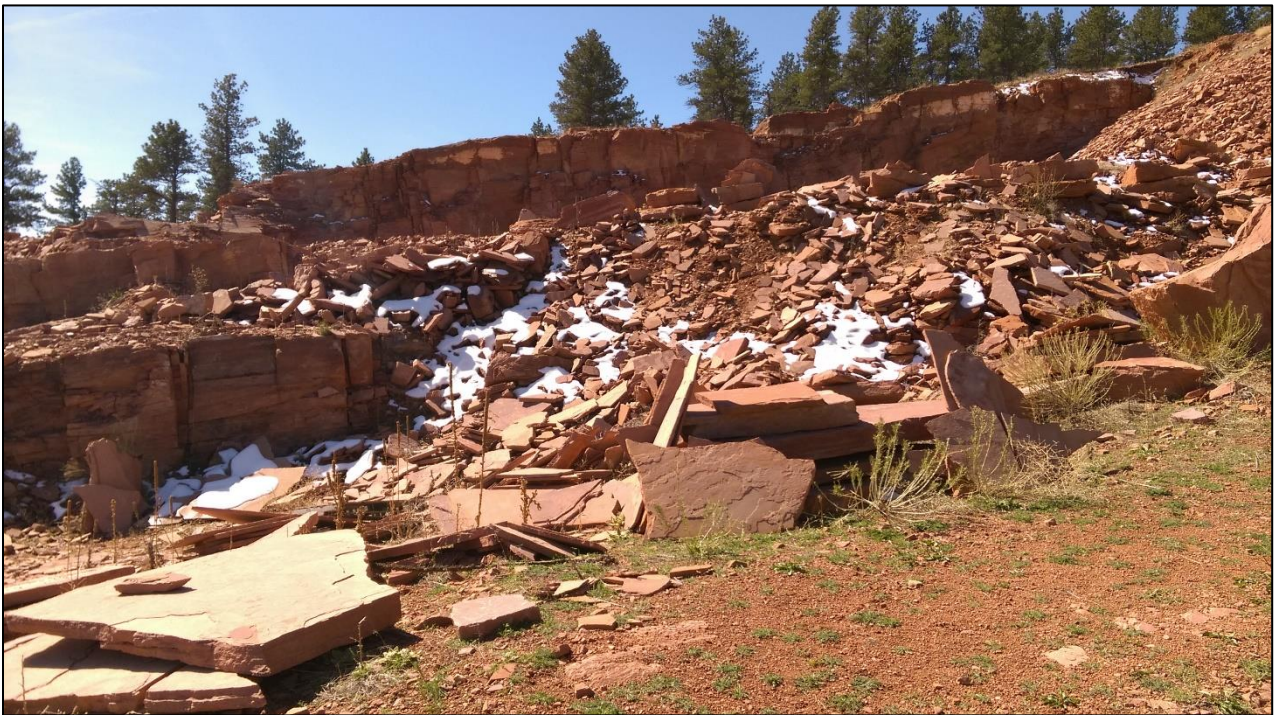
**Photo 2.** View looking south at western portion of highwall present along southern edge of site.

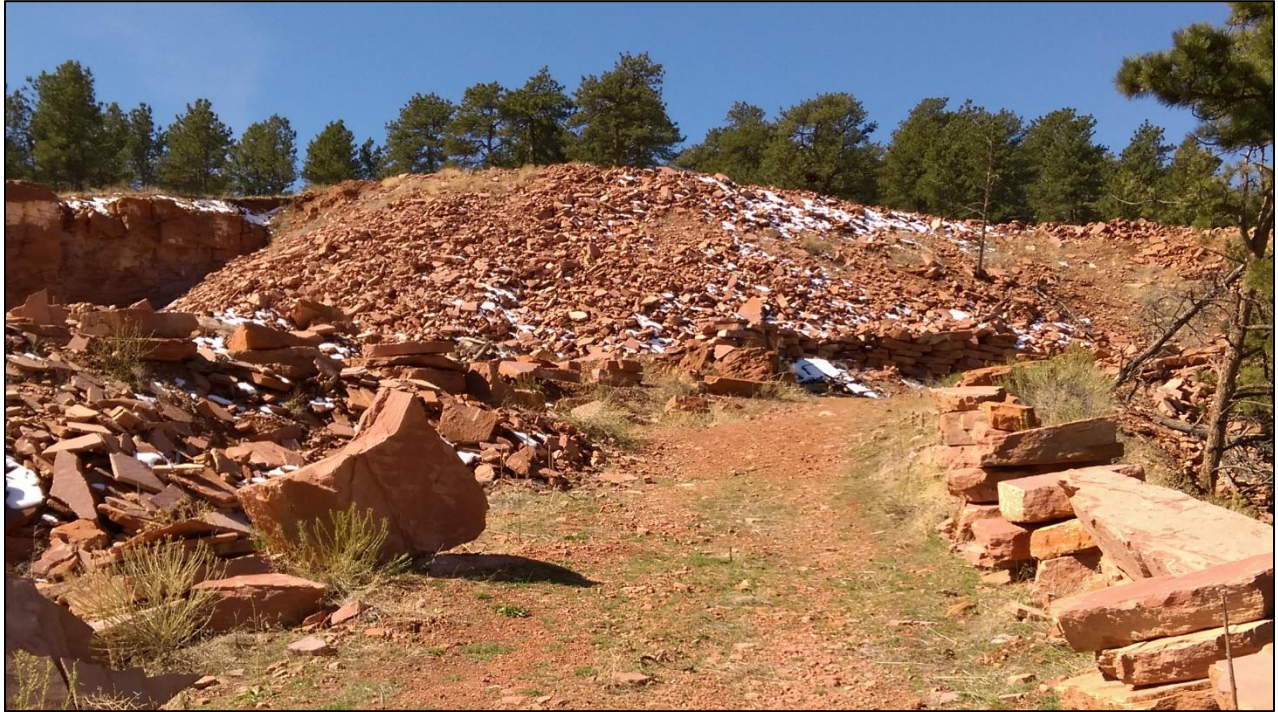
**Photo 3.** View looking southwest at large overburden/waste rock stockpile stored at western edge of site.

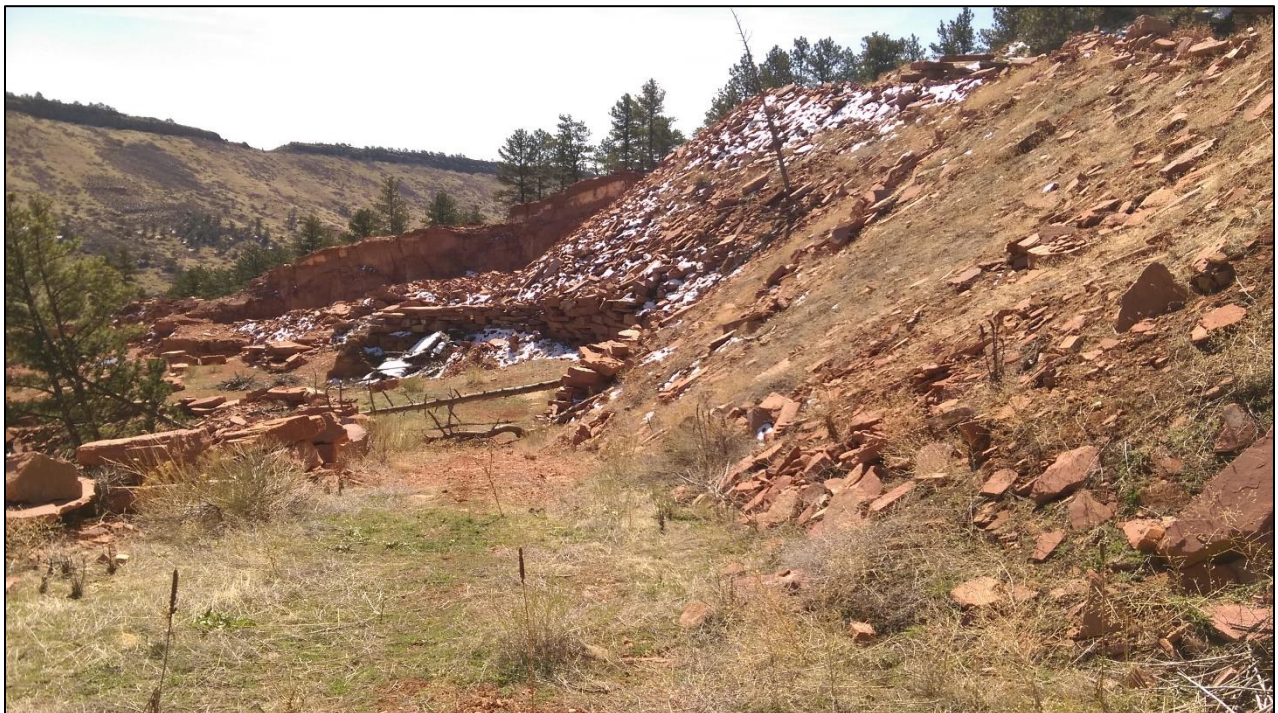
**Photo 4.** View looking southeast, showing portion of large overburden/waste rock stockpile stored at western edge of site (at right) and quarry (in distance).

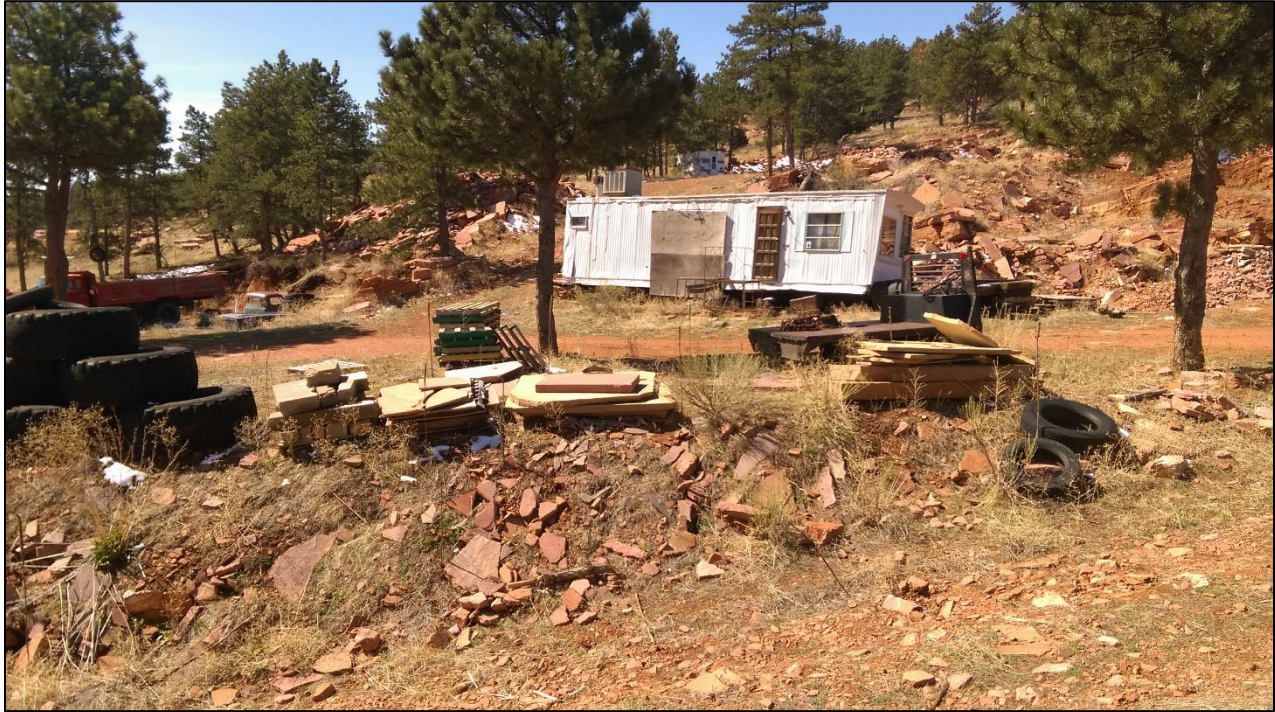
**Photo 5.** View looking southwest, showing stone and equipment storage area located in southeastern portion of site.

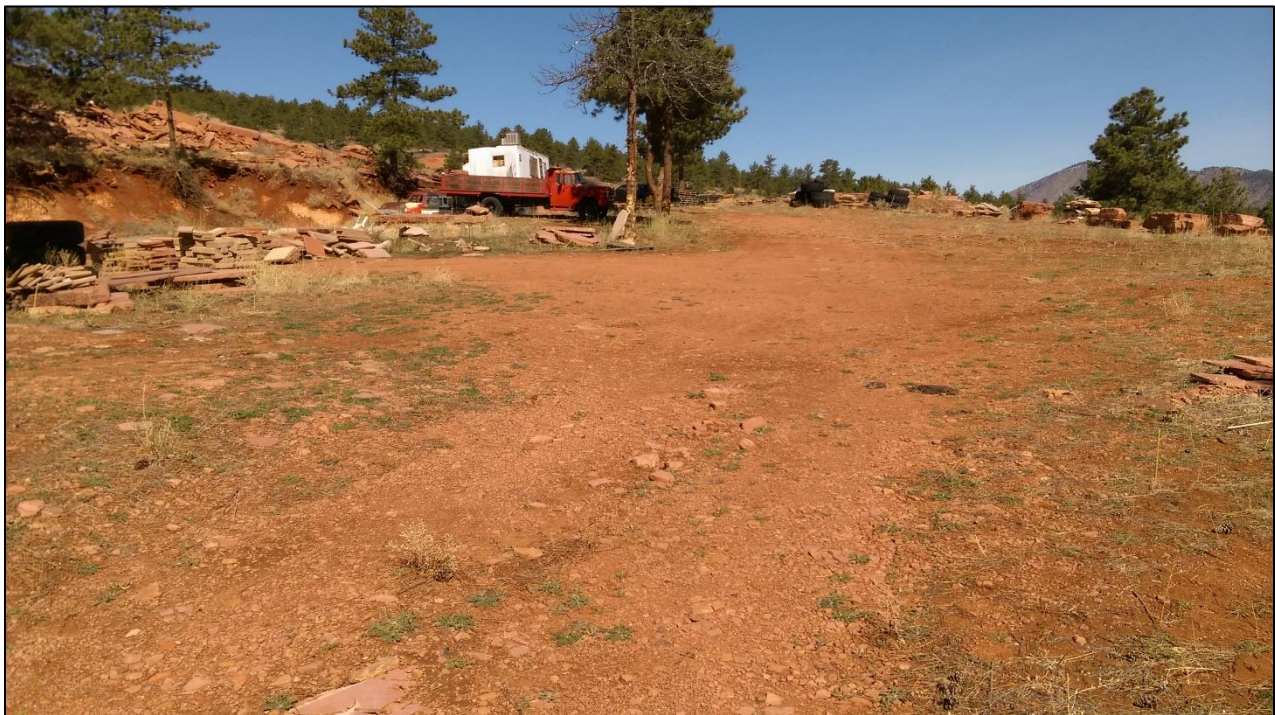
**Photo 6.** View looking north, showing stone and equipment storage area located in southeastern portion of site.

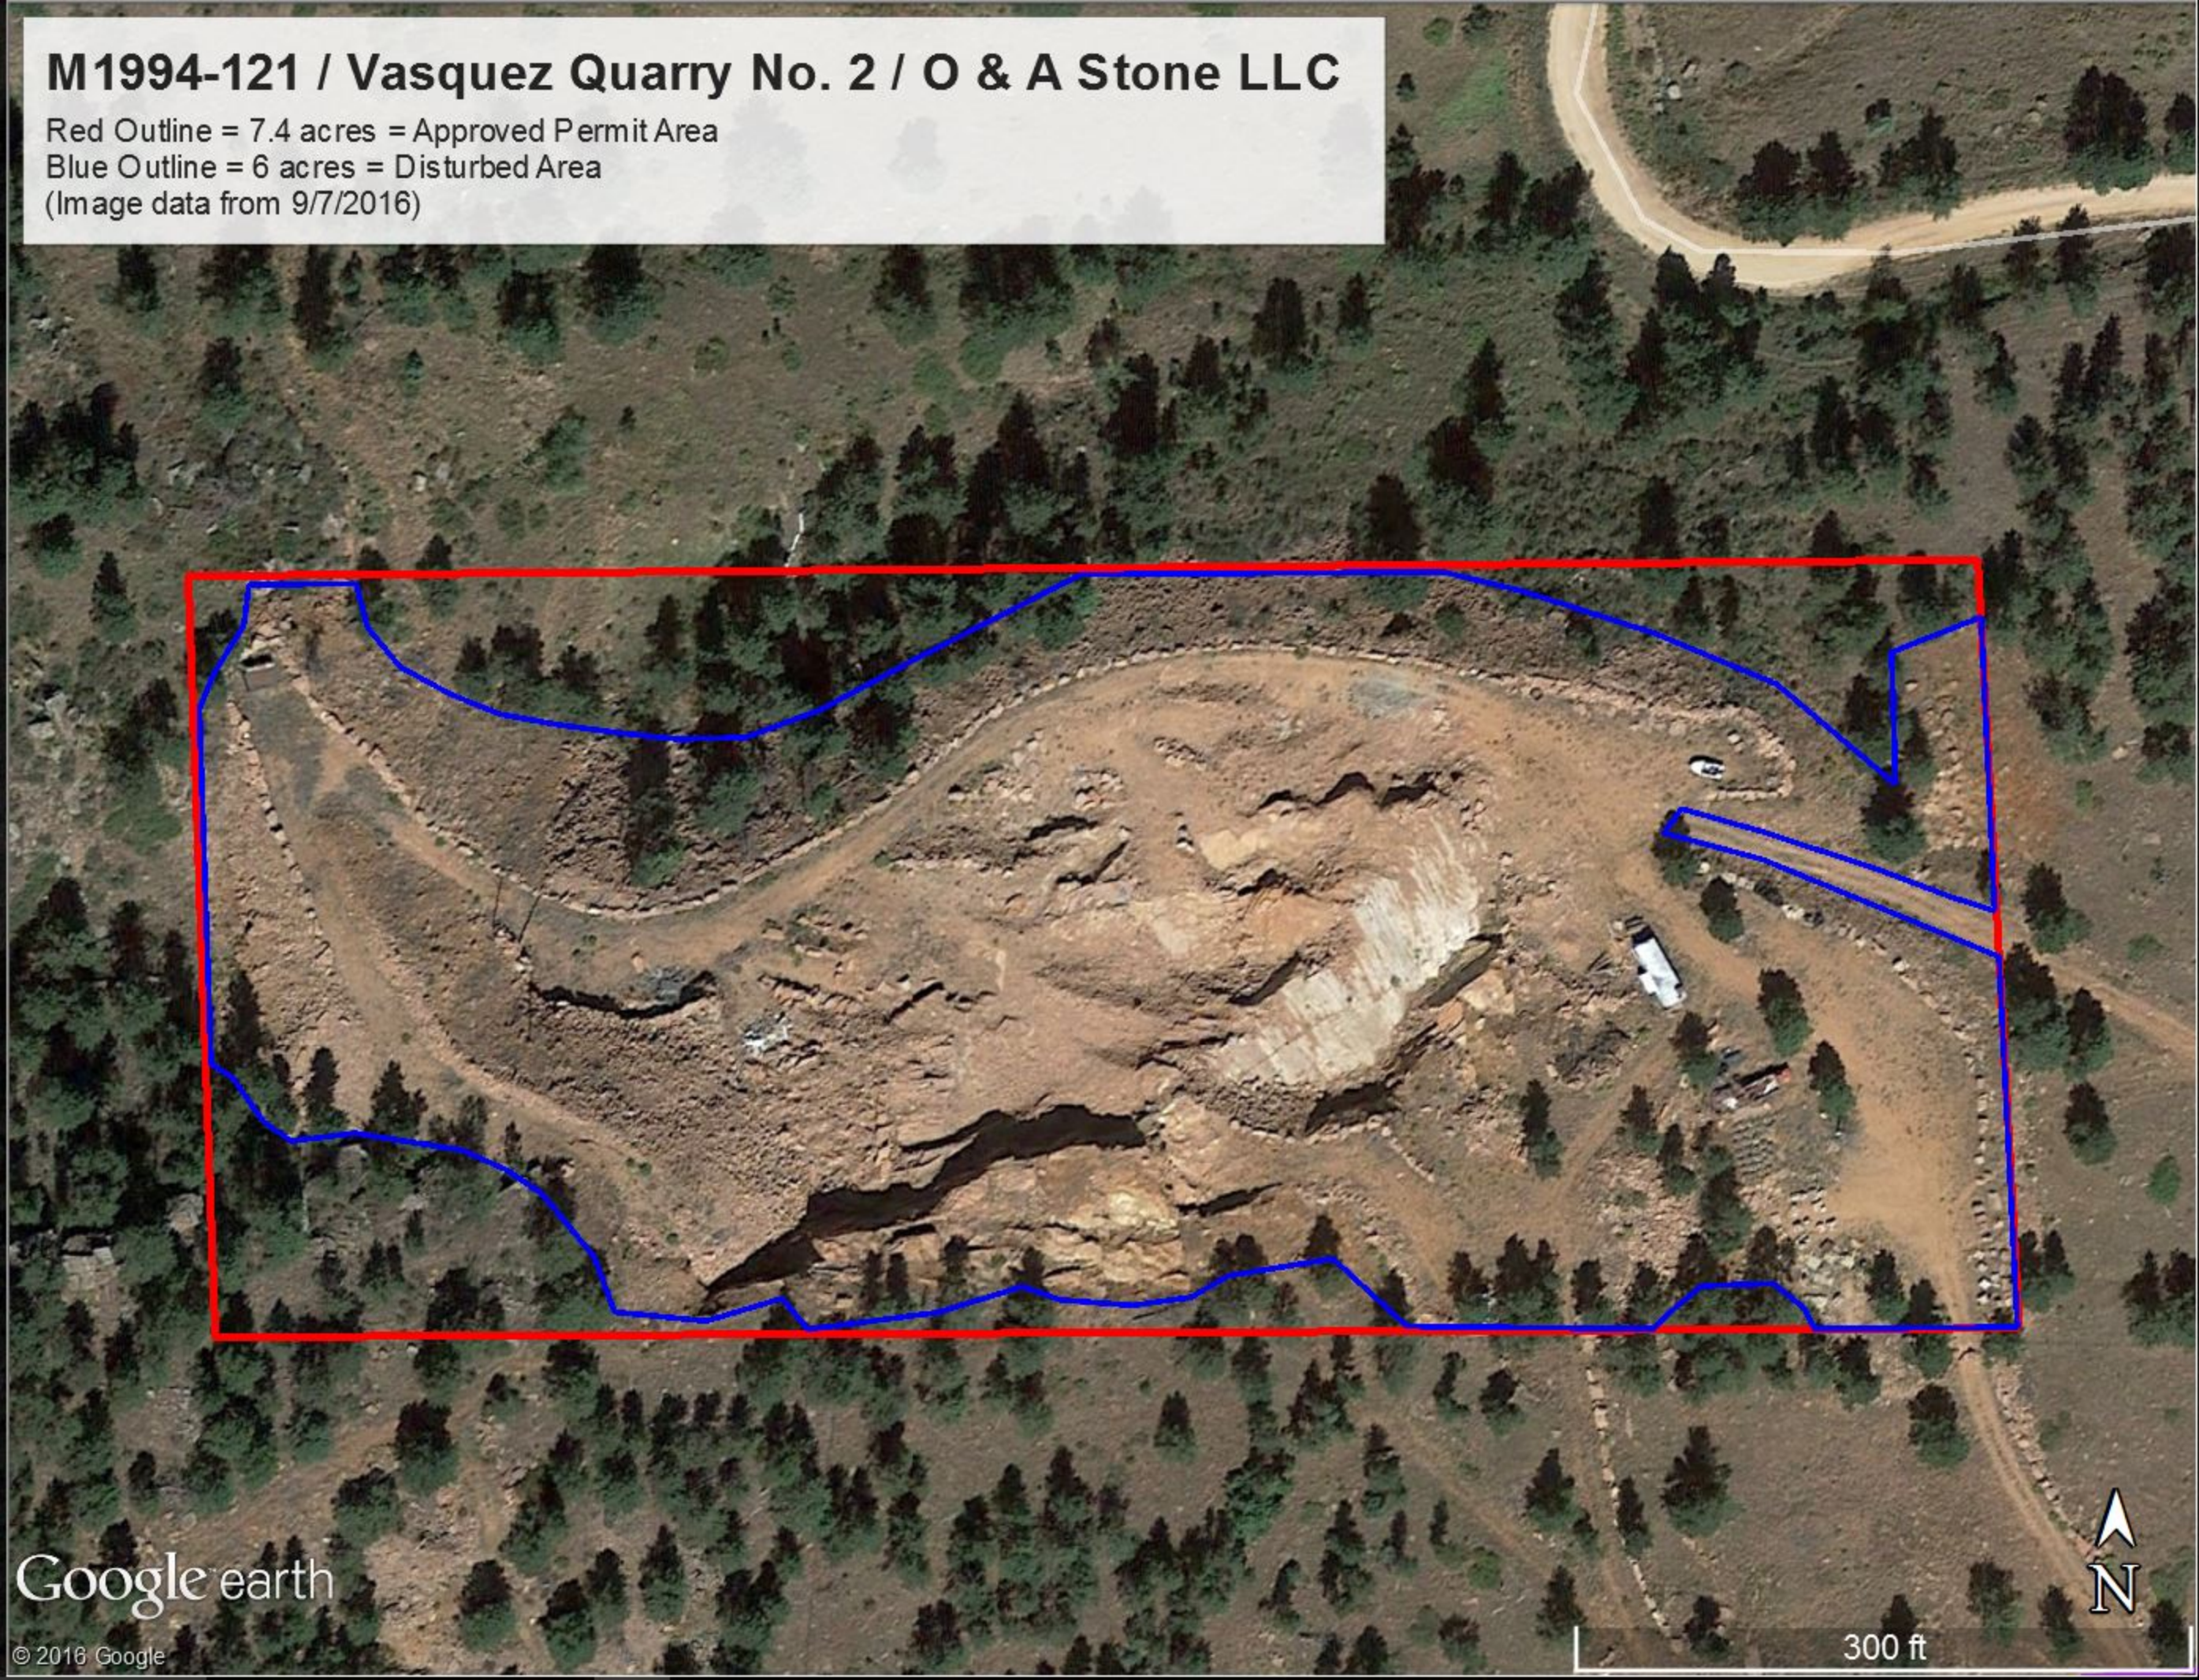
# M1994-121 / Vasquez Quarry No. 2 / O & A Stone LLC

Red Outline = 7.4 acres = Approved Permit Area

Blue Outline = 6 acres = Disturbed Area
