MINERALS PROGRAM INSPECTION REPORT
PHONE: (303) 866-3567

MINE NAME: Stone Canyon Quarry	MINE/PROSPECTING ID#: M-2012-018	MINERAL: Stone (Moss Rock)	COUNTY: Boulder
INSPECTION TYPE: Monitoring	INSPECTOR(S): Amy Eschberger	INSP. DATE: April 6, 2017	INSP. TIME: 11:05
OPERATOR: Stone Canyon Quarry, LLC	OPERATOR REPRESENTATIVE: Bernard Buster	TYPE OF OPERATION: 112c - Construction Regular Operation	
REASON FOR INSPECTION: Normal I&E Program	BOND CALCULATION TYPE: Complete Bond	BOND AMOUNT: \$2,125.00	
DATE OF COMPLAINT: NA	POST INSP. CONTACTS: None	JOINT INSP. AGENCY: None	
WEATHER: Clear	INSPECTOR'S SIGNATURE:

M2012-018 / Stone Canyon Quarry / Stone Canyon Quarry, LLC

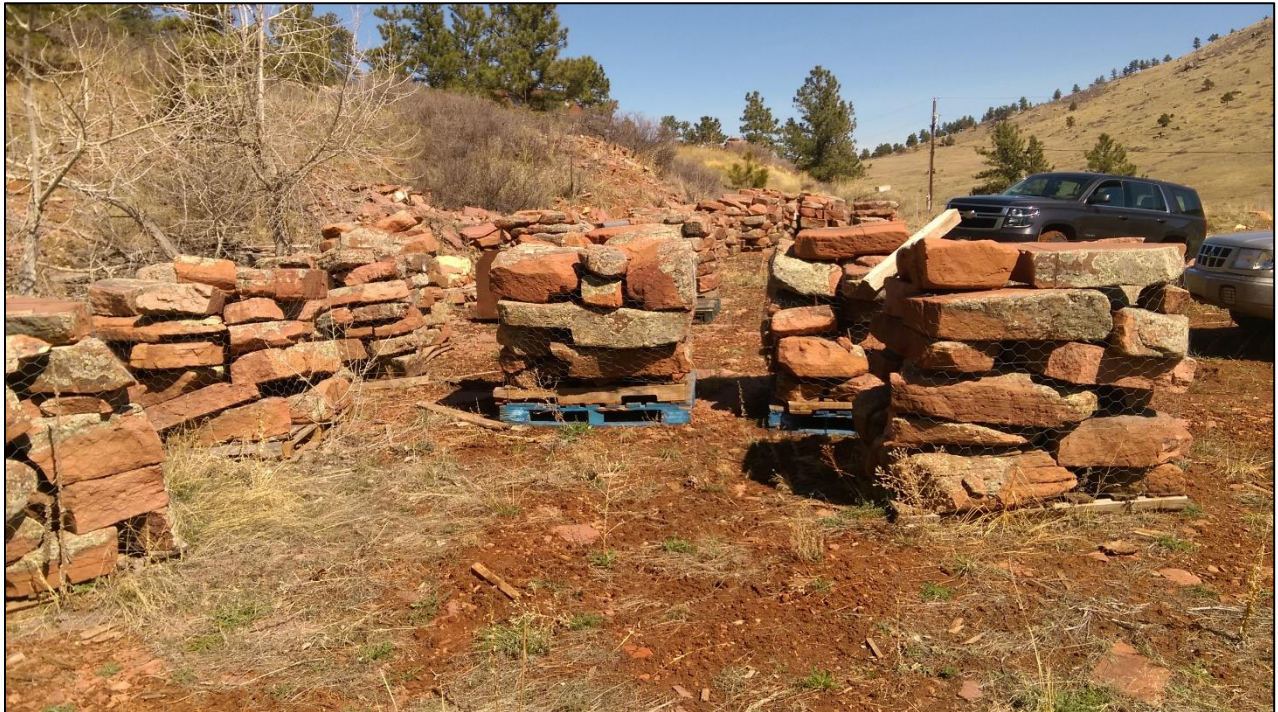
Photo 1. View looking north across palletized stone storage area adjacent to main access road.

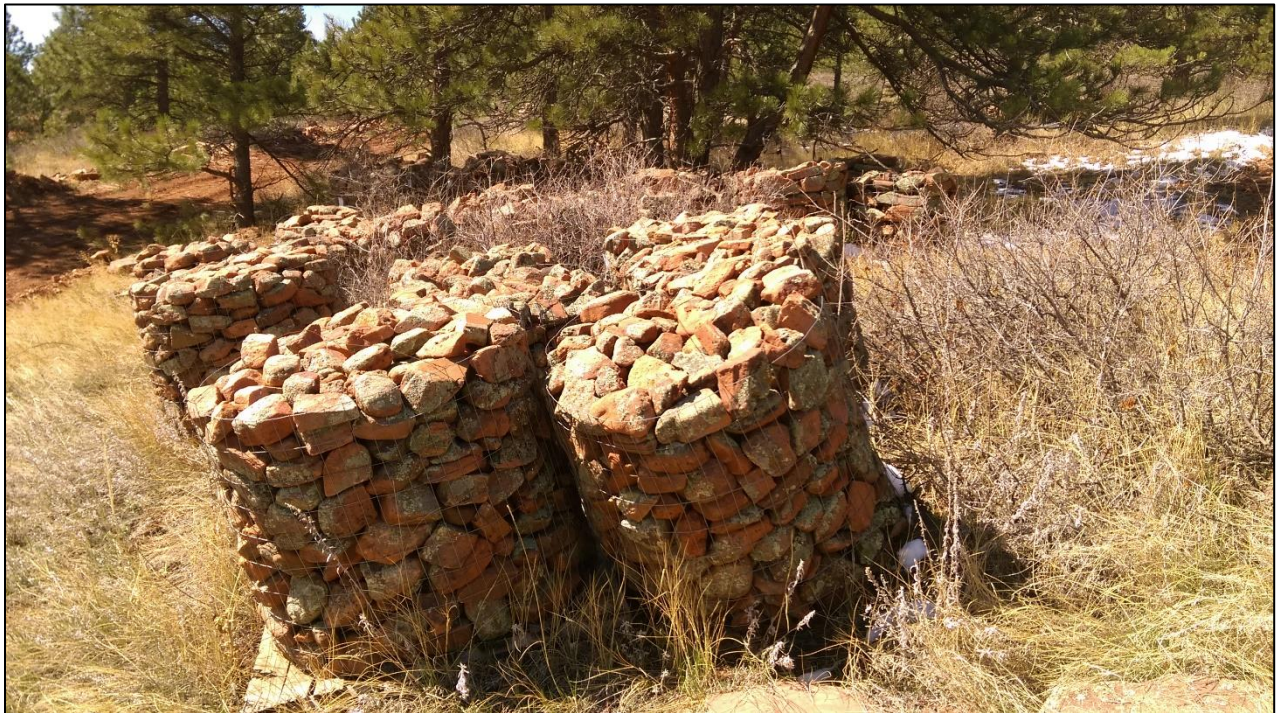
Photo 2. View looking south, showing palletized stone stored at southern edge of permit area, south of the two-track road.

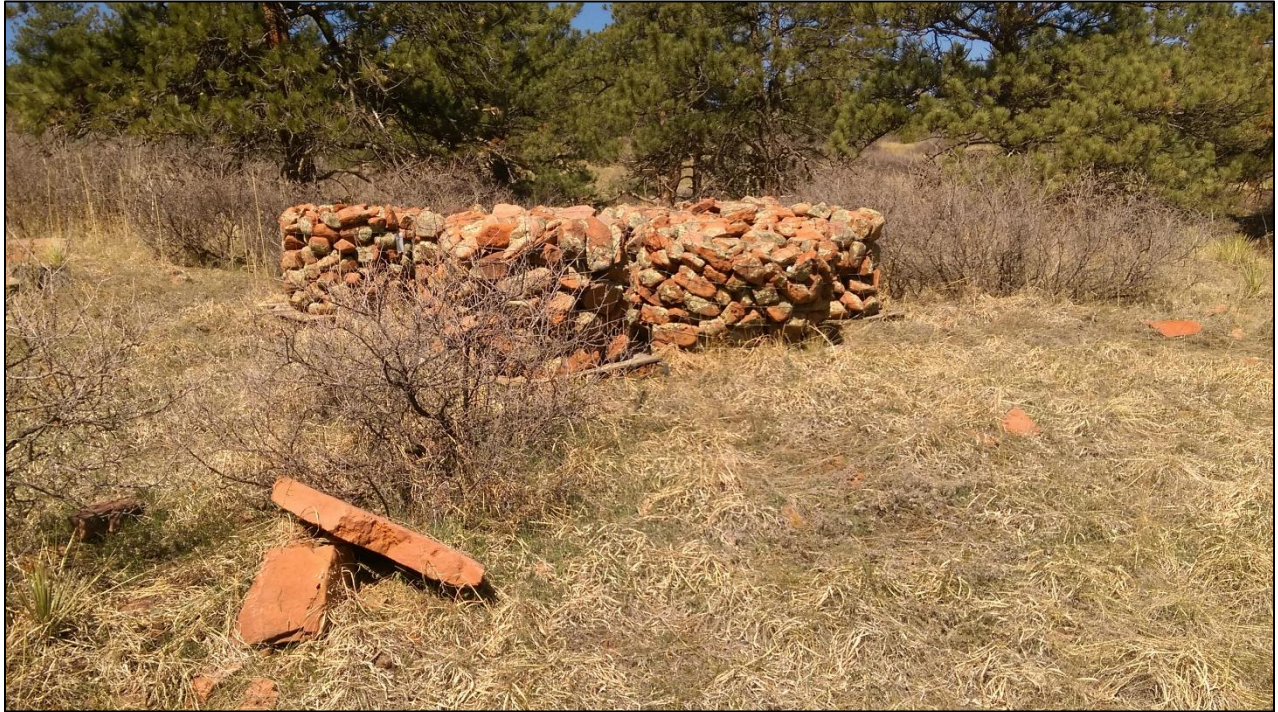
Photo 3. View looking north, showing palletized stone stored in southern portion of permit area, north of the two-track road.

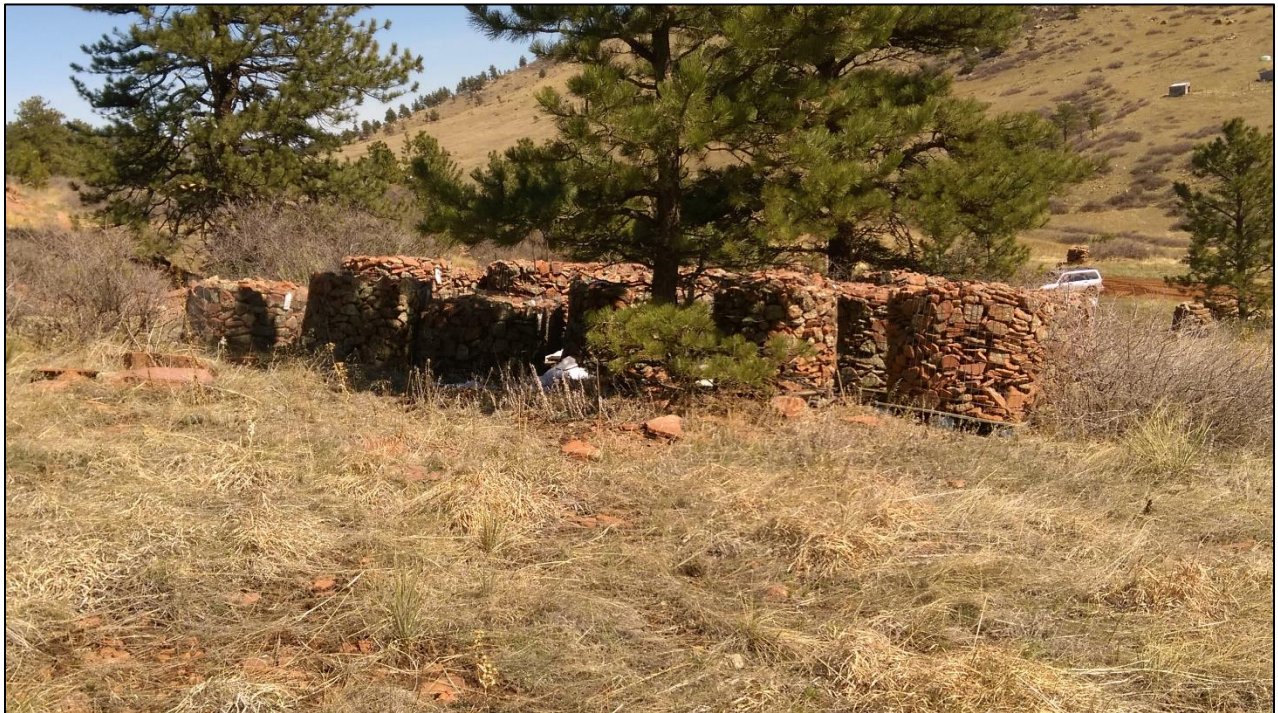
Photo 4. View looking northeast, showing palletized stone stored in southern portion of permit area, north of the two-track road.

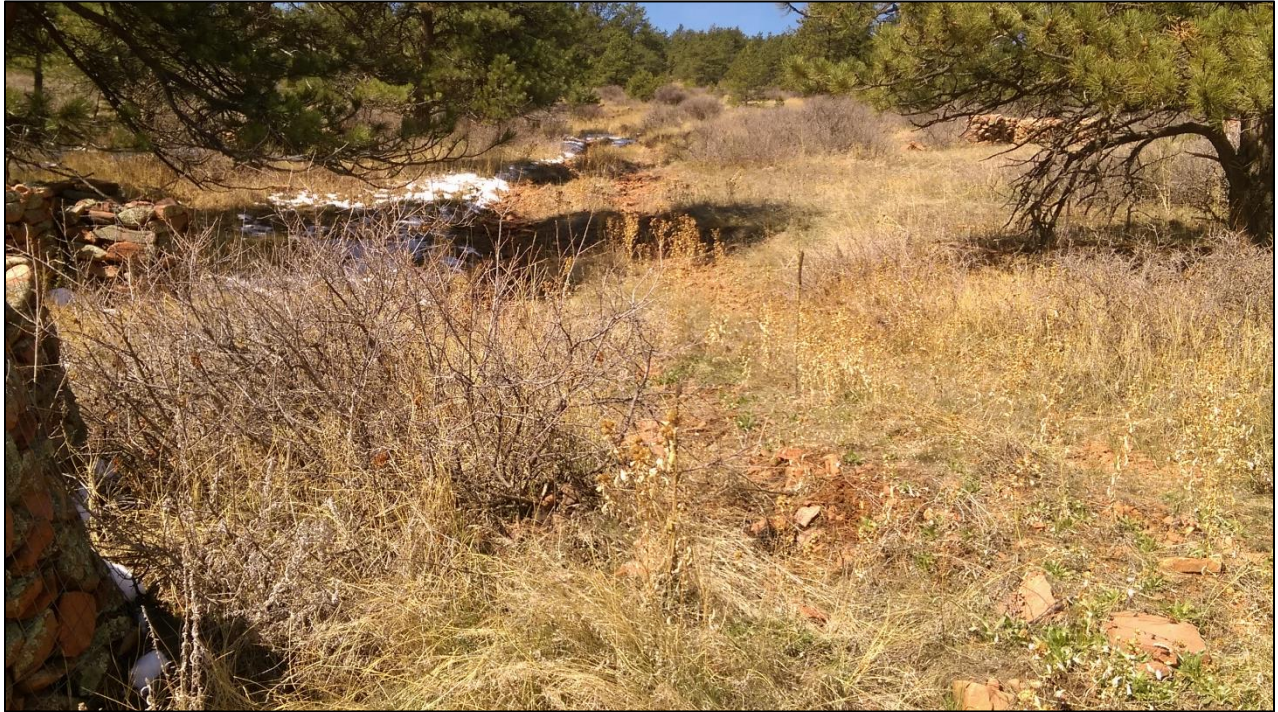
Photo 5. View looking west, showing two-track road present in southern portion of permit area.
