MINERALS PROGRAM INSPECTION REPORT
PHONE: (303) 866-3567

MINE NAME: T Bone Stone Quarry	MINE/PROSPECTING ID#: M-2004-030	MINERAL: Stone	COUNTY: Boulder
INSPECTION TYPE: Monitoring	INSPECTOR(S): Amy Eschberger	INSP. DATE: May 17, 2017	INSP. TIME: 12:30
OPERATOR: T Bone Stone, Inc.	OPERATOR REPRESENTATIVE: Bill Tenore	TYPE OF OPERATION: 110c - Construction Limited Impact	
REASON FOR INSPECTION: Normal I&E Program	BOND CALCULATION TYPE: Partial Bond	BOND AMOUNT: \$68,574.00	
DATE OF COMPLAINT: NA	POST INSP. CONTACTS: None	JOINT INSP. AGENCY: None	
WEATHER: Clear	INSPECTOR'S SIGNATURE:

M-2004-030 / T Bone Stone Quarry / T Bone Stone, Inc.

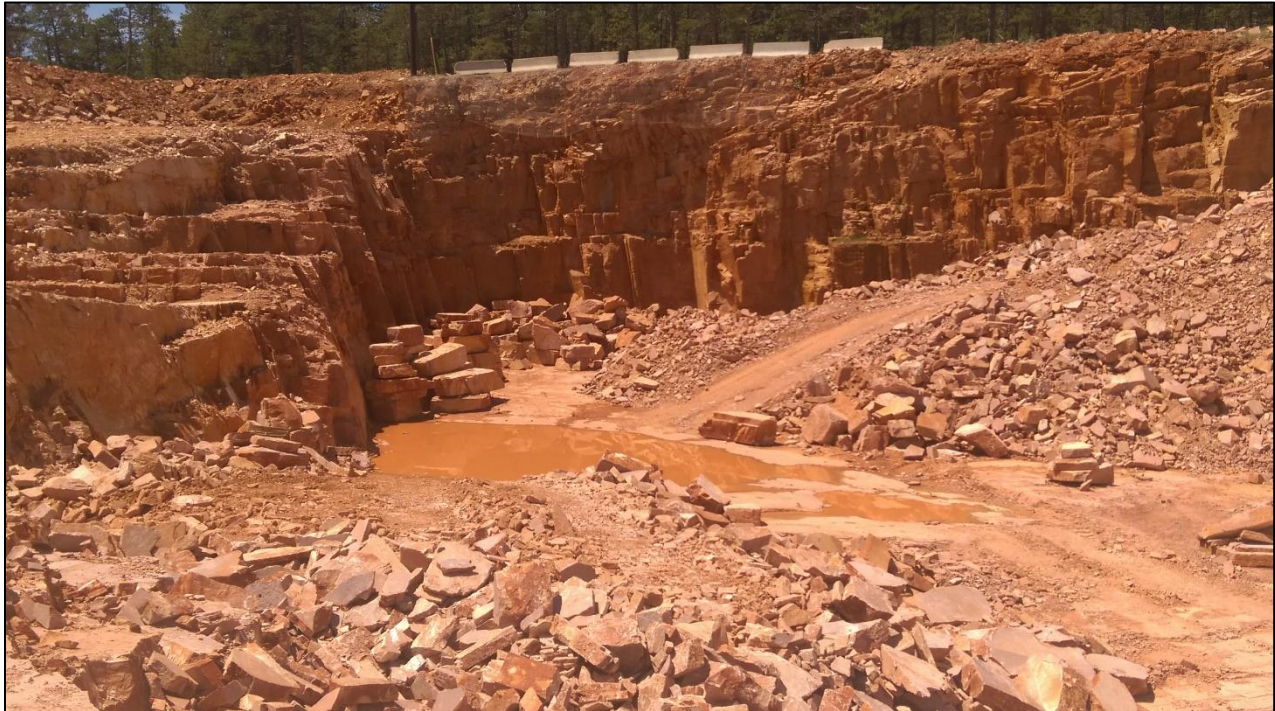
Photo 1. View of north quarry with highwalls of up to 30 feet in height

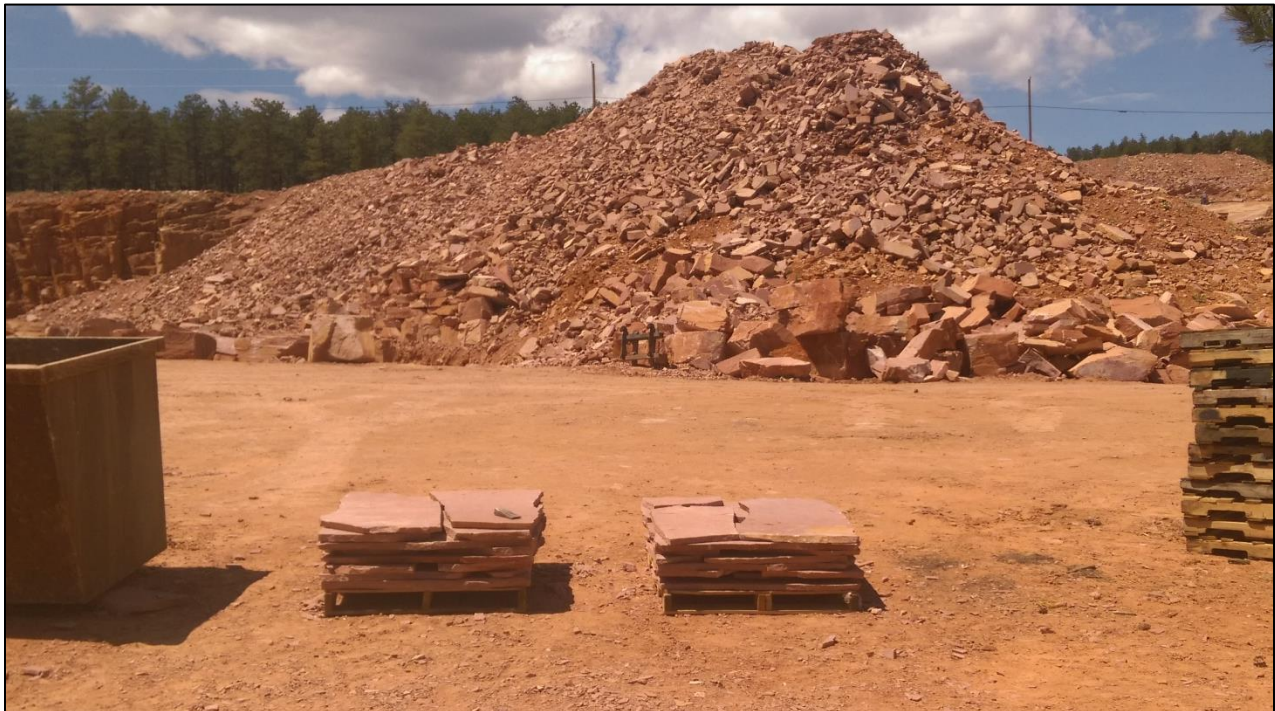
Photo 2. View of overburden stored along northern edge of north quarry.

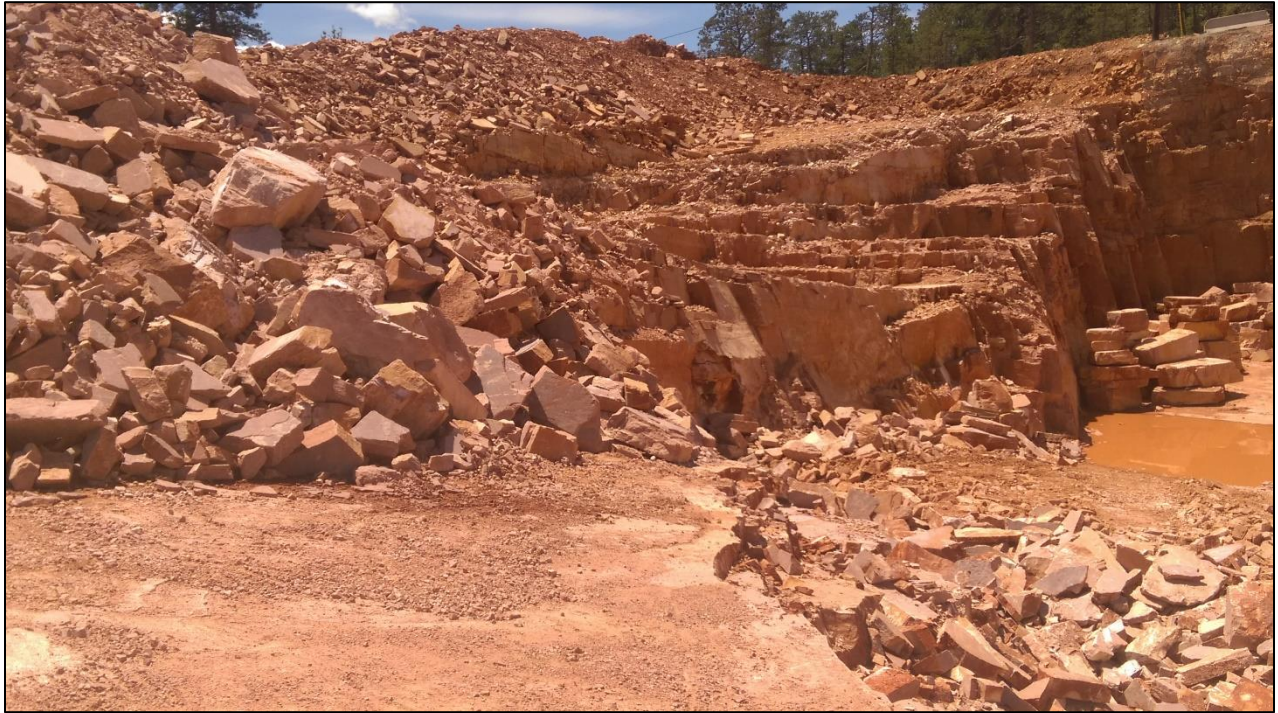
Photo 3. View of overburden stored along southern edge of north quarry.

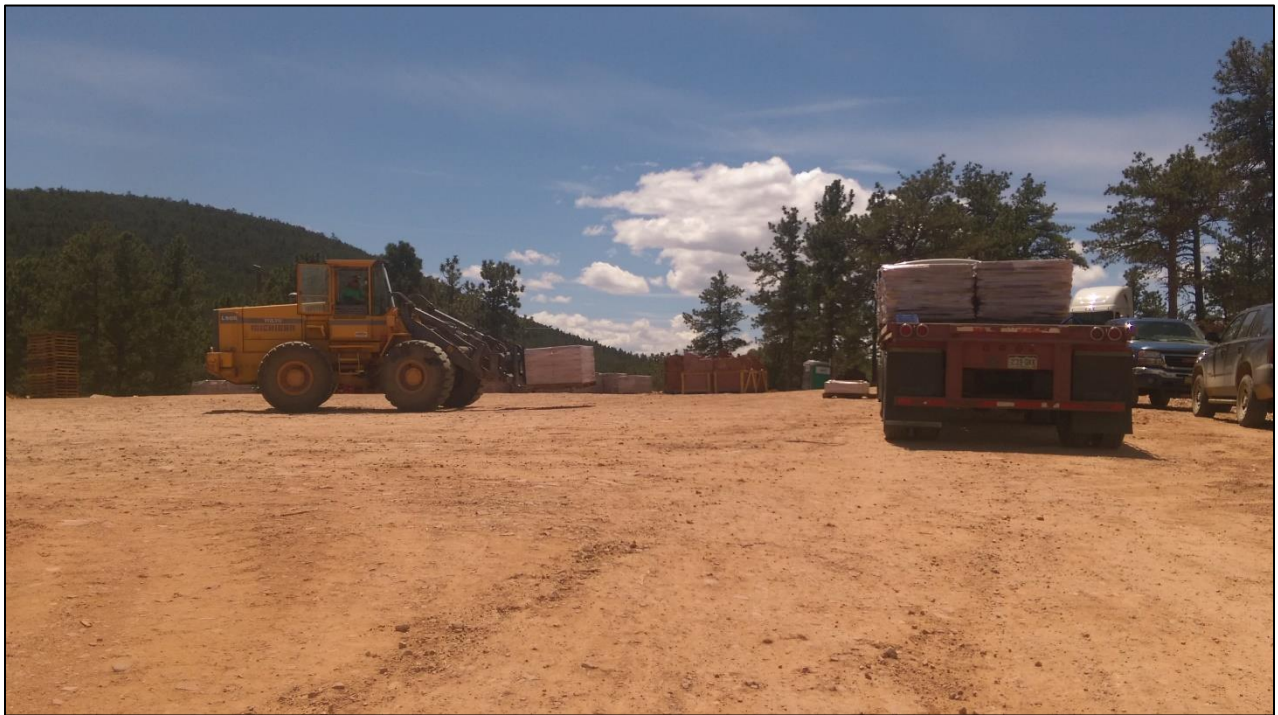
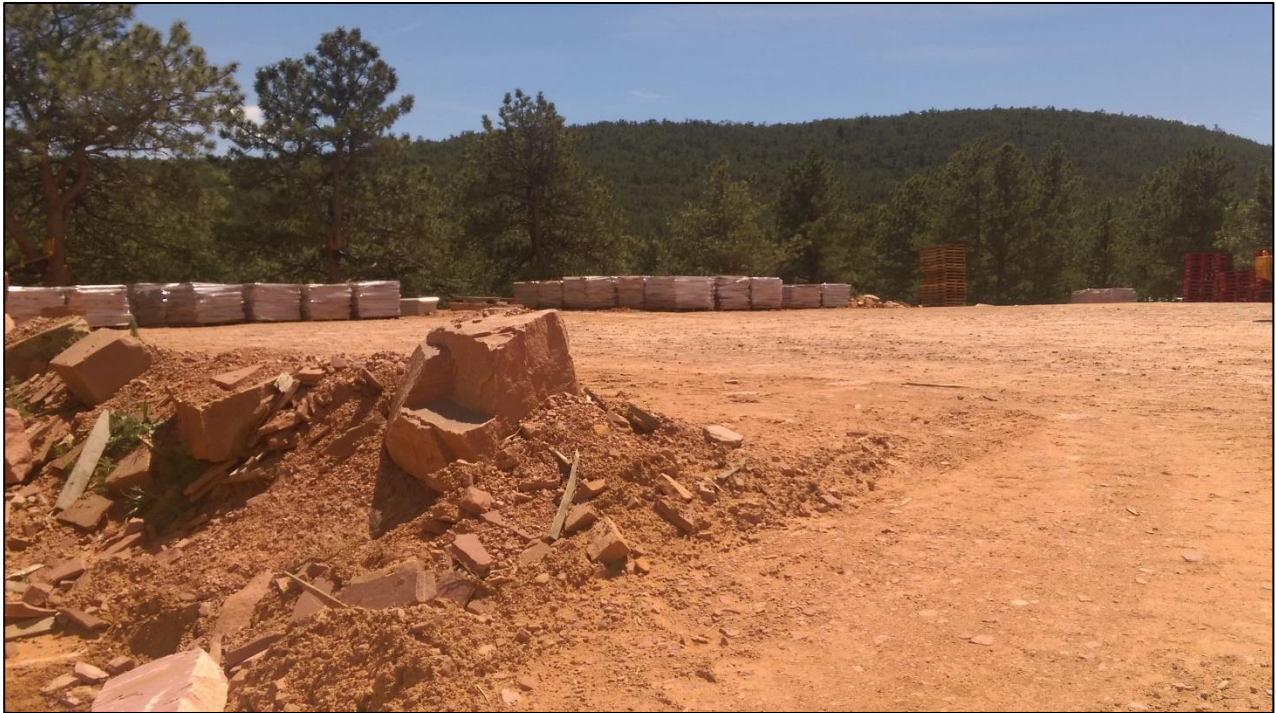
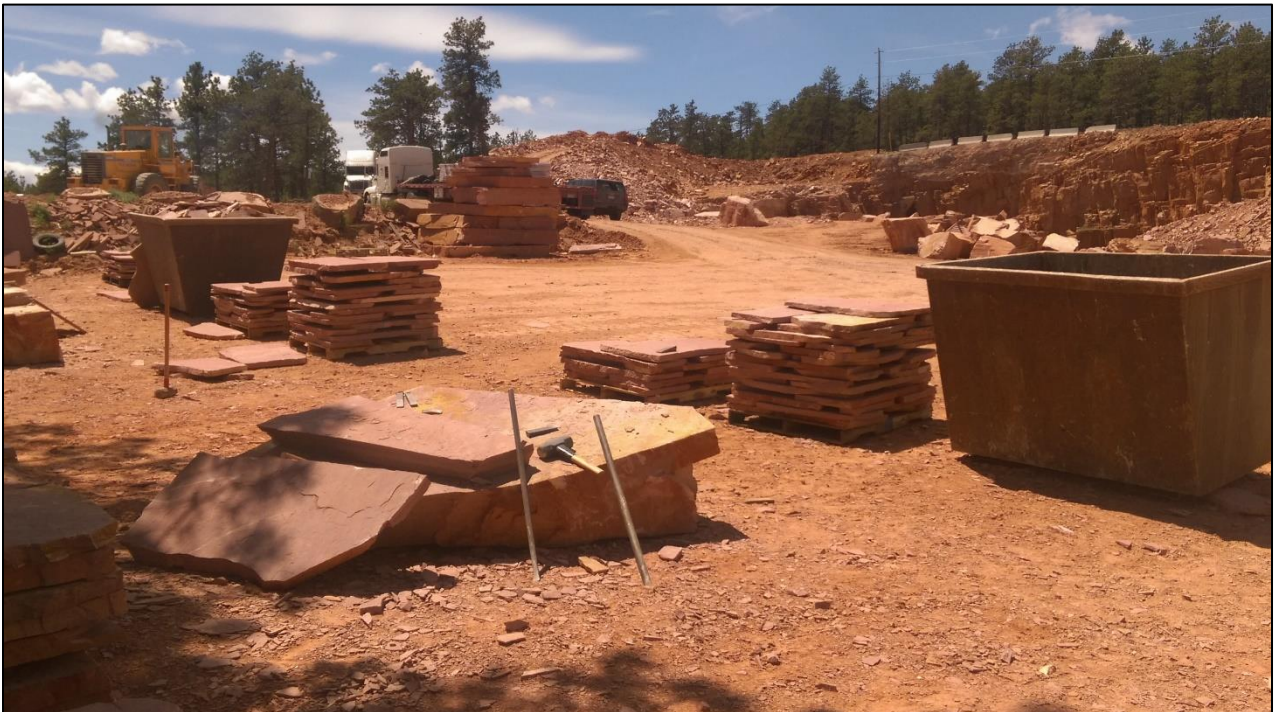
At the time of the inspection, it was partly cloudy and breezy. The Division observed standing water throughout the region due to a recent storm event. The permit boundary was delineated with posts. The site was active during the inspection, including stone working and transportation activities. The Division estimates the operation has disturbed a total of approximately 12.75 acres (see enclosed Google Earth image of site). Disturbance includes two main quarry areas, referred to in this report as north quarry and south quarry. The north quarry is approximately 30 feet deep (**Photo 1**) with overburden stockpiled along its northern and southern edges (**Photos 2 and 3**). Approximately 325 feet of highwall ranging from 5-30 feet in height exist in the north quarry. A loading and storage area is present just east of the north quarry, on the other side of the access road (**Photos 4-6**).

Photo 4. View of loading and storage area present east of north quarry on other side of access road.

Photo 5. View of loading and storage area present east of north quarry on other side of access road.

Photo 6. View of loading and storage area present east of north quarry on other side of access road.

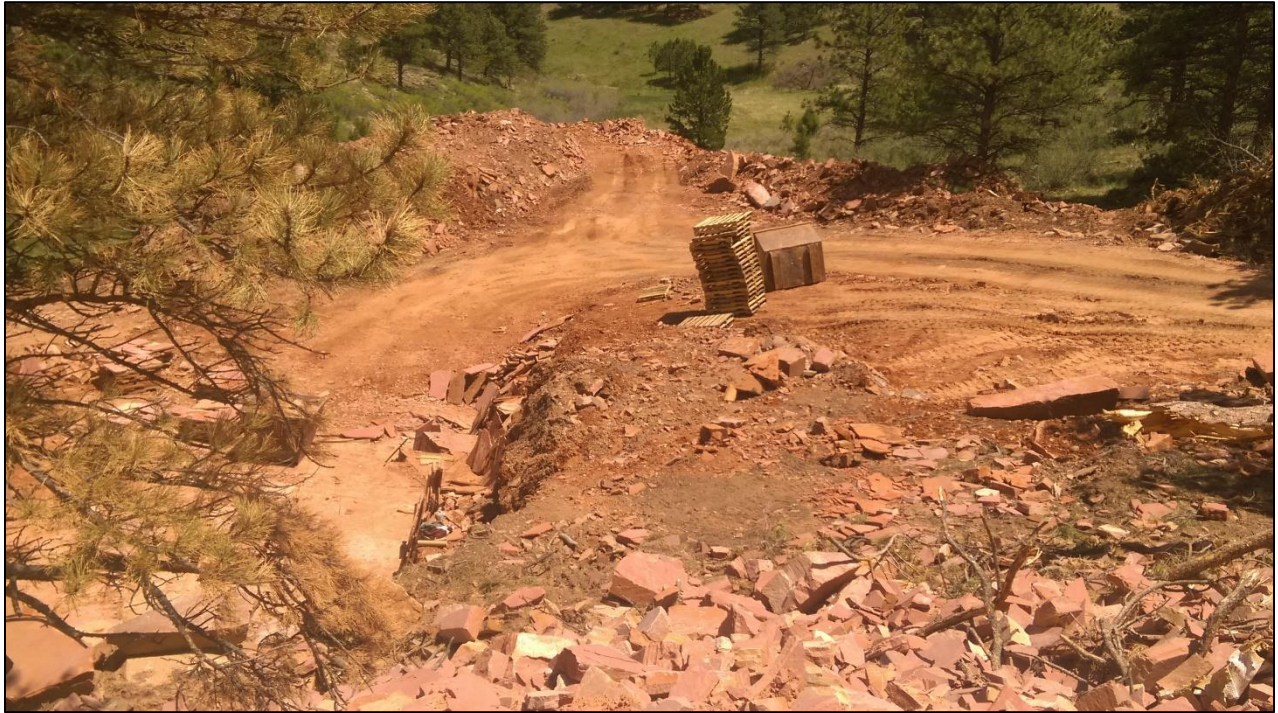
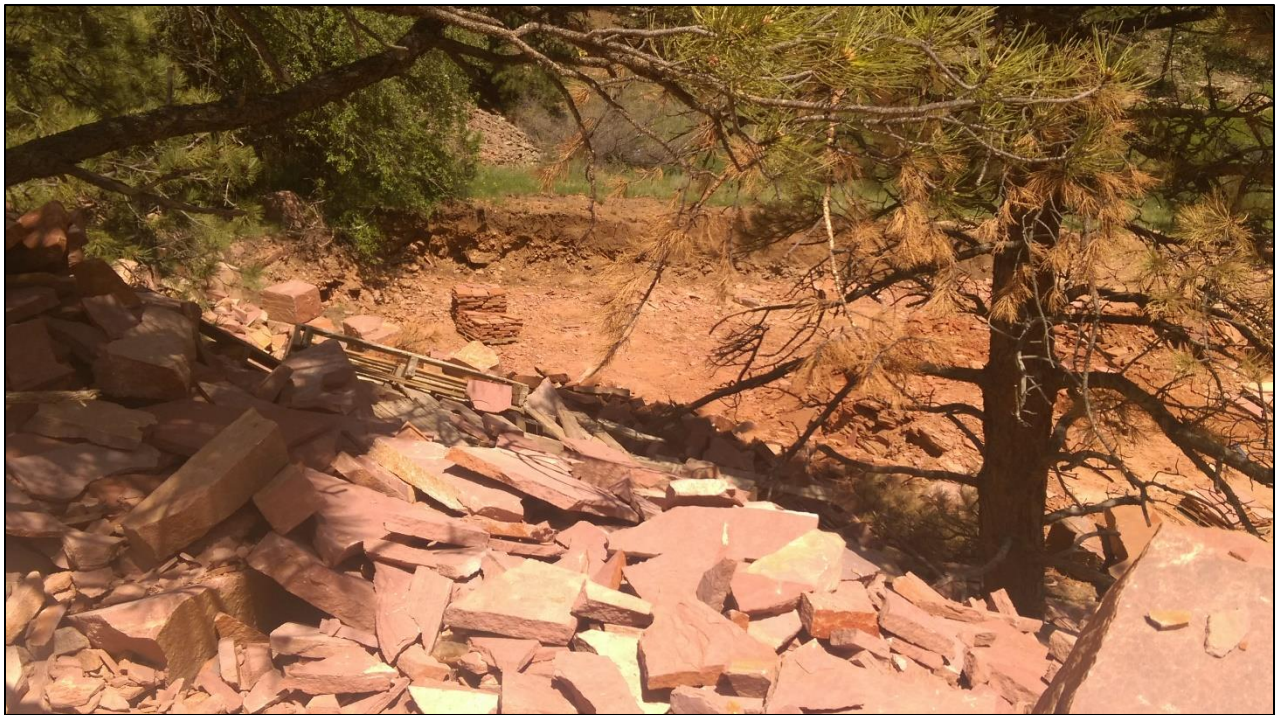
Since the date of the last aerial image available in Google Earth (9/7/2016), the operation has begun opening up the area located east of the loading and storage area in the northern portion of the site (**Photos 7 and 8**). The Division estimates this disturbance to be approximately 0.25 acre in size. This area is included in the total disturbed acreage amount and approximated on the enclosed Google Earth image of the site. Disturbance on site also includes an equipment and fuel storage area located adjacent to the haul road that connects the two quarries (**Photos 9 and 10**). The Division observed that fuel storage tanks were properly bermed for secondary containment.

Photo 7. View of area recently disturbed east of loading and storage area in northern portion of site.

Photo 8. View of area recently disturbed east of loading and storage area in northern portion of site.

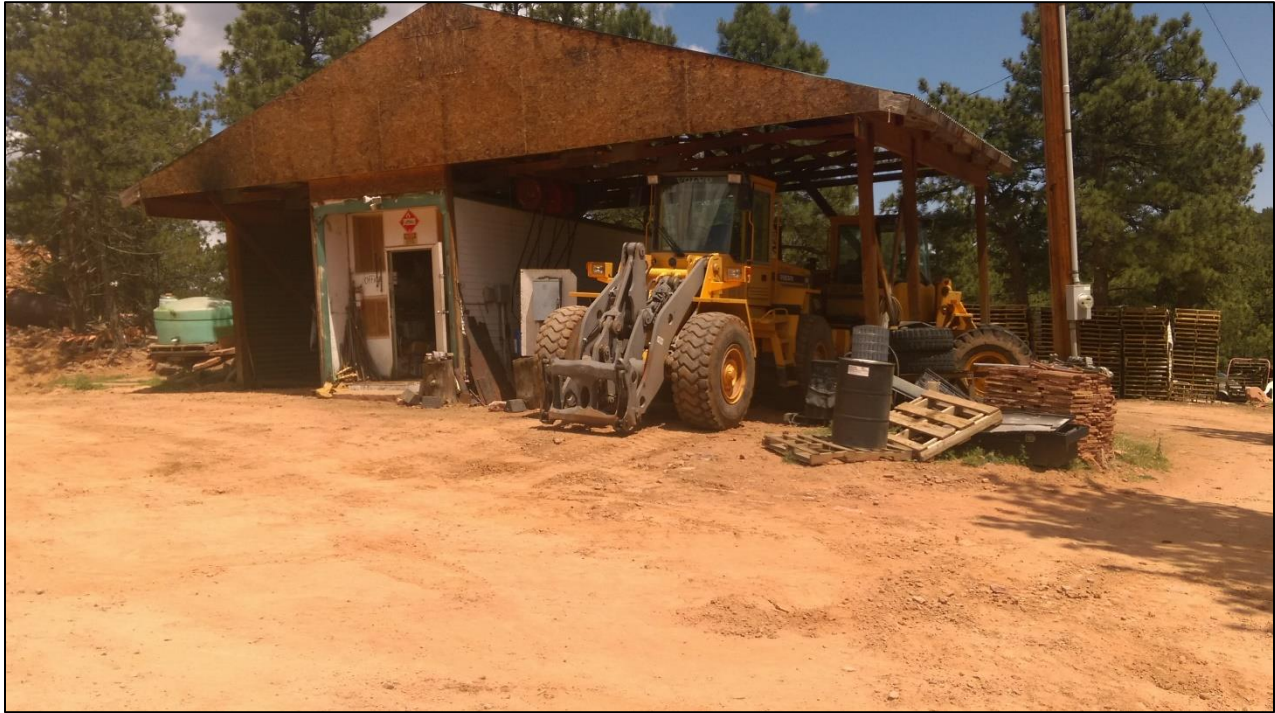
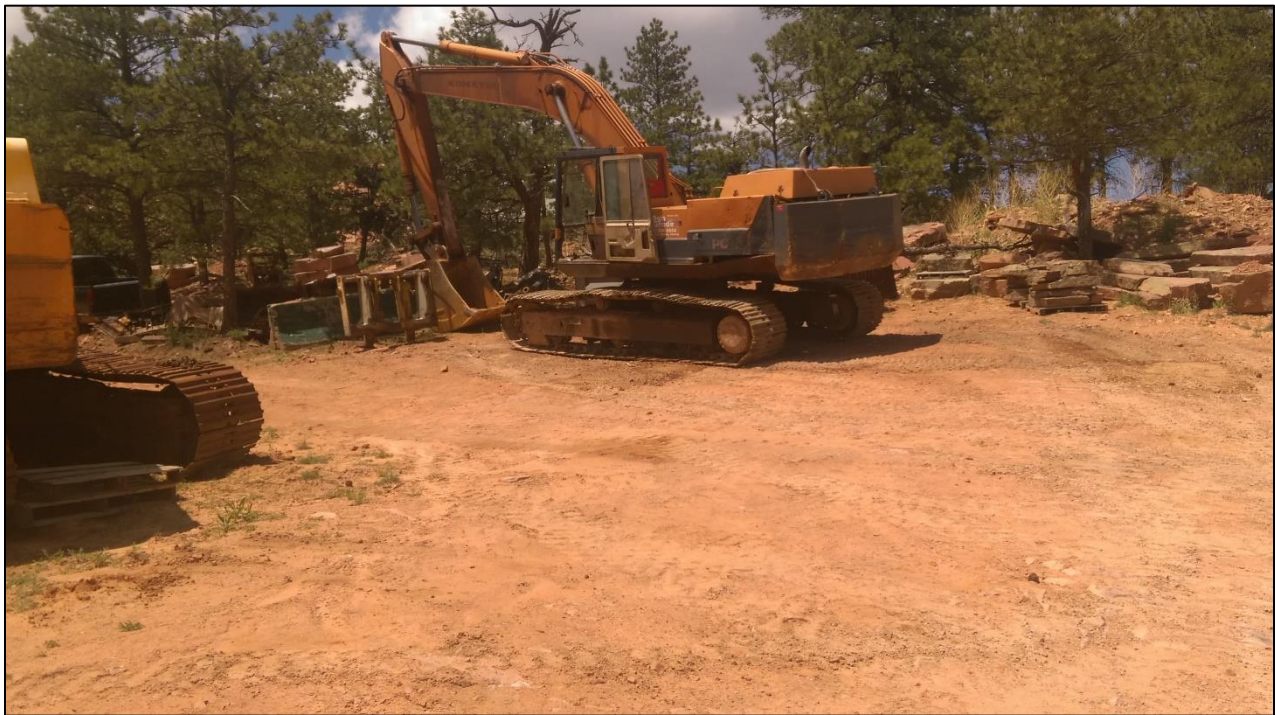
Photo 9. View of equipment and fuel storage area located adjacent to access road between the two quarries.

Photo 10. View of equipment and fuel storage area located adjacent to access road between the two quarries.

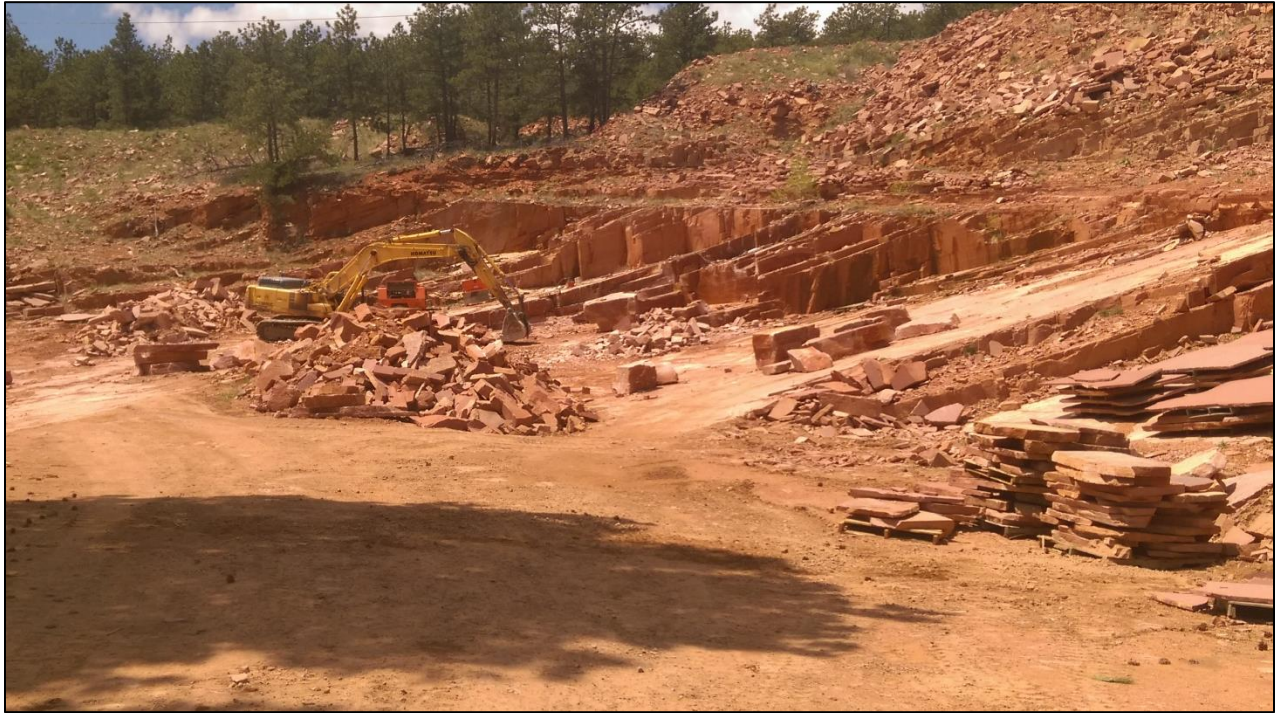
The south quarry is approximately 15 feet deep with overburden stockpiled along its northern and southern edges (**Photos 11-13**). Approximately 400 feet of highwall ranging from 3-15 feet in height exist in the south quarry. A stone working and storage area is located just east of the south quarry, on the other side of the access road (**Photos 14 and 15**). This area includes portable stone cutting machinery and storage of palletized stone. Overburden is stockpiled mainly along the southern edge of this area (**Photo 16**). Disturbance at the site also includes an overburden storage area and palletized stone storage area adjacent to an existing haul road in the southeastern portion of the permit area. The Division estimates these two storage areas to comprise

Photo 11. View of south quarry with highwalls of up to 15 feet in height.

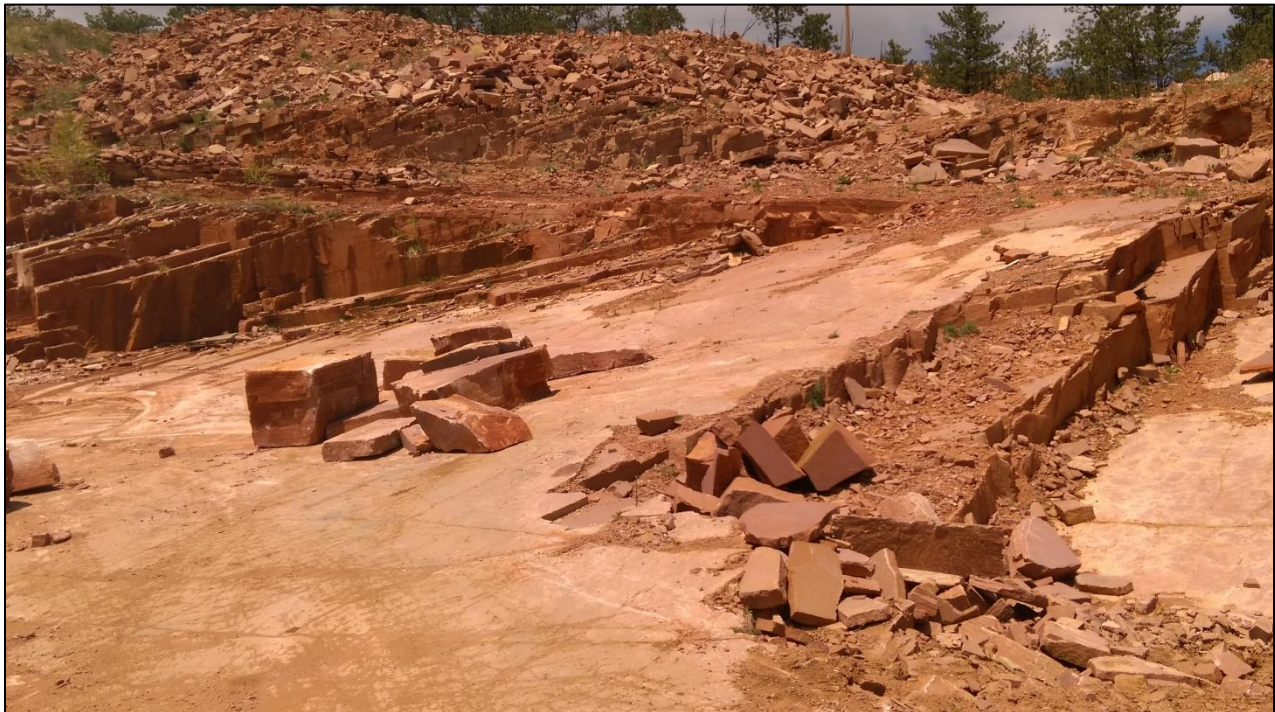
Photo 12. View of south quarry with highwalls of up to 15 feet in height. Note overburden stored along northern edge of quarry.

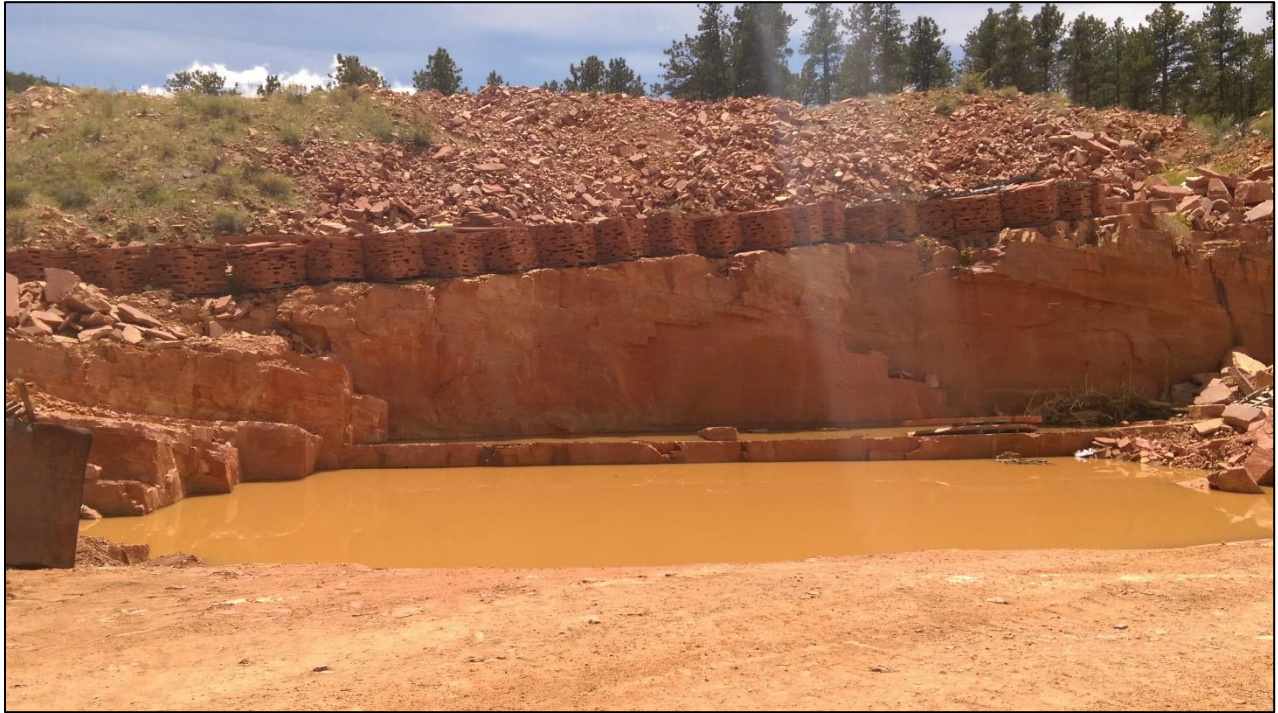
Photo 13. View of south quarry with highwalls of up to 15 feet in height. Note overburden stored along southern edge of quarry. Water visible on pit floor is attributed to recent storm event.

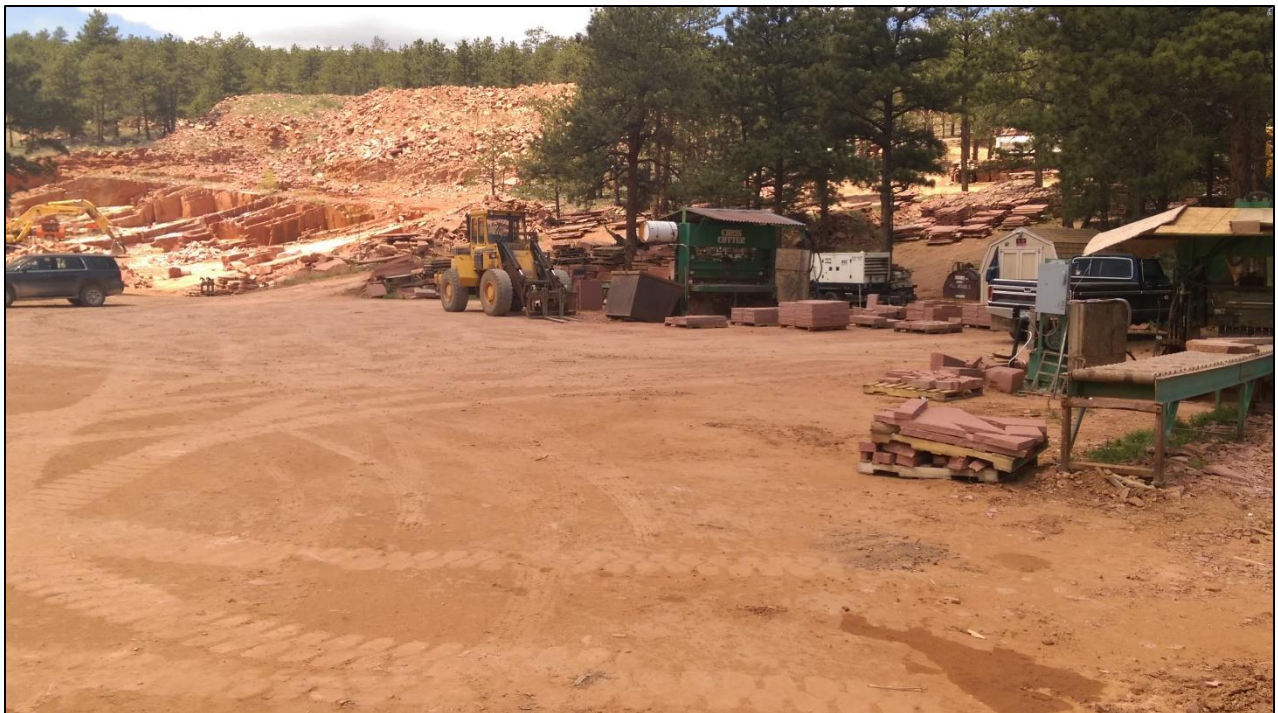
Photo 14. View of stone working and storage area present east of south quarry on other side of haul road. All stone cutting equipment is portable and thus will not require demolition for reclamation.

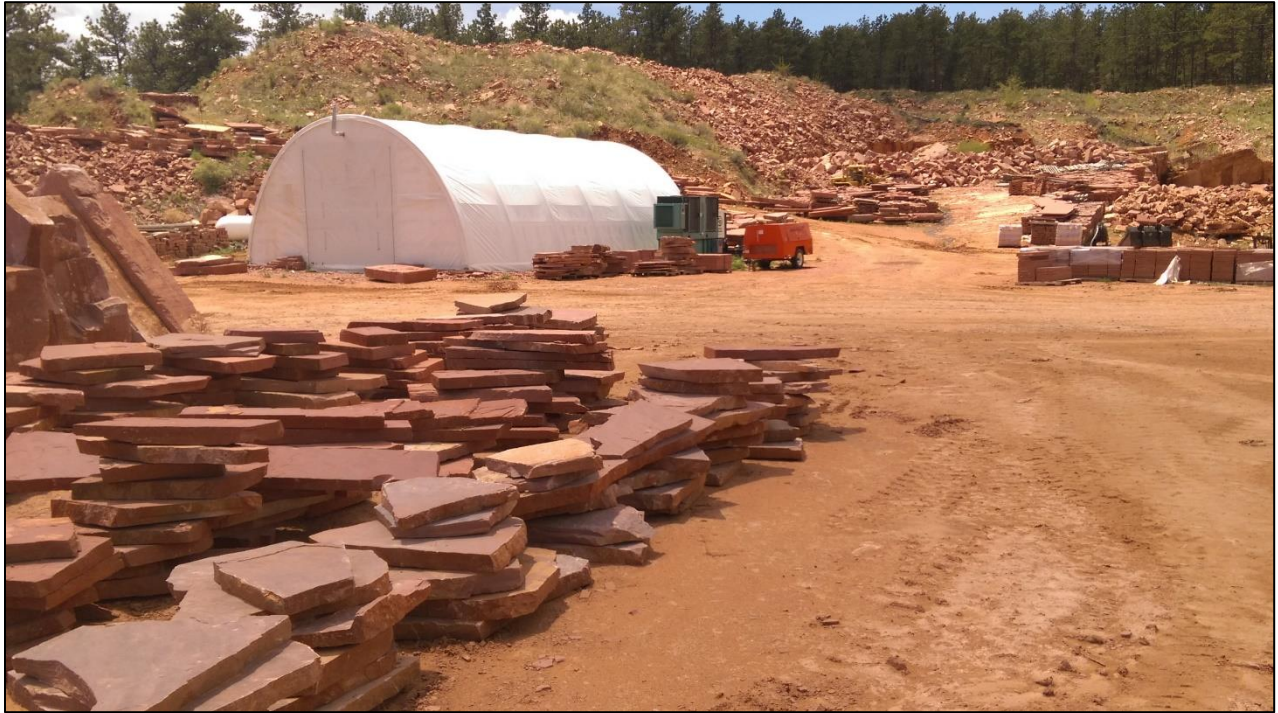
Photo 15. View of stone working and storage area present east of south quarry on other side of haul road. All stone cutting equipment is portable and thus will not require demolition for reclamation. The white tent houses a bridge saw.

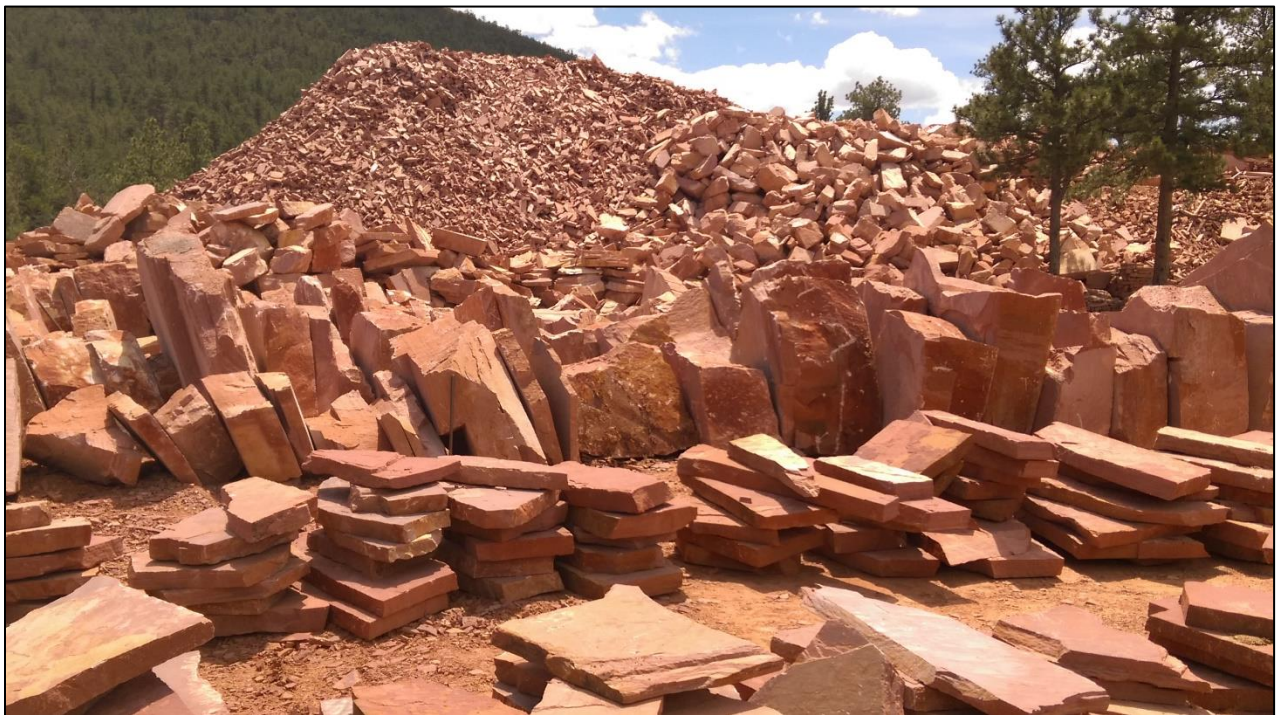
Photo 16. View of overburden stored along southern edge of stone working and storage area located east of south quarry. Foreground shows stacks of extracted stone.

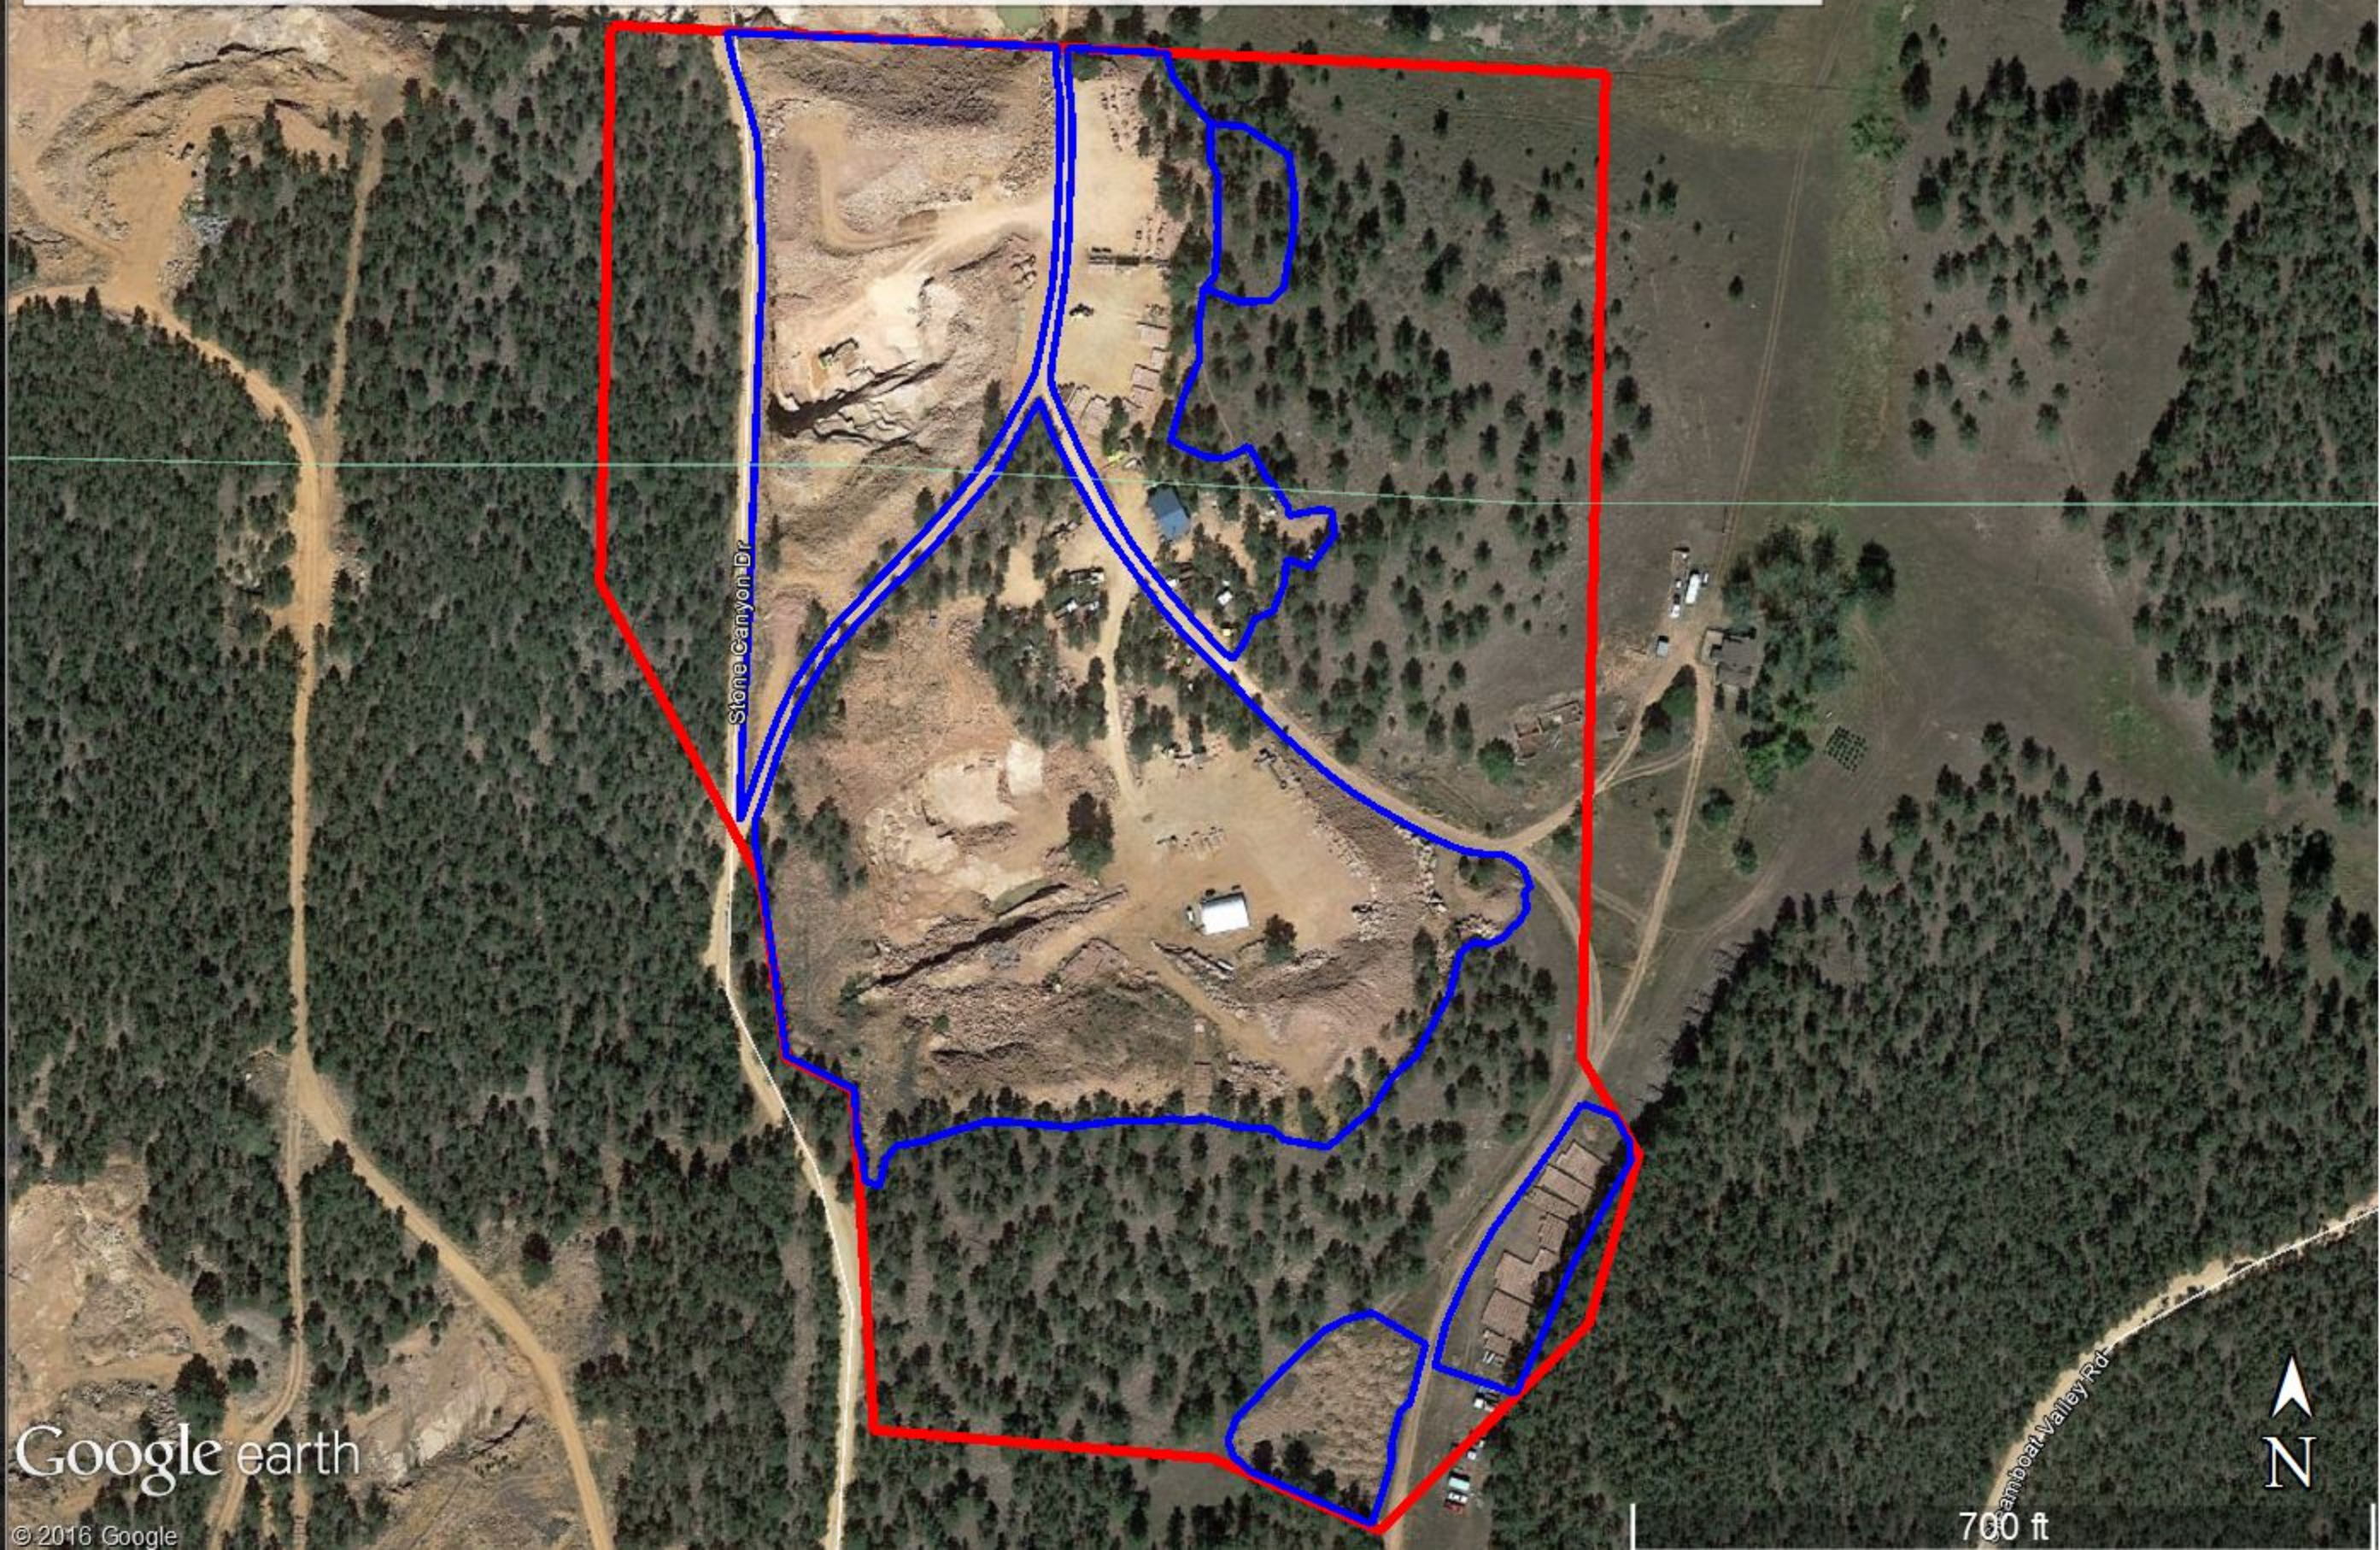
Red Outline = 25 acres = Approved Permit Area

Blue Outline = 12.75 acres = Total Disturbed Area (0.25 acre in NE portion estimated based on 5/17/2017 inspection)
