MINERALS PROGRAM INSPECTION REPORT
PHONE: (303) 866-3567

MINE NAME: Pickard Pit	MINE/PROSPECTING ID#: M-2012-048	MINERAL: Gravel	COUNTY: Kit Carson
INSPECTION TYPE: Monitoring	INSPECTOR(S): Elliott R. Russell	INSP. DATE: March 27, 2017	INSP. TIME: 12:00
OPERATOR: Kit Carson County	OPERATOR REPRESENTATIVE: Dave Hornung	TYPE OF OPERATION: 110c - Construction Limited Impact	
REASON FOR INSPECTION: Normal I&E Program	BOND CALCULATION TYPE: None	BOND AMOUNT: NA	
DATE OF COMPLAINT: NA	POST INSP. CONTACTS: None	JOINT INSP. AGENCY: None	
WEATHER: Clear	INSPECTOR'S SIGNATURE:

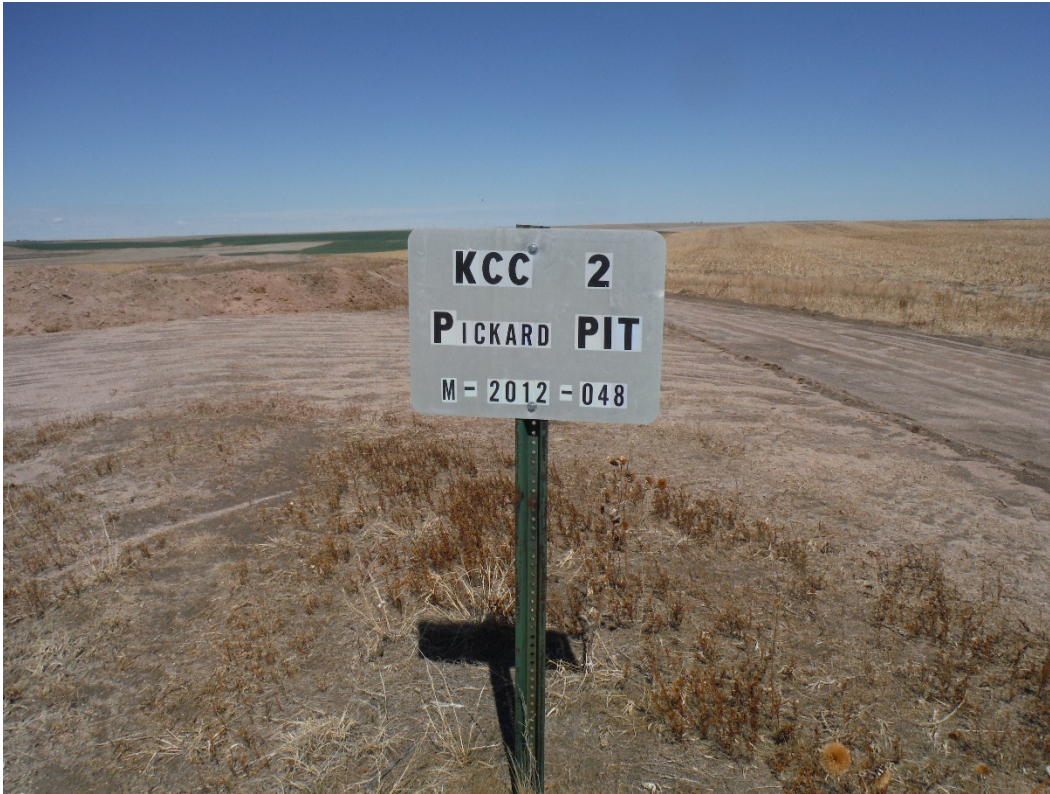
Fig 1. Mine identification sign; looking north.

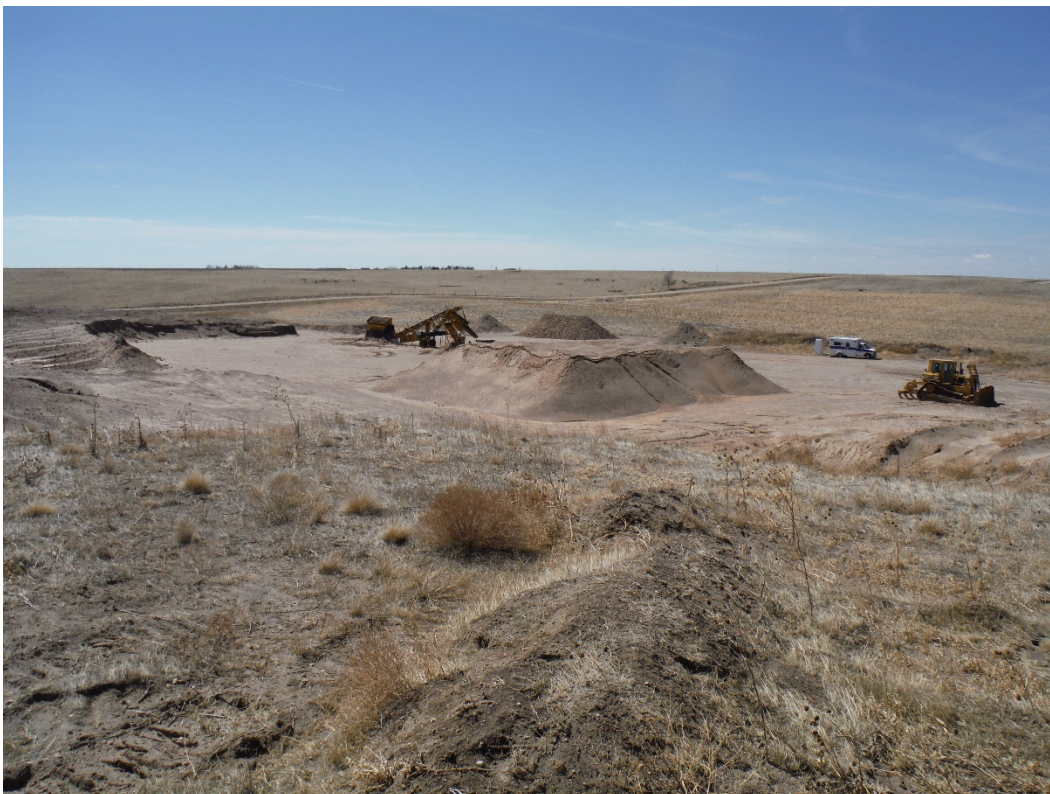
Fig 2. Site overview; looking southwest.

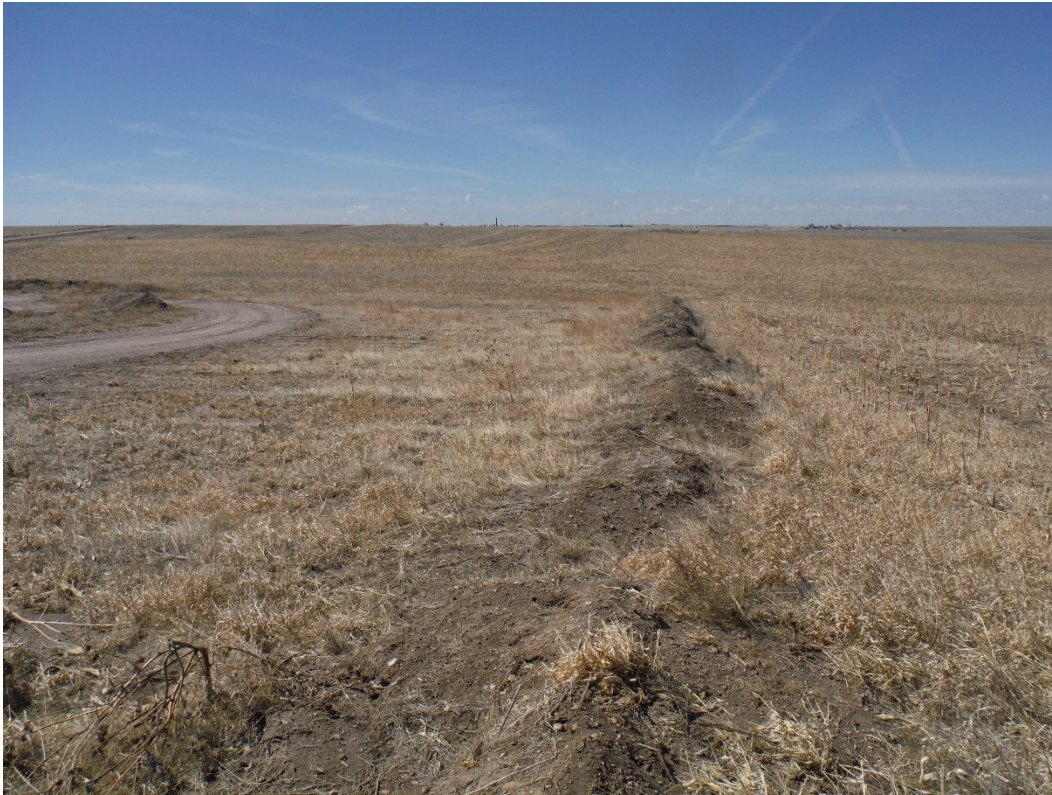
Fig 3. Small berm of topsoil along the northern permit boundary, appears to aid with stormwater control; looking west.

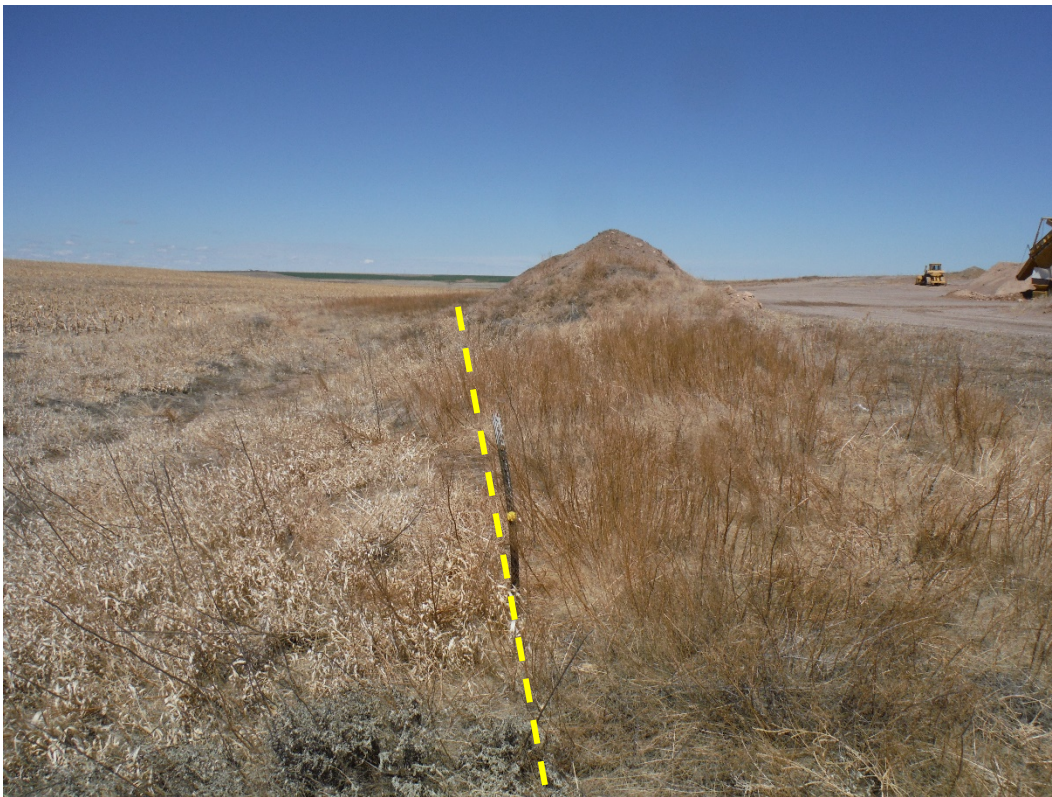
The site consists of a single excavation area with a large processing area where multiple screened stockpiles of product were located. Topsoil had been salvaged and stockpiled in various locations around the site. The topography of the site and the location of topsoil stockpile berms appeared to keep all storm water on-site. Care should be taken with adding to the western topsoil stockpile as the outside toe is in close proximity of the permit boundary.

Fig 4. Topsoil stockpile along western permit boundary (yellow line); looking northwest.
