MINERALS PROGRAM INSPECTION REPORT
PHONE: (303) 866-3567

MINE NAME: Beeson Pit	MINE/PROSPECTING ID#: M-1982-186	MINERAL: Sand and gravel	COUNTY: Kit Carson
INSPECTION TYPE: Monitoring	INSPECTOR(S): Elliott R. Russell	INSP. DATE: March 27, 2017	INSP. TIME: 13:15
OPERATOR: Kit Carson County	OPERATOR REPRESENTATIVE: Dave Hornung	TYPE OF OPERATION: 112c - Construction Regular Operation

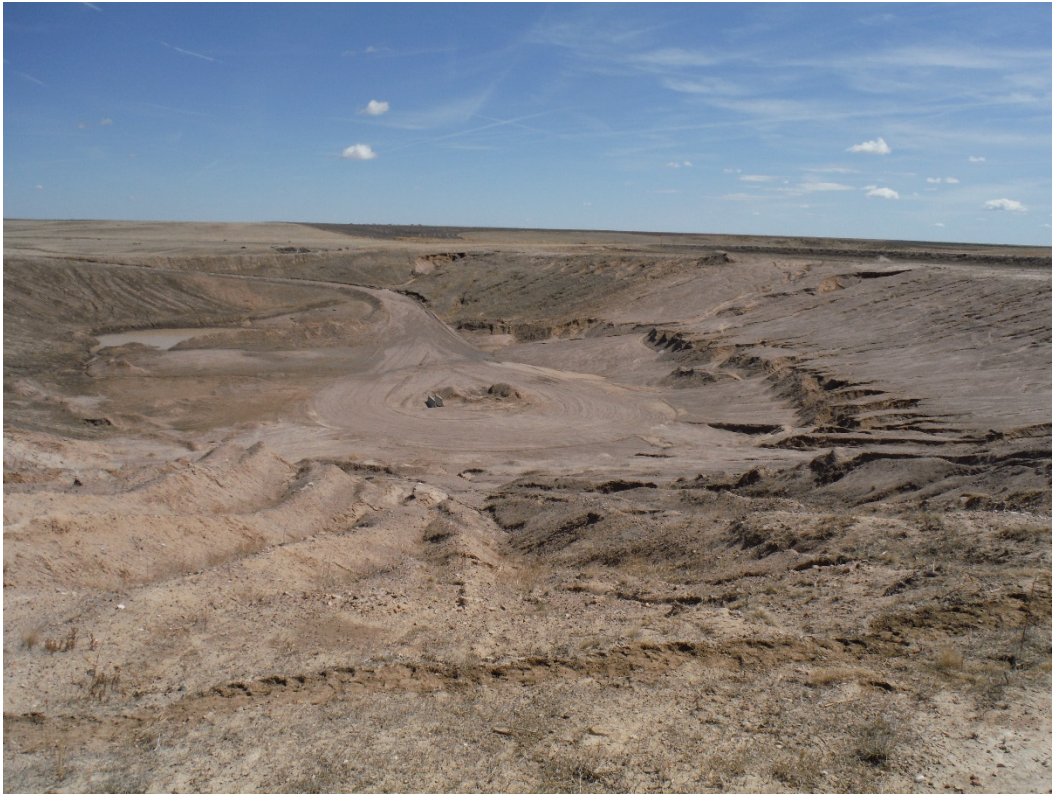
The Division met Mr. Hornung at the mine site entrance on the south side of County Road K, $\frac{3}{4}$ of a mile west of County Road 40. The site consists of a single excavation (see **Photo 1**) along Sand Creek, an ephemeral channel. There was no equipment on site, however, the Division observed evidence of recent activity.

Photo 1. Site overview; looking east.

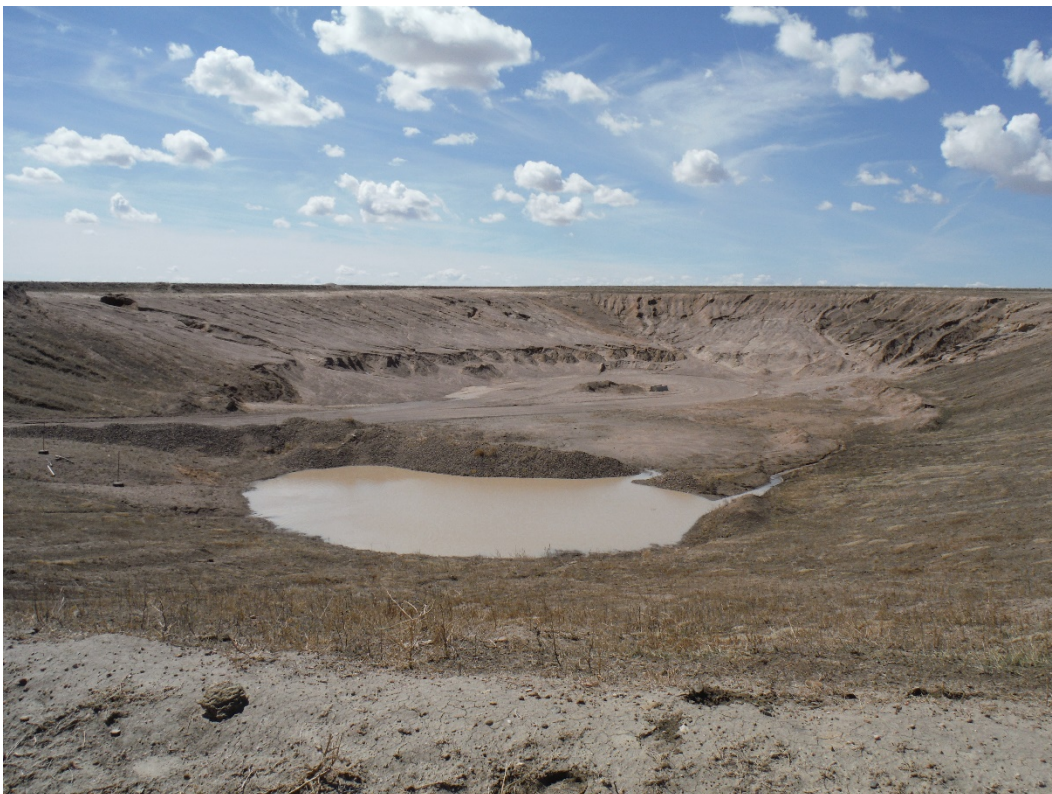
Hydrologic Balance: Standing water was observed in the northeast portion of the pit, likely from a recent rain event (see **Photo 2**).

Photo 2. Standing water in the northeast portion of the pit; looking southwest.

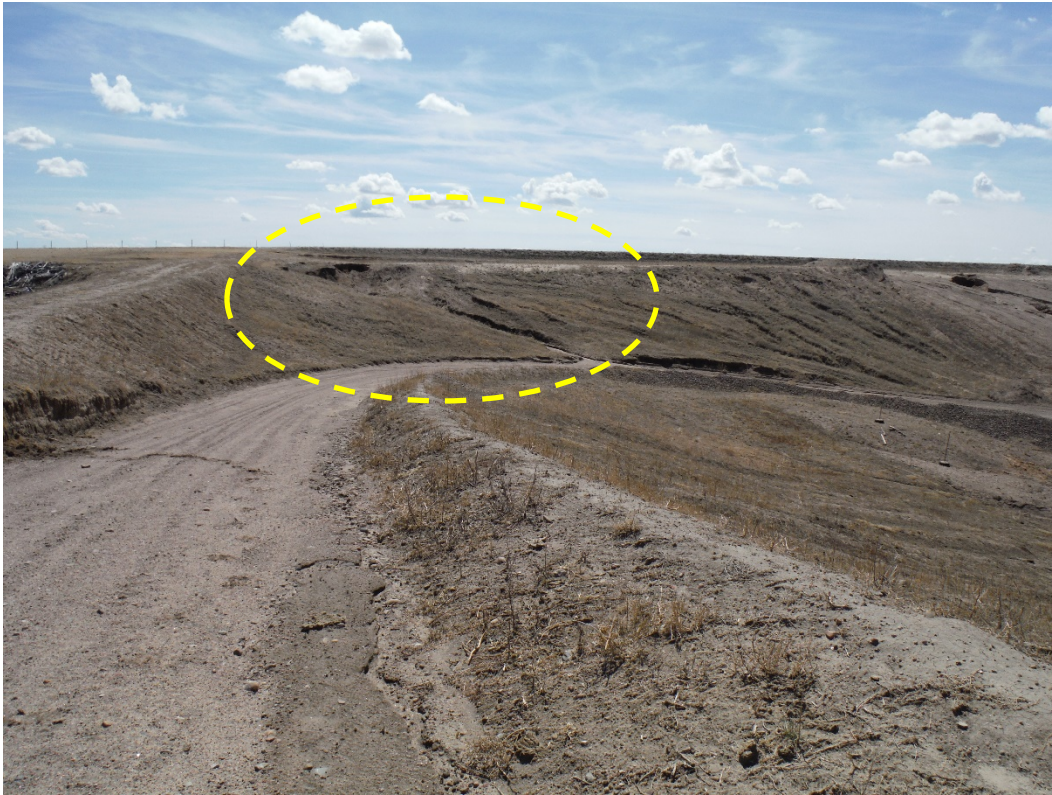
Sediment Control: The active mining slopes contained some minor erosion, but this is not cited as a compliance problem because the sediment is carried into the pit and does not impact off-site lands. The Division recommends the Operator monitor, and if necessary repair/mitigate, an erosional feature located in the southeast corner of the pit (see **Photo 3**) as this could migrate and potentially impact off-site lands.

Photo 3. Erosional feature of concern; looking south.

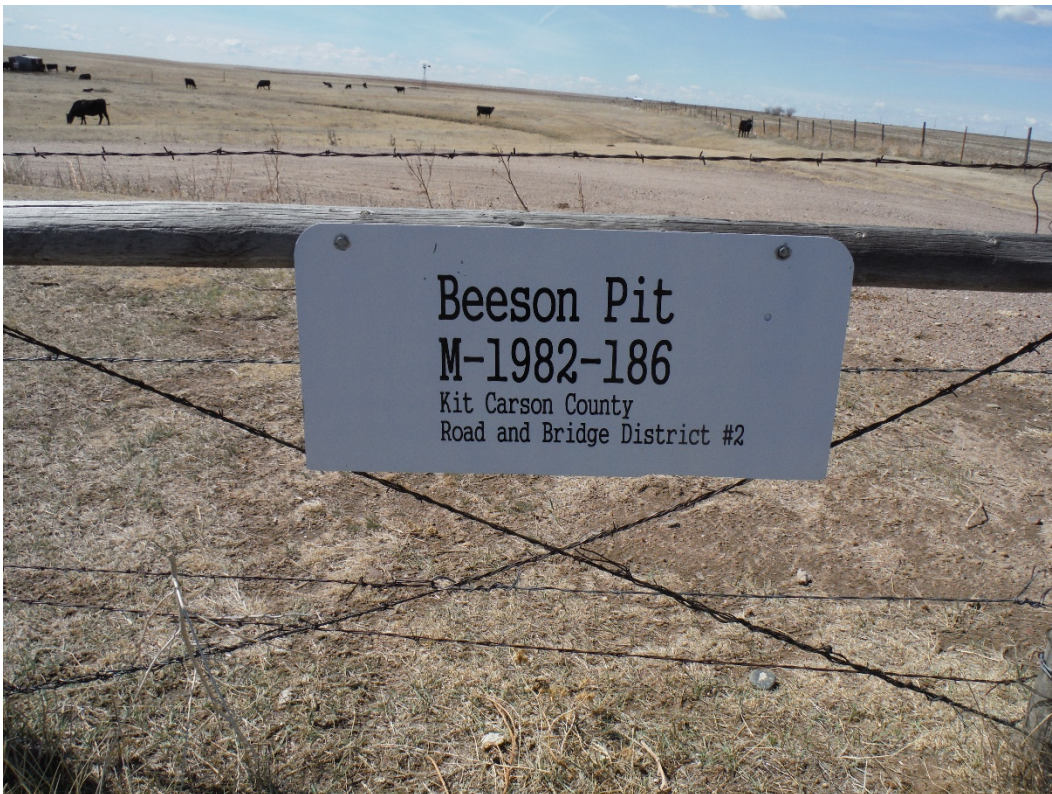
Signs and Markers: The permit sign was posted at the site entrance (see **Photo 4**). The permit boundary was delineated by metal t-posts (see **Photos 5 and 6**).

Photo 4. Permit identification sign; looking west..

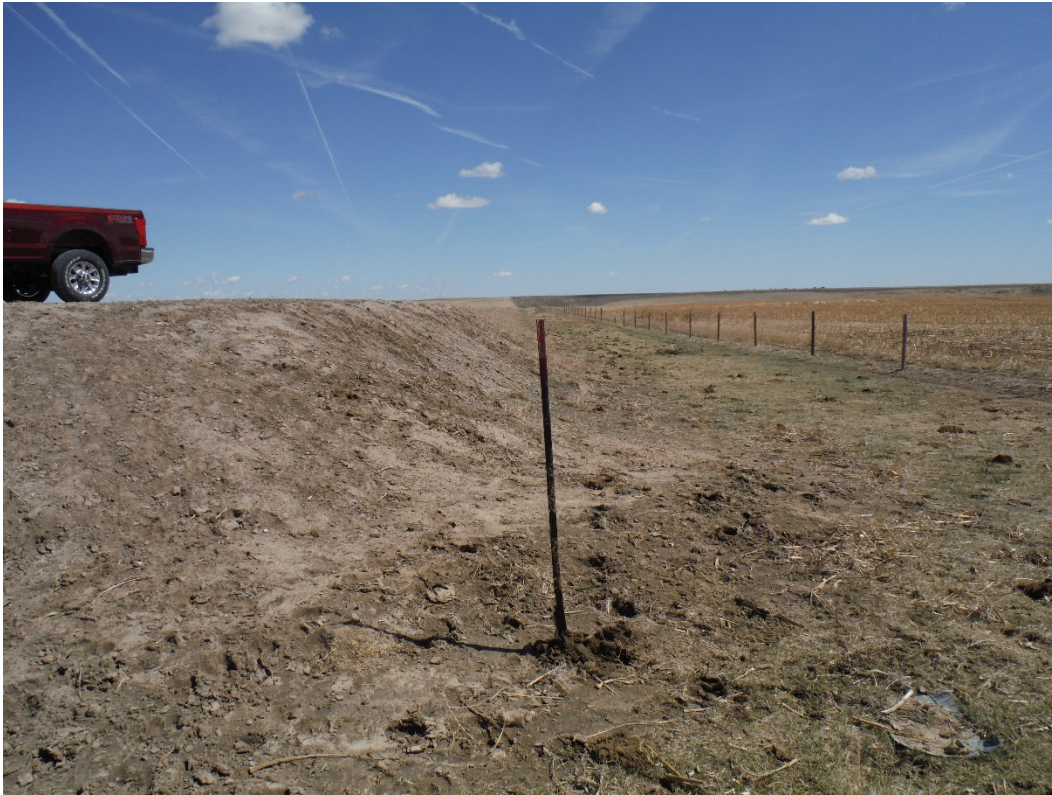
Photo 5. Southwest boundary marker; looking east.

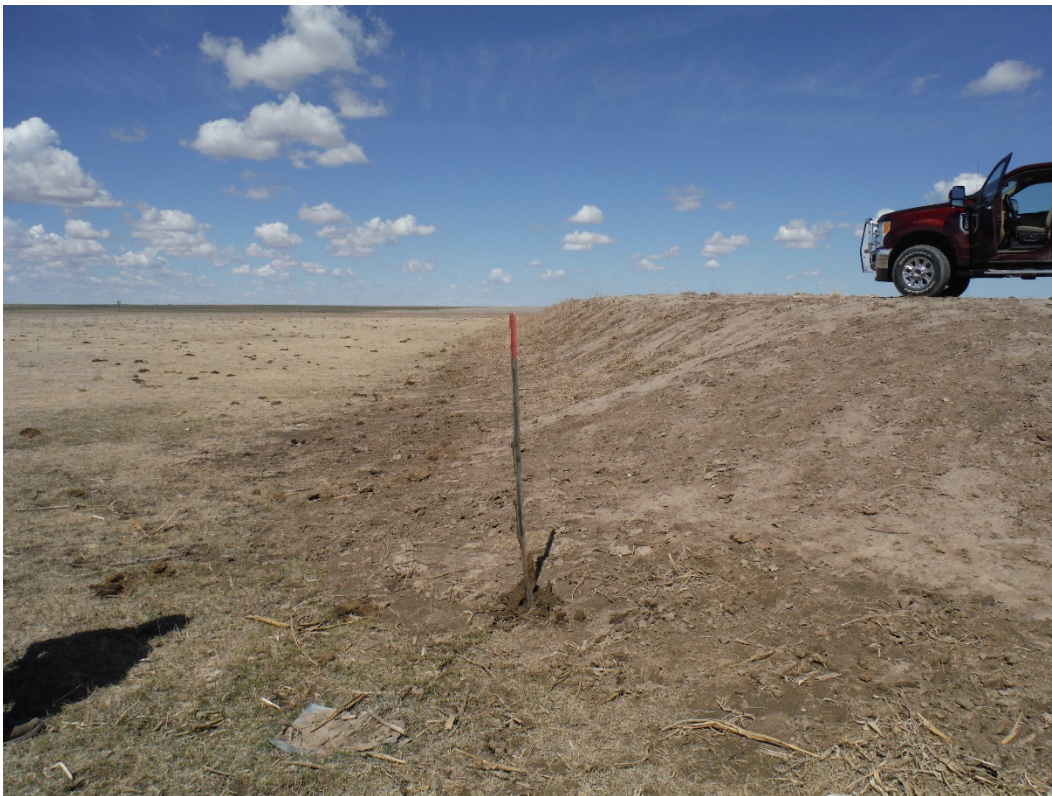
Photo 6. Southwest boundary marker; looking north.

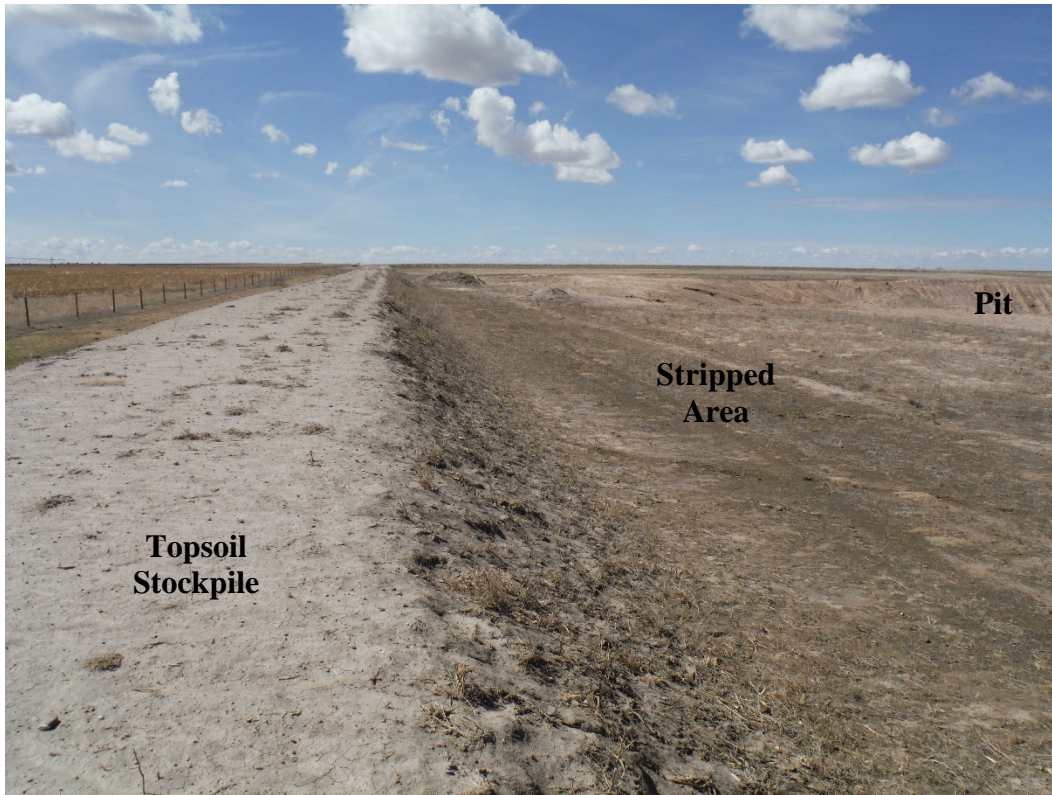
Topsoil: Topsoil was salvaged and stockpiled along the southern and western permit boundary as well as a portion of the northern permit boundary (see **Photo 7**).

Photo 7. Topsoil stockpile located along the southern permit boundary; looking west.
