MINERALS PROGRAM INSPECTION REPORT
PHONE: (303) 866-3567

MINE NAME: Eberhart Pit	MINE/PROSPECTING ID#: M-1982-054	MINERAL: Sand and gravel	COUNTY: Kit Carson
INSPECTION TYPE: Monitoring	INSPECTOR(S): Elliott R. Russell	INSP. DATE: March 27, 2017	INSP. TIME: 14:40
OPERATOR: Kit Carson County	OPERATOR REPRESENTATIVE: Dave Hornung	TYPE OF OPERATION: 112c - Construction Regular Operation

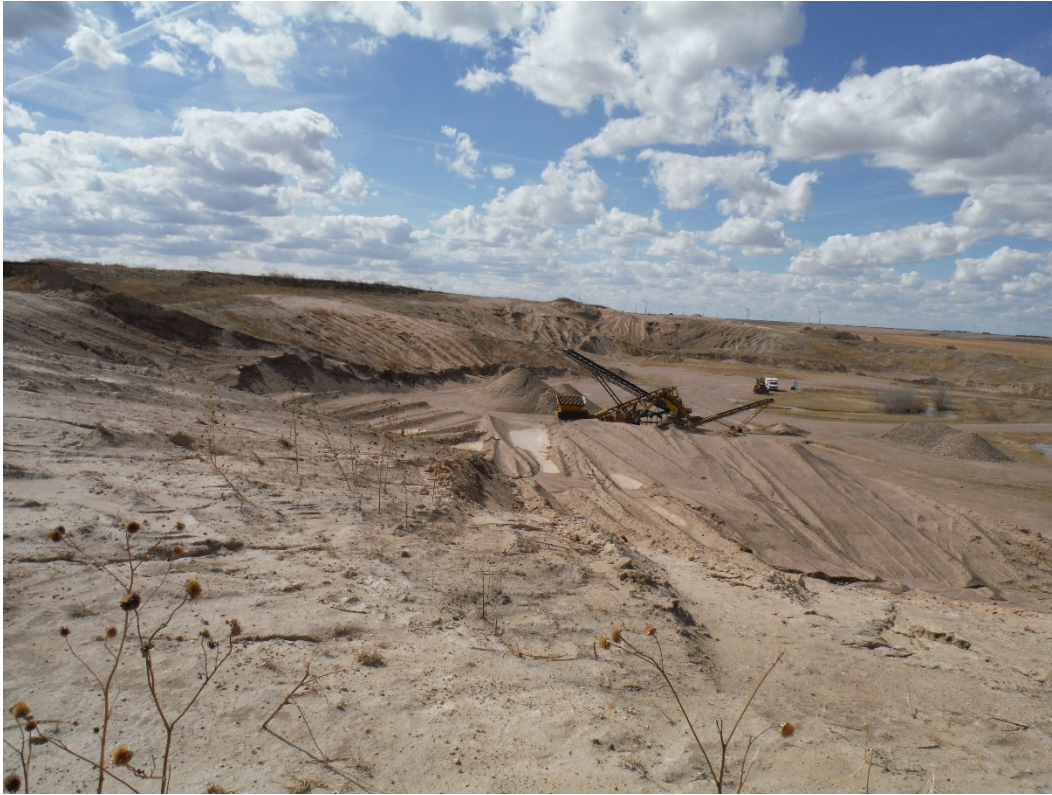
The Division met Mr. Hornung at the mine site entrance on the west side of County Road 59, 1 mile north of County Road V. The site consists of a single excavation area with a large processing area on the pit floor where multiple screened stockpiles of product were located (see **Photos 1 and 2**). The site appeared to be recently active. Equipment on the site consisted of a screen, a bulldozer, and a former ambulance serving as a mobile office.

Photo 1. Site overview; looking northwest.

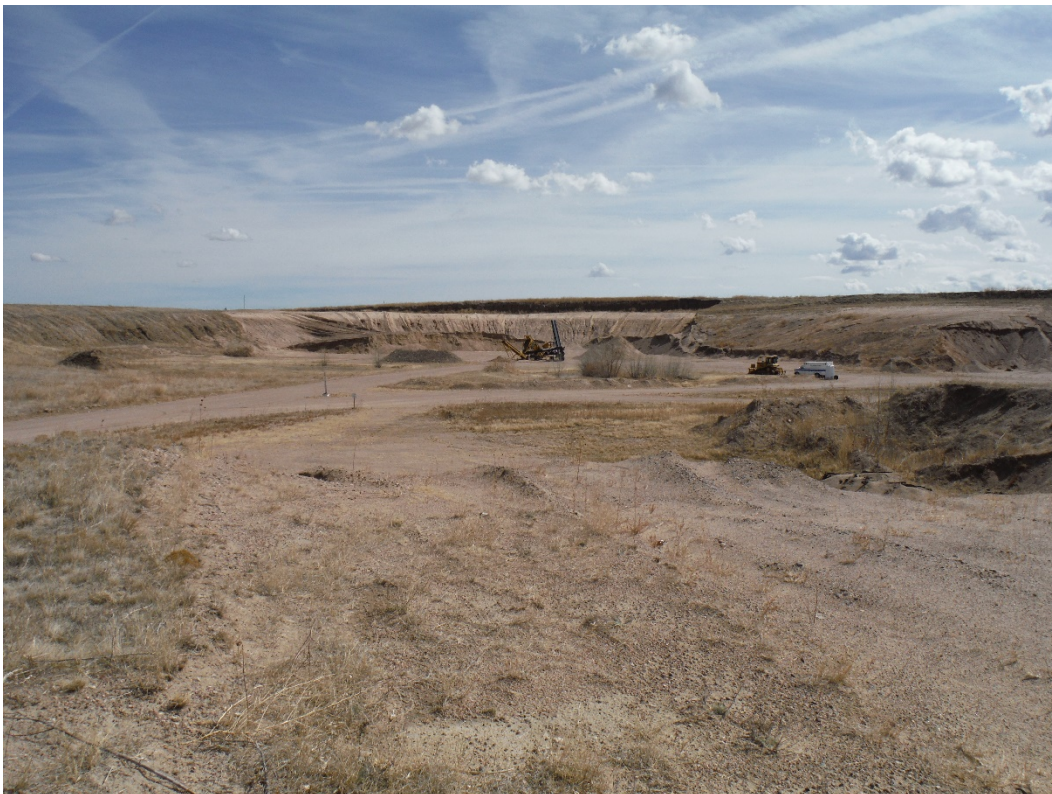
Photo 2. Site overview; looking south.

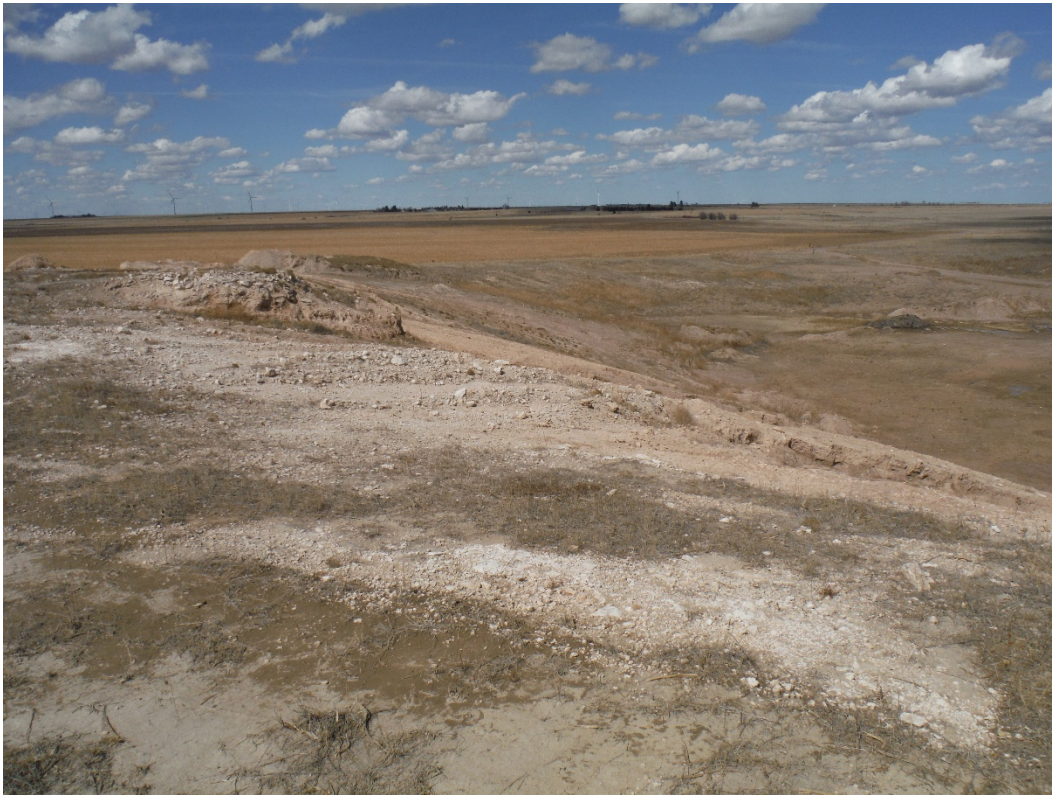
Backfilling and Grading: Mining slopes are maintained at approximately 3H:1V except a small area near the toe which was near vertical (see **Photos 3 and 4**).

Photo 3. Western mine slope; looking north.

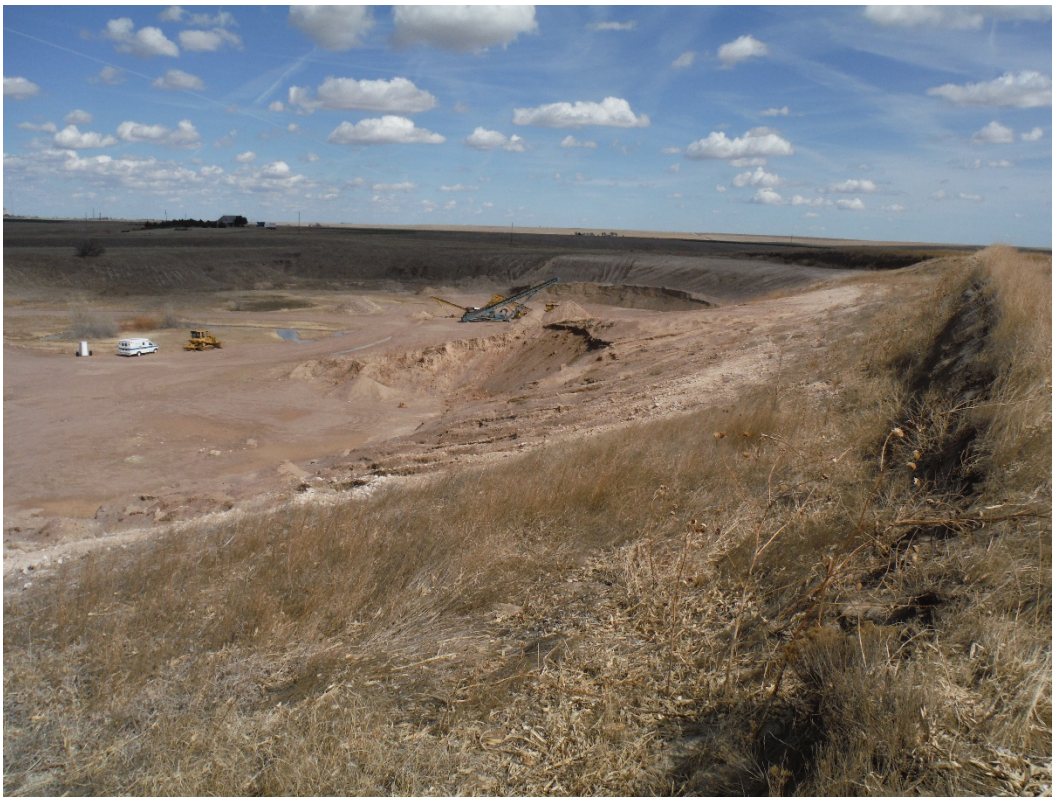
Photo 4. Southern mine slope; looking east.

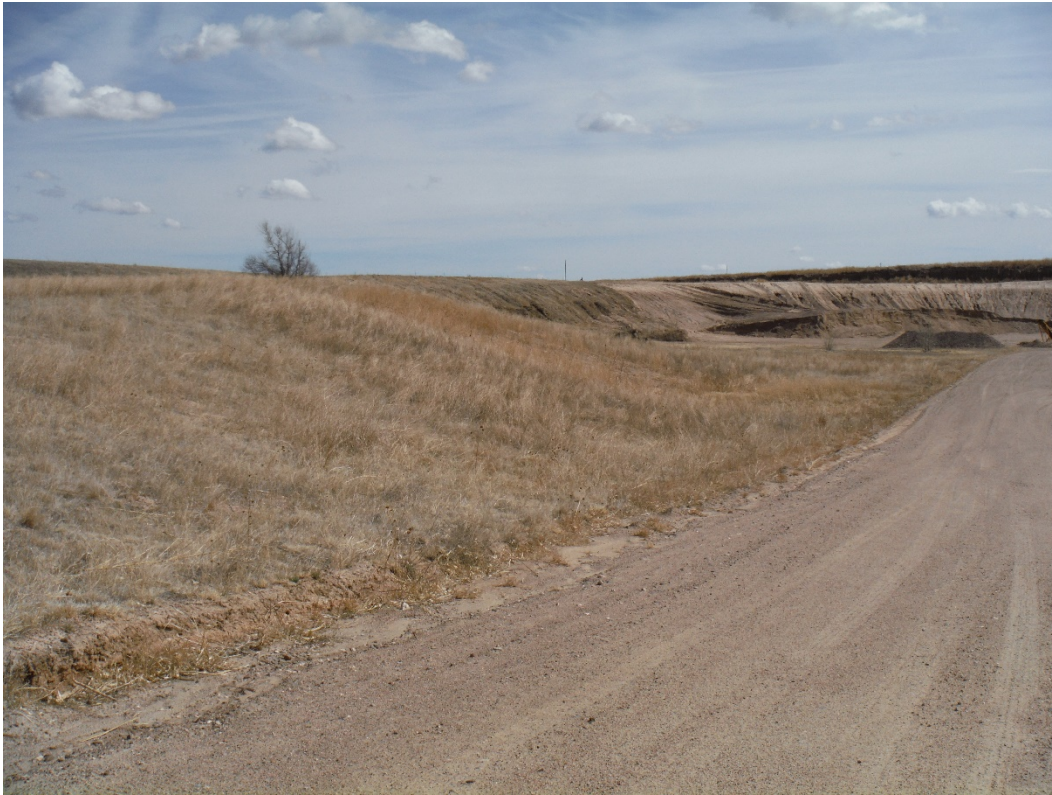
Revegetation: Portions of the northeastern pit slopes was starting to revegetate (see **Photo 5**).

Photo 5. Revegetated slope in the northeast portion of the site; looking east.
