**MINERALS PROGRAM INSPECTION REPORT**  
**PHONE: (303) 866-3567**

<b>MINE NAME:</b> Fairplay Au Pit	<b>MINE/PROSPECTING ID#:</b> M-1991-037	<b>MINERAL:</b> Gold	<b>COUNTY:</b> Park
<b>INSPECTION TYPE:</b> Preoperation Inspection	<b>INSPECTOR(S):</b> Michael A. Cunningham	<b>INSP. DATE:</b> May 17, 2017	<b>INSP. TIME:</b> 09:30
<b>OPERATOR:</b> High Speed Mining, LLC	<b>OPERATOR REPRESENTATIVE:</b> Lance Baller	<b>TYPE OF OPERATION:</b> 110c - Construction Limited Impact	
<b>REASON FOR INSPECTION:</b> Normal I&E Program	<b>BOND CALCULATION TYPE:</b> Complete Bond	<b>BOND AMOUNT:</b> \$21,110.00	
<b>DATE OF COMPLAINT:</b> NA	<b>POST INSP. CONTACTS:</b> None	<b>JOINT INSP. AGENCY:</b> None	
<b>WEATHER:</b> Clear	<b>INSPECTOR'S SIGNATURE:</b>

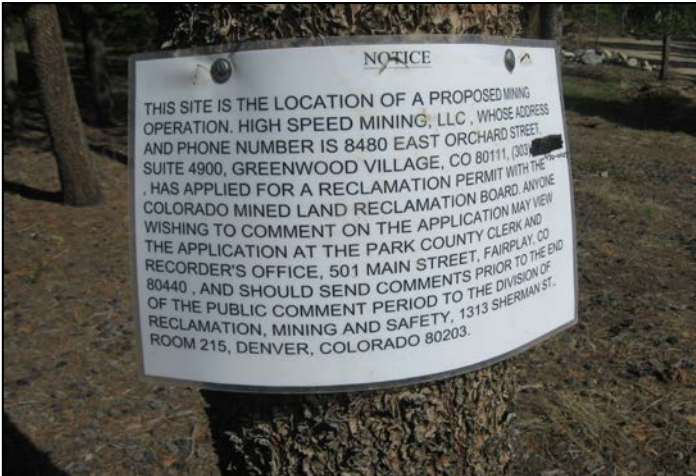
1. Public Notice sign posted at site entrance.

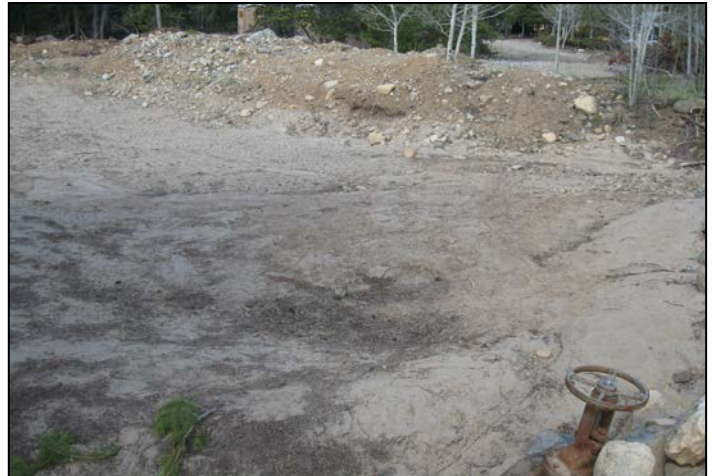
The Division and representatives from the Office of the State Engineer (OSE) inspected the water holding ponds and the wash pond, which were the subject of a violation issued at the January 25, 2017 Mined Land Reclamation Board (Board) Hearing. These mine features are currently located outside of the 8 acre permit boundary and are not being utilized in the mining operation. On May 3, 2017, the Operator submitted a written request to utilize the ponds. The Division denied the request to utilize the ponds until such time as those affected lands are incorporated into the 112 Hard Rock permit boundary and reclamation of the those affected lands is bonded for. The Operator appealed the Division's decision in accordance with Rule 1.4.11 and the matter was heard by the Board at the May 24, 2017 Board Hearing. The Board upheld the Division's decision to not allow the use of the ponds in the mining operation until such time as those affected lands were incorporated into the permit boundary and an appropriate financial warranty was posted.

2. Water holding pond.

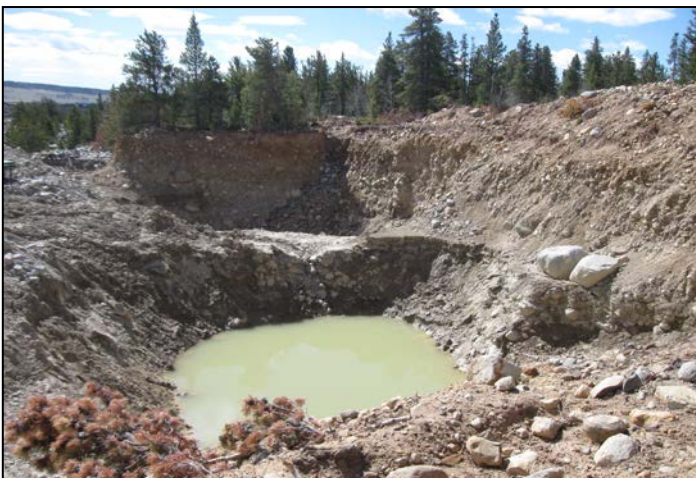
3. Wash pond.

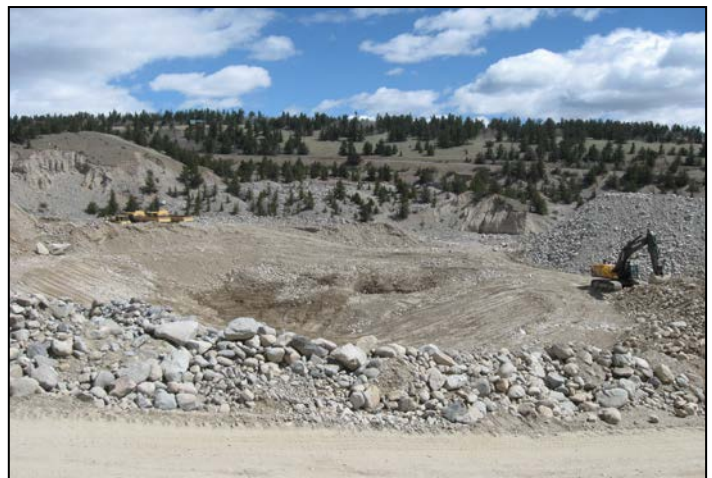
Prior to inspecting the 33.4 acres which were being incorporated into the permit boundary, the Division inspected the area within the 8 acre permit boundary. As noted above, the operation was not active at the time of the inspection. The wash plant was set up near the eastern permit boundary. During the previous year the Operator had excavated a pit along the western permit boundary. The Operator and the Division discussed utilizing the existing pit as a wash pond, since the existing wash pond was partially located outside of the permit boundary and could not be used. The Operator received approval of a Technical Revision on May 26, 2017 to utilize the existing pit as a lined wash pond. The material which was mined and washed is currently stockpiled immediately north of the pit and the wash plant.

4. Overview of pit excavation, photo taken facing north.

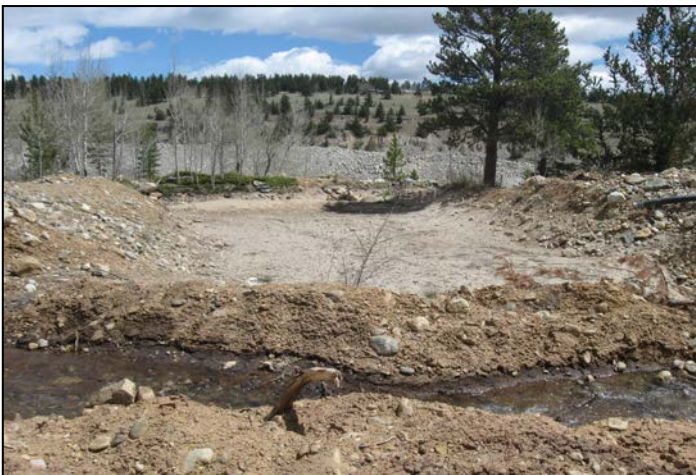
During the inspection Garver Brown, the District 23 Water Commissioner, provided background on the historic water use at this mine site and informed the Division that there were no restrictions on how water could be conveyed from the Platte City Mining Ditch into the mine site, provided the water was conveyed by gravity. The Platte City Mining Ditch was flowing at the time of the inspection. The water was bypassing the above referenced ponds and was discharging onto the property located immediately to the east of the Fairplay Au Pit. The tailwater from the Platte City Mining Ditch returns to the River after it passes the Fairplay Au Pit. Garver Brown also informed the Division the Operator has a lease which allows for 60 acre-feet to be pumped from the River. The pumping of water from the River would be allowed since the pump and all appurtenances would be located within the permit boundary. Following the discussion of water usage at the site, the representatives from the OSE departed and the Division proceeded to inspect the remainder of the site.

5. Platte City Mining Ditch flowing in front of the water holding pond.

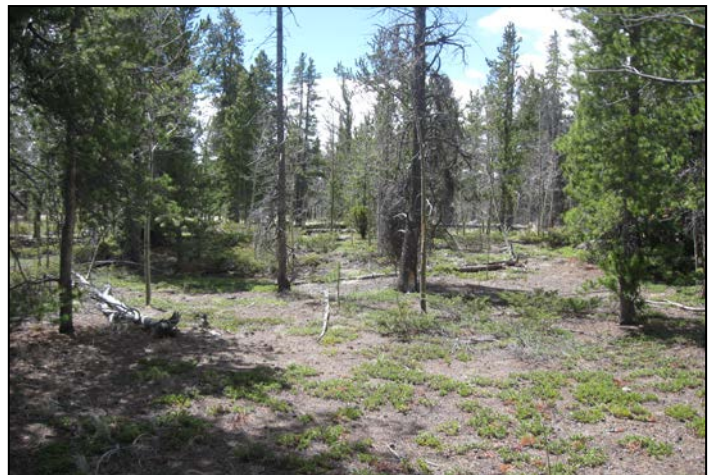
The lands which are being incorporated into the revised permit area consist of forested areas which are dominated by conifers and aspen. The Division observed the Platte City Mining Ditch splits into two segments once it crosses over to the east side of the access road. The main portion of the ditch currently provides water to the mining operation and the other segment which runs to the south and parallels the county road is not currently in use. This segment of the Platte City Mining Ditch was not accounted for in the Conversion Application. The Division will address this issue during the adequacy review of the Conversion Application. The mining operation will be conducted in 3 Phases. The land which is located to the east of the access road is relatively flat and comprises Phase 1. The land to the west of the access road contains steep slopes and consists of a knob which comprises Phase 2 and Phase 3 of the mining operation.

6. Typical vegetation surrounding the mine site.

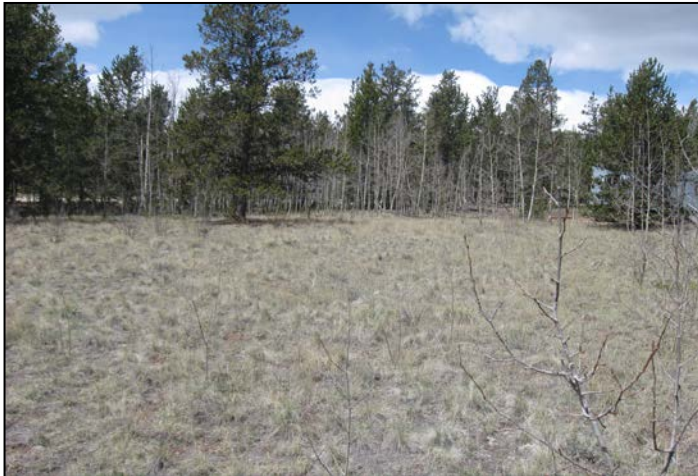
7. Typical vegetation surrounding the mine site.

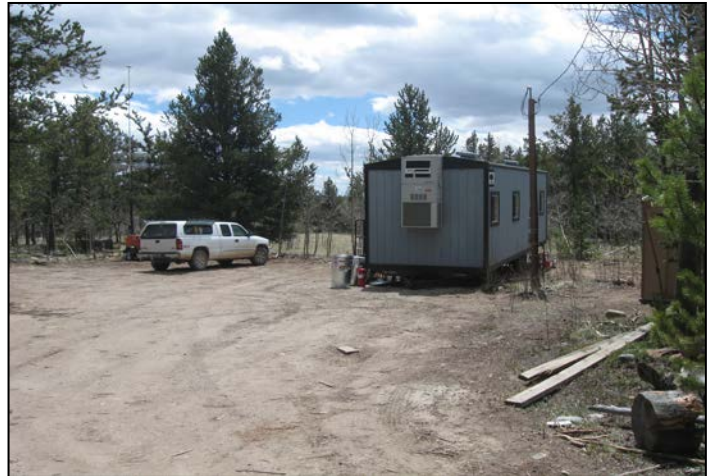
The Division proceeded to inspect the areas to the south and west of the current permit area. The Division observed several trailers, portable generators, portable lights, shipping containers, ATV's and other equipment belonging to the Gold Rush film crew, which were located outside of the 8 acre permit boundary. The Division does not consider these items to be related to the mining operation and the placement of these items on the property of High Speed Mining, LLC is not regulated by the Division.

8. Portable trailer not associated with the mining operation.

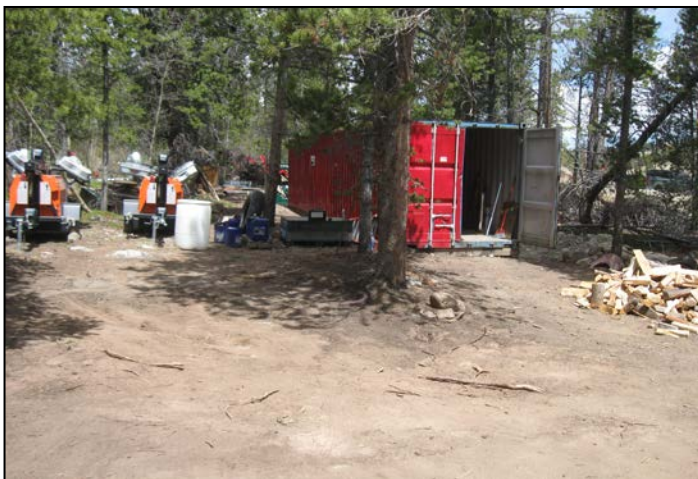
Response: The Division did not observe any mining related equipment outside of the permit boundary. As noted above, the equipment and portable structures which were located outside of the permit boundary belonged to the Gold Rush film crew and are not regulated by the Division.

9. Equipment not associated with the mining operation.

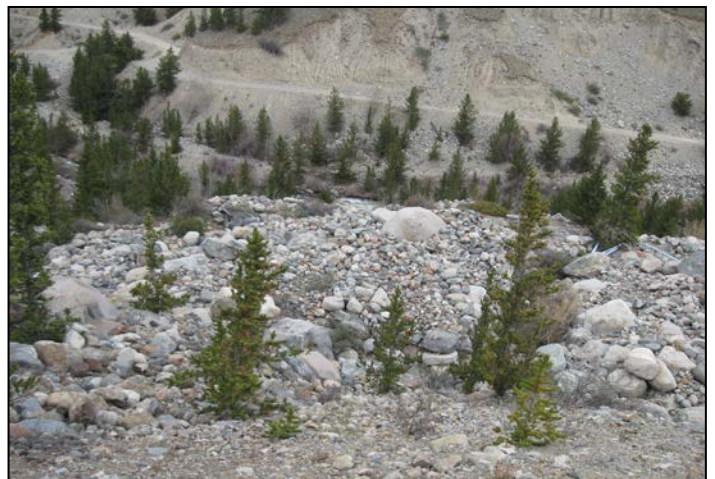
10. Historic disturbance along the Middle Fork of the South Platte River.
