Bureau of Land Management Colorado River Valley Field Office Minerals Inspection Report

General Information	
Date	5/3/2017
Project Name	Rifle Quarry
Operator	Colorado Lien Company
Serial Number	COC-077876
Project Classification	Plan of Operations
Project Location	T4S R92W Sec15, Garfield County
Inspection Purpose	Reclamation site inspection
Time Period Onsite	1 hour
Attendees	Jessica Lopez Pearce, BLM Geologist

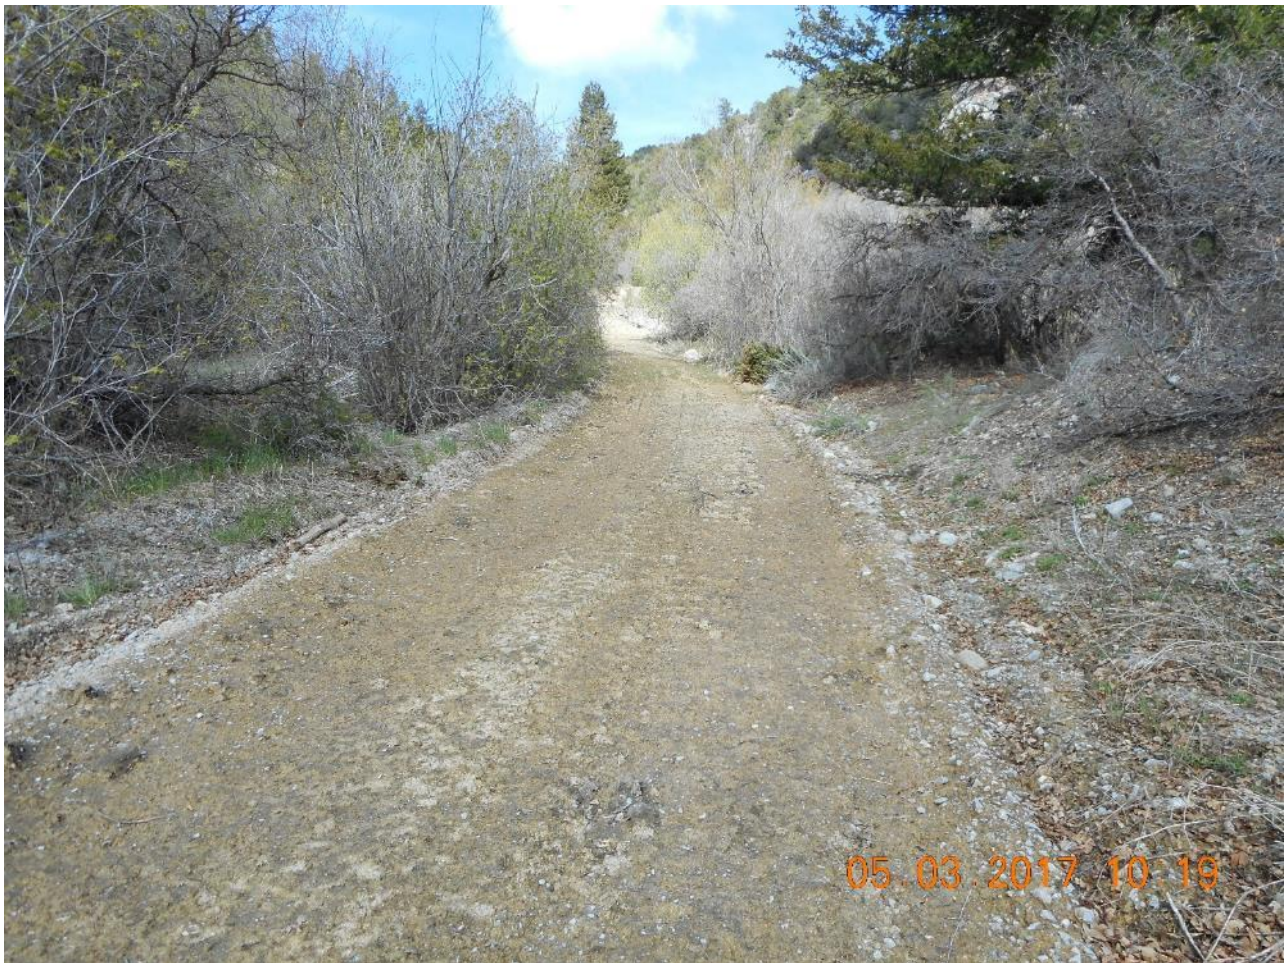
Upon my arrival at the quarry, I found the access road blocked per the Final Reclamation Plan. The surface of the road appeared to be covered in the approved alternative growth media and mulching material (a combination of fish emulsion solids, spent grain solids, spent potato mash solids, mulch, and topsoil) and seeded (Photo 1). There were small grass sprouts, but I was unable to identify if the vegetation was in compliance with the 2016 BLM-approved seed mix. Signage was present at the southeast corner of the main quarry area.

Photo 1: Looking west at the barricaded access road. Alternative growth media and mulching material was applied to the surface.

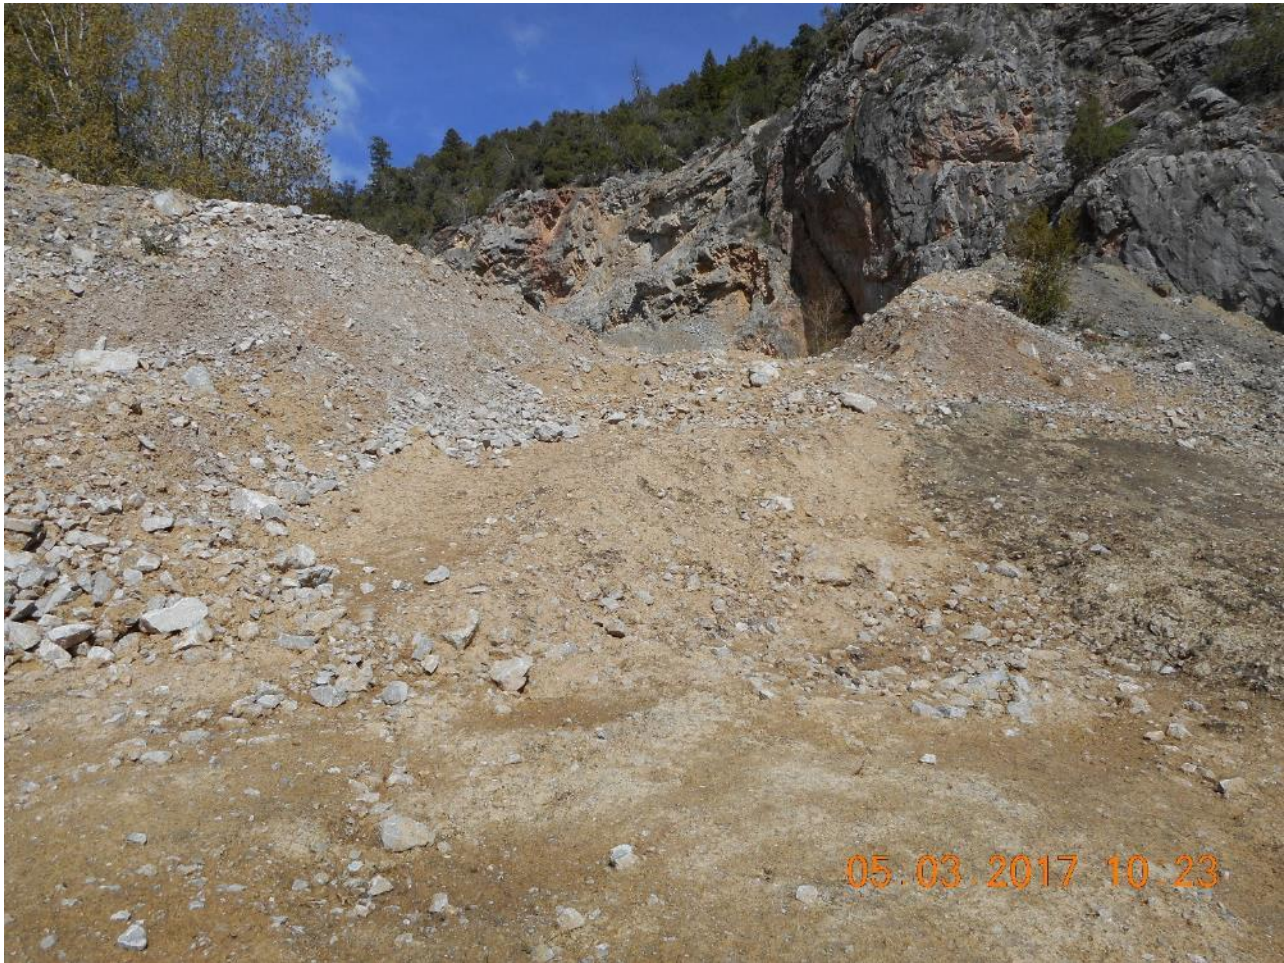
The 1.65-acre site includes a highwall on the north side and a backfilled and regraded area to the south. The backfilled quarry floor terminates to the east with an east-facing, 20-foot high, approximately 2:1 slope. I observed a bermed access route up the eastern slope to the recontoured quarry floor (Photo 2). The eastern slope, the quarry floor, the northern upper access bench, as well as most of the remaining quarry area was covered in the alternative growth media and mulching material. Some of the ground was damp and the material appeared compacted, while other areas were dry. It appeared that some portions of the quarry area had thick coverage of alternative growth media and mulching material, while other areas had thinner coverage or the material had washed away (Photo 3).

Photo 2: Looking west to the slope on the eastern side of the quarry. This slope of backfilled material is approximately 2:1.

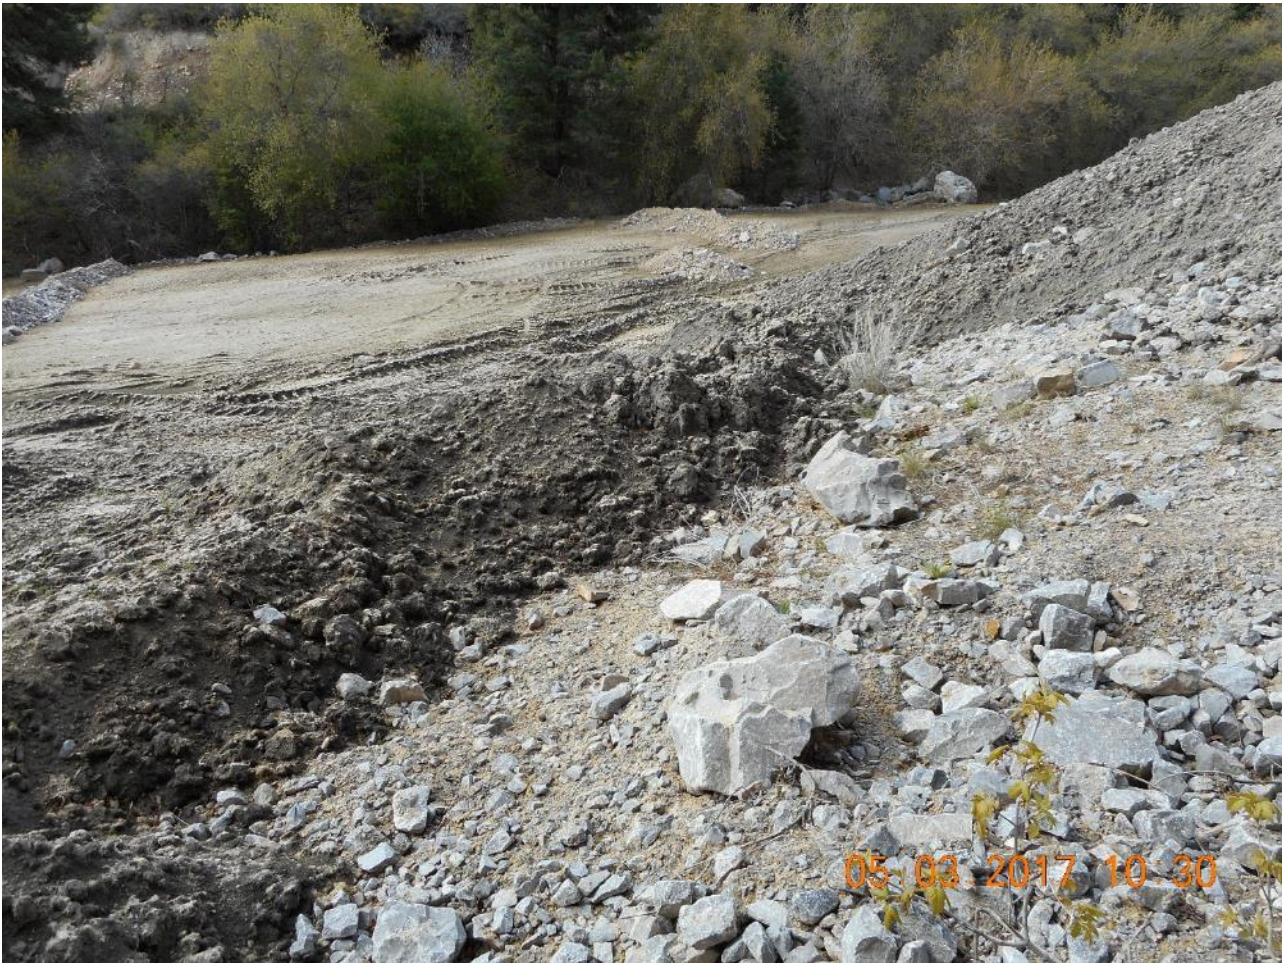
Photo 3: Looking south (highwall is behind the camera) at the distinction between quarry floor with applied alternative growth media and mulching material (left) vs. bare backfilled quarry (right).

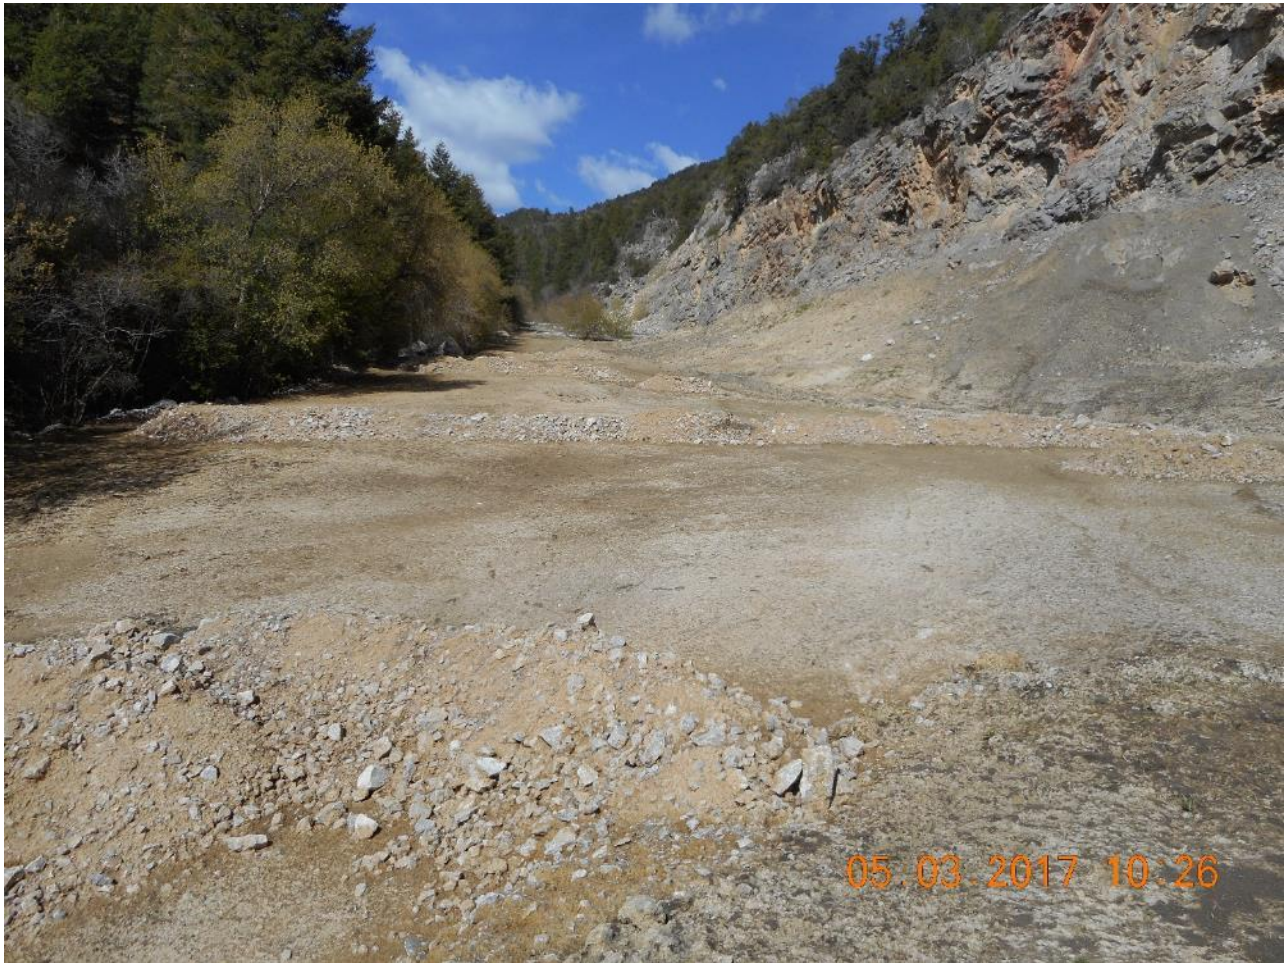
There were several 24" tall sediment control windrows running perpendicular to the west-to-east gradient on the quarry floor. These windrows were covered in alternative growth media and mulching material and were partially effective in trapping sediment (Photo 4). There was some evidence of rilling and erosion of material in channels on the quarry floor (Photo 5). The channelization and erosion wasn't extensive at this time, but additional erosion could occur if measures are not taken. Additional sediment control structures (or the extension of existing windrows) may need to be added to the quarry floor to prevent establishment of larger rills and erosion. Future inspections will continue to monitor effectiveness of sediment control.

Photo 4: Looking west at the sediment control windrows that run north-south (right to left) across the quarry floor.

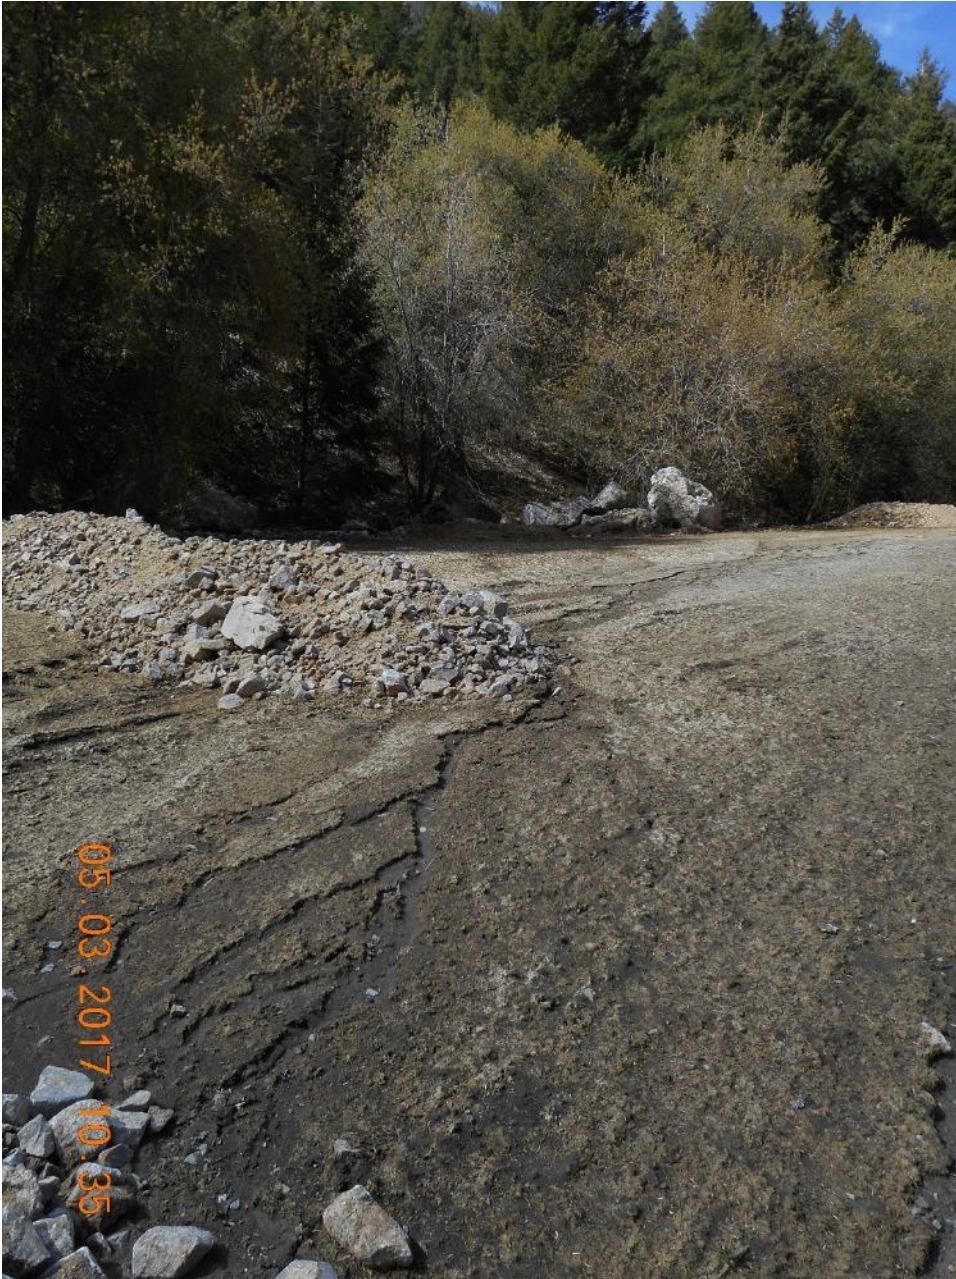
Photo 5: Looking southwest at minor erosion on the recontoured quarry floor.

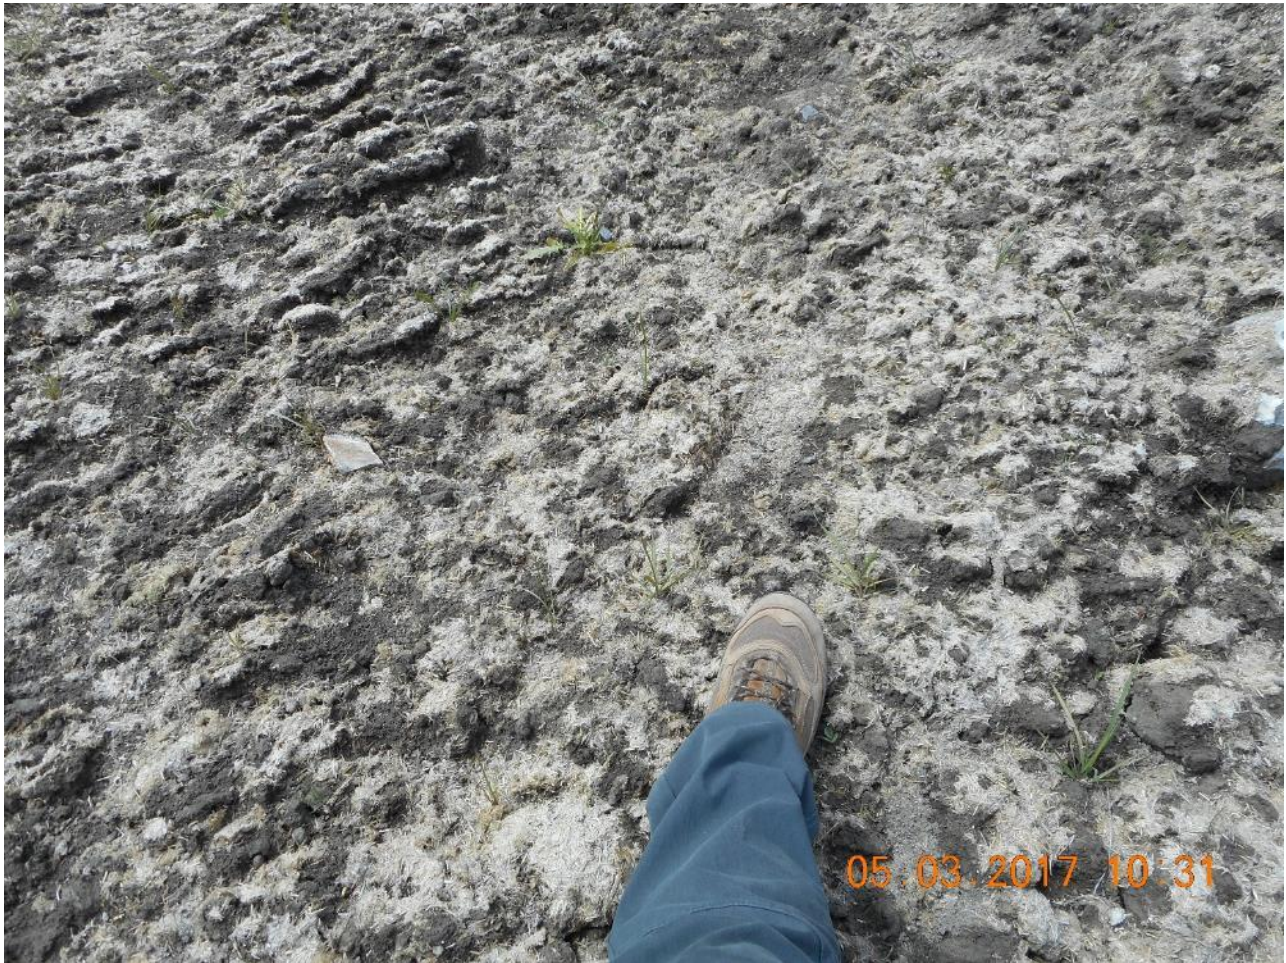
I observed some revegetation; there were some grass sprouts present (Photo 6). However, my visit occurred early in the growing season and another visit later in the year will better evaluate revegetation success.

Photo 6: Grass is beginning to sprout from the seeded alternative growth media and mulching material on the quarry floor and access road.
