**COLORADO**Division of Reclamation,
Mining and Safety

MINERALS PROGRAM INSPECTION REPORT**PHONE: (303) 866-3567**

MINE NAME: Gloria Z Mine	MINE/PROSPECTING ID#: M-1984-094	MINERAL: Sand & gravel, gold	COUNTY: Park
INSPECTION TYPE: Monitoring	INSPECTOR(S): Michael A. Cunningham	INSP. DATE: May 17, 2017	INSP. TIME: 12:30
OPERATOR: Sanborn Sand and Gravel/dba Golden Cross Aggregates, Inc.	OPERATOR REPRESENTATIVE: Mike Pfister	TYPE OF OPERATION: 112c - Construction Regular Operation

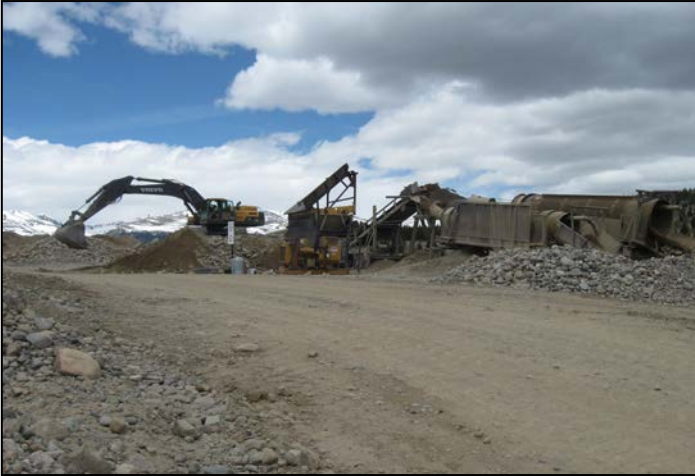
1. Gold processing plant.

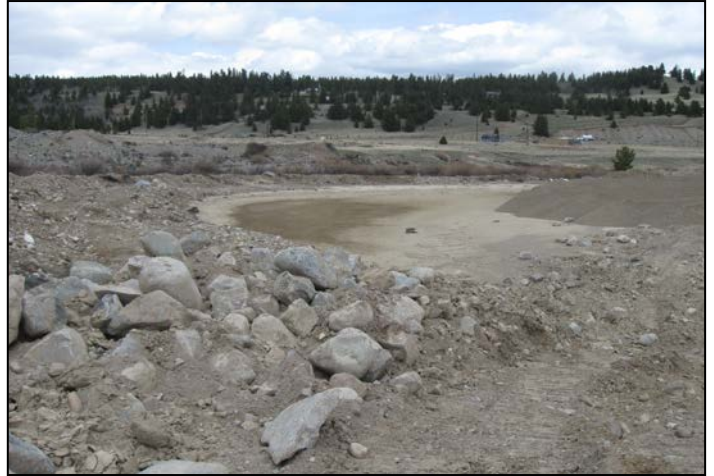
2. Western portion of settling pond which is no longer in use.

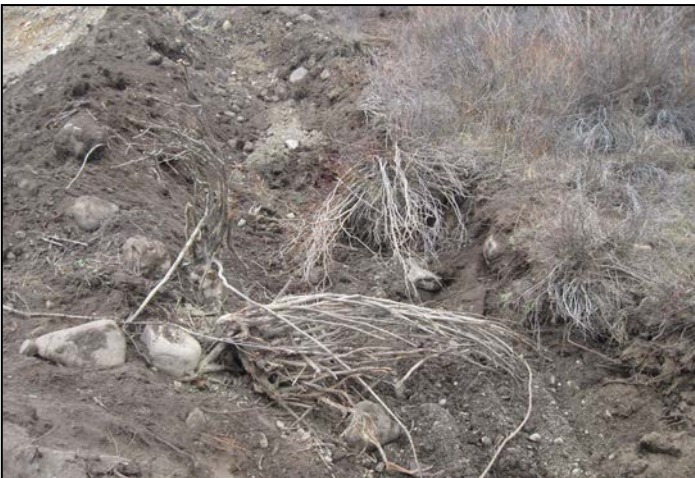
PROBLEM/POSSIBLE VIOLATION: Problem: The stormwater collection ditches were not being properly maintained. This is a problem pursuant to C.R.S. 34-32.5-124 for failure to comply with the conditions of an order, permit or regulation.

The Division traversed the stormwater collection ditches located along the western and northern perimeters of the affected lands. The ditches were not being properly maintained and contained roots, soil and vegetation which would prevent stormwater from flowing through the ditches. This has been cited as a problem and will require corrective action from the Operator. Please see the first page of this report for additional information.

3. Debris in the stormwater collection ditch.

CORRECTIVE ACTIONS: The Operator shall perform maintenance on the stormwater collection ditches on or before the corrective action date. The stormwater collection ditches shall be cleared of soil, vegetation and any other obstructions so there is positive drainage to allow stormwater to flow from the collection ditches to the stormwater collection area.

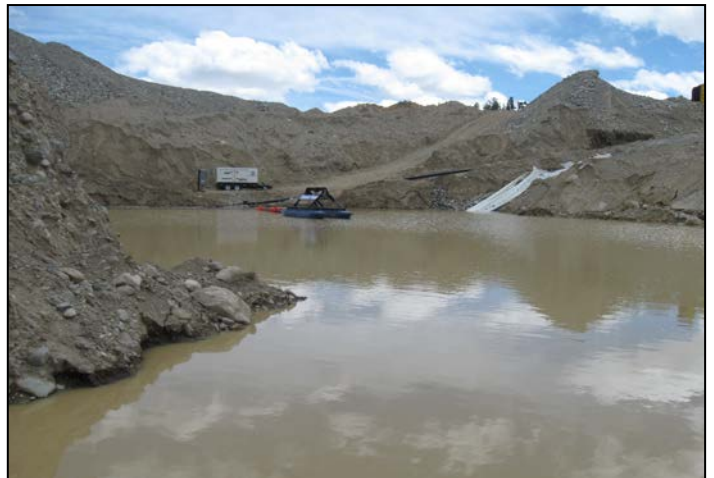
4. Water holding pond.

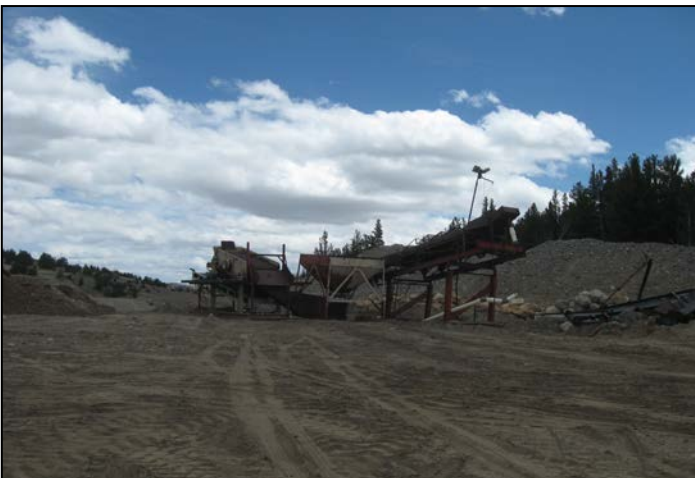
5. Gravel plant, not in use.

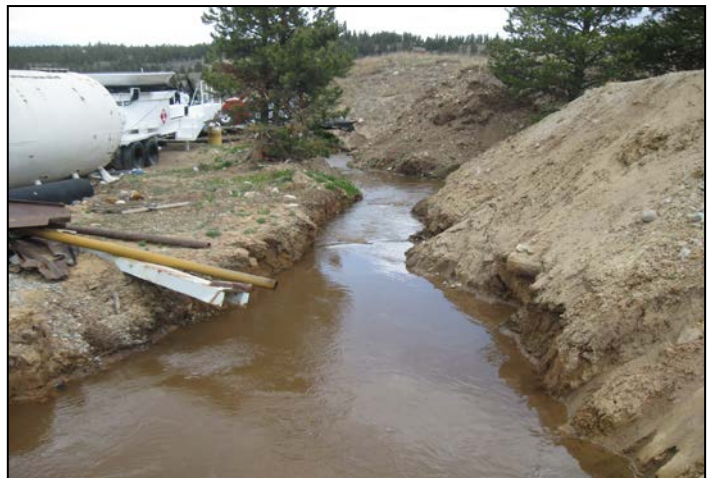
6. Water flowing into the site from the Sacramento Creek.
