MINERALS PROGRAM INSPECTION REPORT**PHONE: (303) 866-3567**

MINE NAME: 8-Mile Clay Mine	MINE/PROSPECTING ID#: M-1977-320	MINERAL: Clay	COUNTY: Fremont
INSPECTION TYPE: Monitoring	INSPECTOR(S): Timothy A. Cazier	INSP. DATE: June 22, 2016	INSP. TIME: 10:15
OPERATOR: Summit Brick & Tile Co.	OPERATOR REPRESENTATIVE: Matt Welte, Mike Leidich	TYPE OF OPERATION: 112c - Construction Regular Operation	
REASON FOR INSPECTION: Normal I&E Program	BOND CALCULATION TYPE: Partial Bond	BOND AMOUNT: \$49,166.00	
DATE OF COMPLAINT: NA	POST INSP. CONTACTS: None	JOINT INSP. AGENCY: None	
WEATHER: Clear	INSPECTOR'S SIGNATURE:

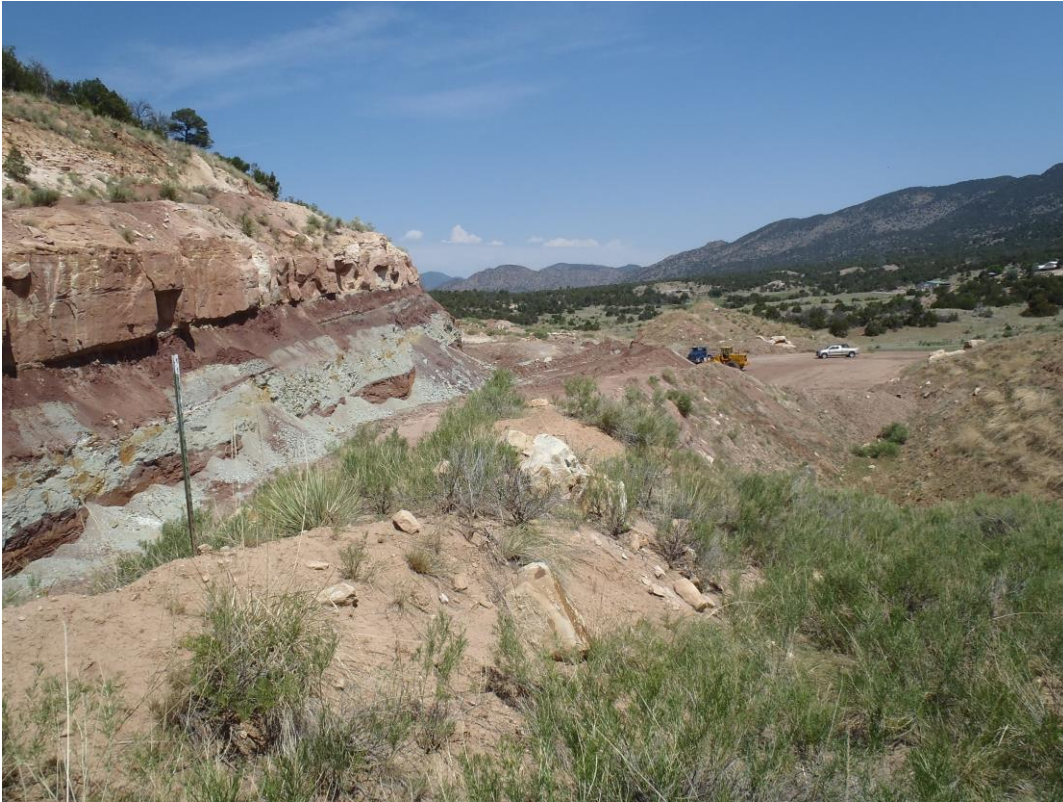
Backfilling and Grading: Highwall benches are required during active mining for this permit (see **Photo 1**). Backfill material appeared to be available. The Division received a letter signed by Joseph Welte (Summit Brick & Tile) dated July 26, 1994 responding to a Division request for a slope stability analysis related to the 1993 permit conversion application. The letter indicated "the geotechnical report of slope stability analysis" was enclosed. The Division's electronic records do not include a copy of this stability analysis. If you have a copy of this slope stability analysis, please submit a copy to the Division.

Photo 1. Existing mine bench (looking NW).

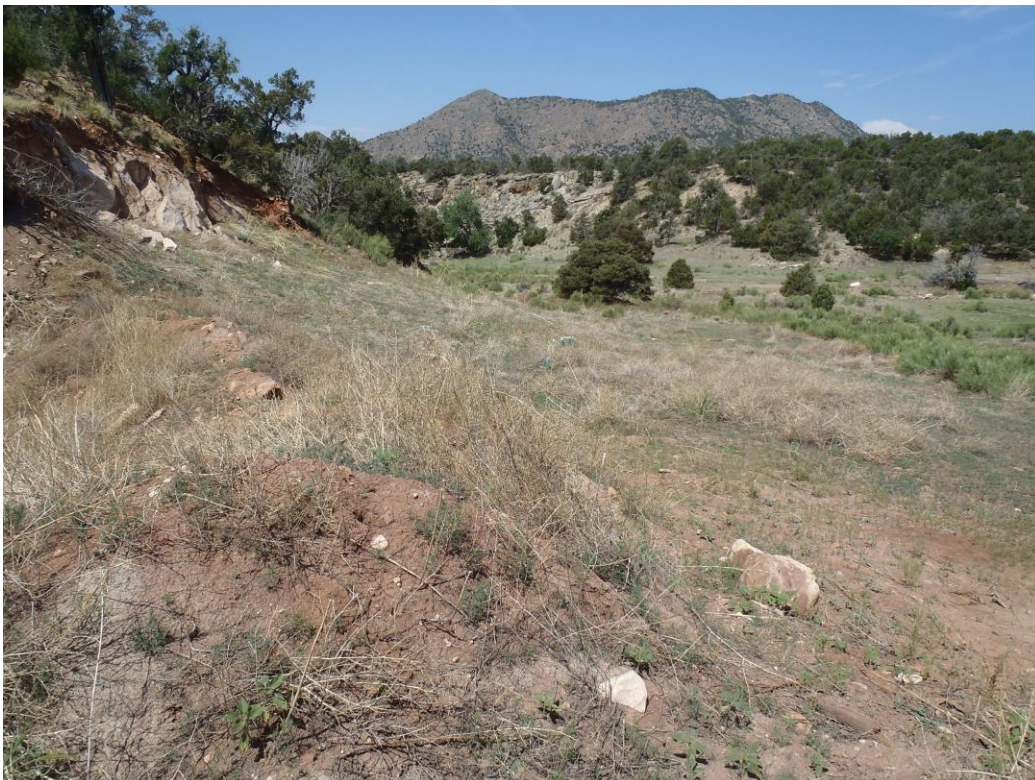
Reclamation Success: The north end (phases III and IV) has sloped to 3H:1V or flatter and topsoiled. Mr. Welte indicated the revegetation was the result of natural progression.

Revegetation: A small amount of unidentified thistle was observed in the permitted area. The Division recommends implementing weed management program to prevent noxious weed species from becoming a problem. The only area that had been revegetated was the pre-law area north of the north side access road (see **Photo 2**).

Photo 2. Revegetated area (north end, looking NW).

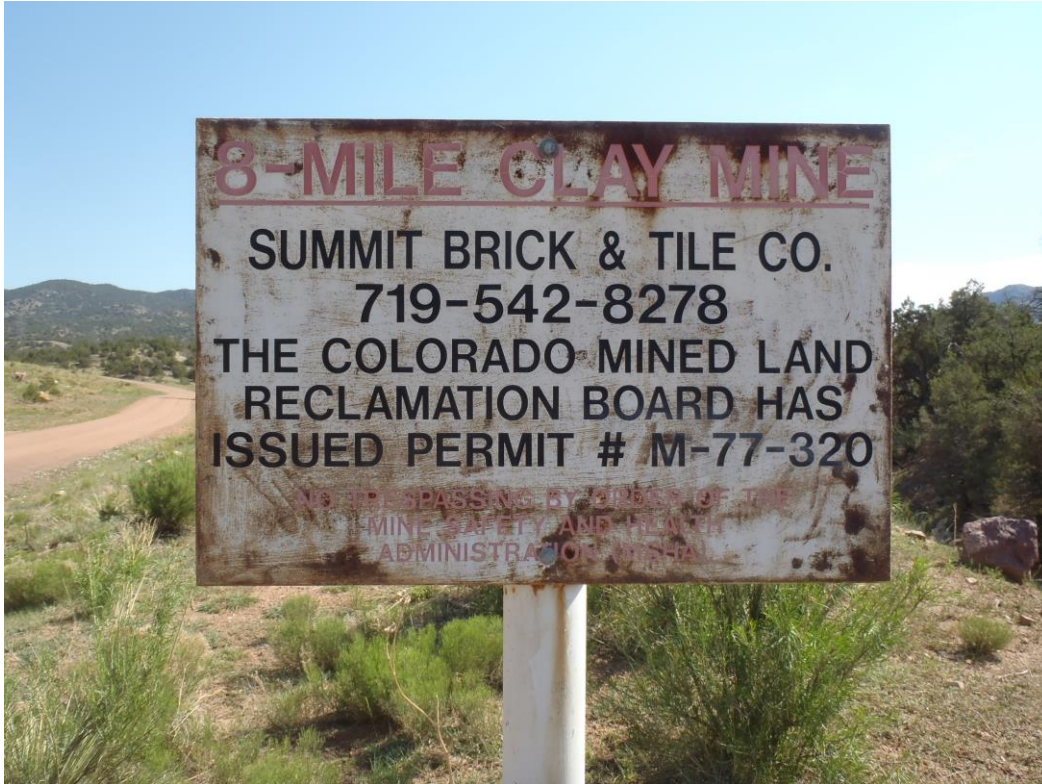
Signs and Markers: The permit sign was properly posted (see **Photo 3**) and boundary markers were observed to delineate the permit boundary (see **Photo 4**).

Photo 3. Permit sign at entrance.

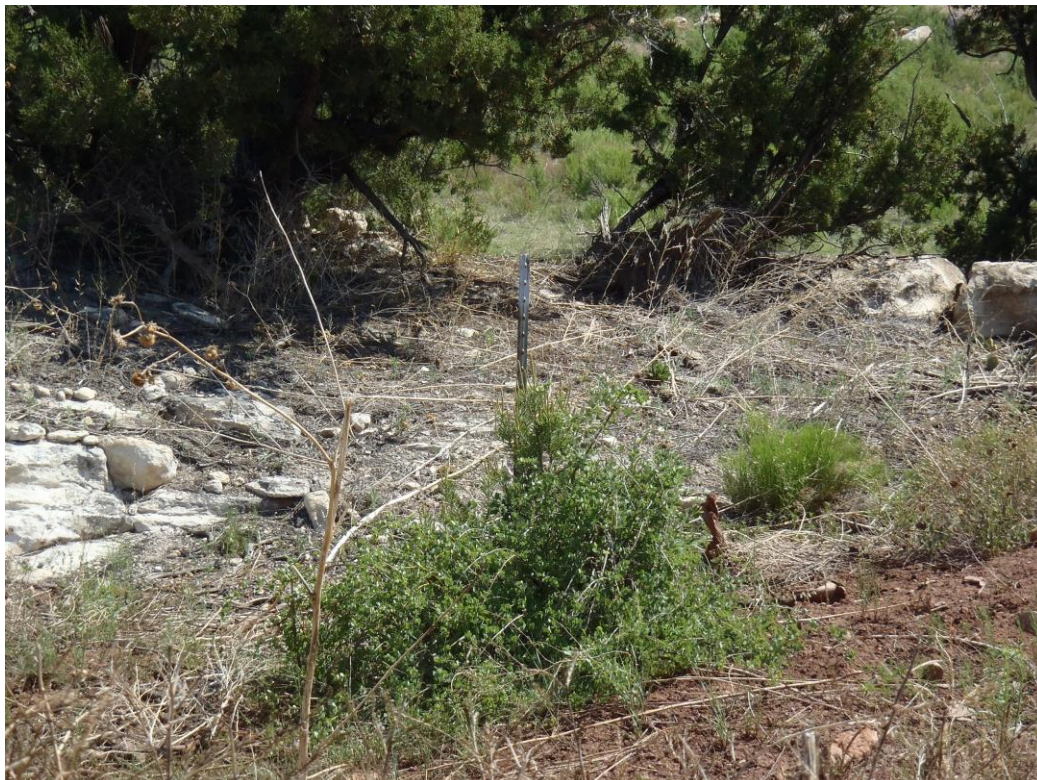
Photo 4. Typical permit boundary marker.

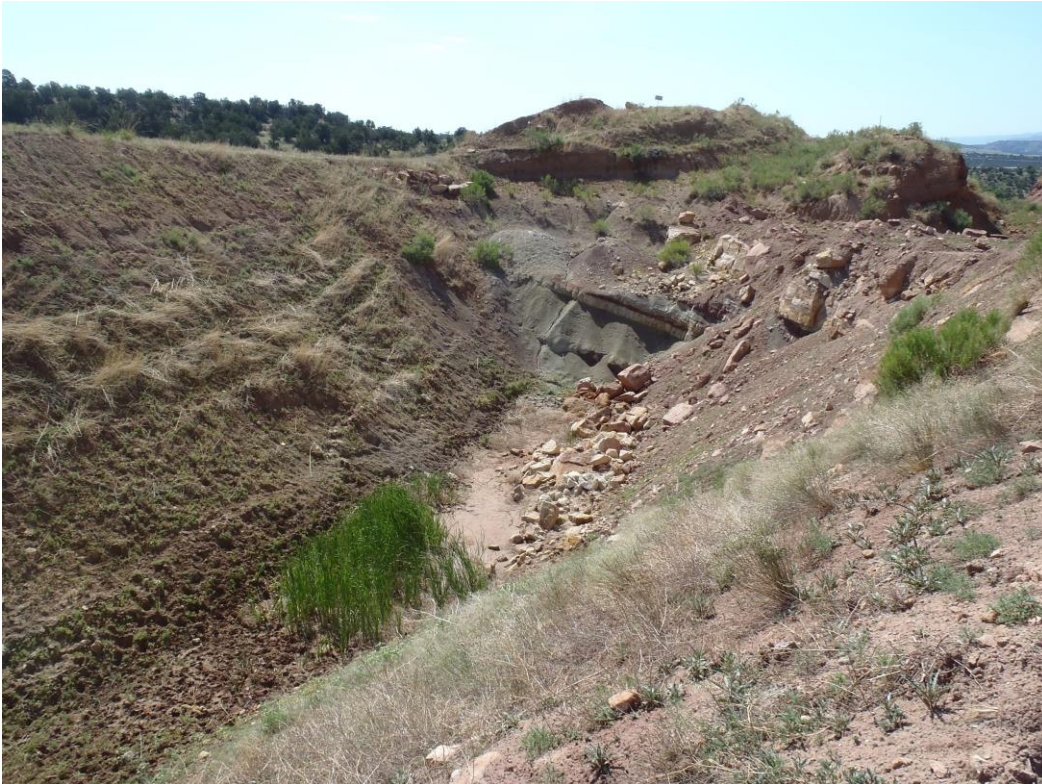
Storm Water MGT Plan: No oil or fuel spills observed. Representatives stated the stormwater management plan is kept in the main office. Stormwater drains to the two sediment ponds (**Photo 5**) and infiltrates.

Photo 5. Topsoil stormwater/sediment pond (below bench, looking SE).

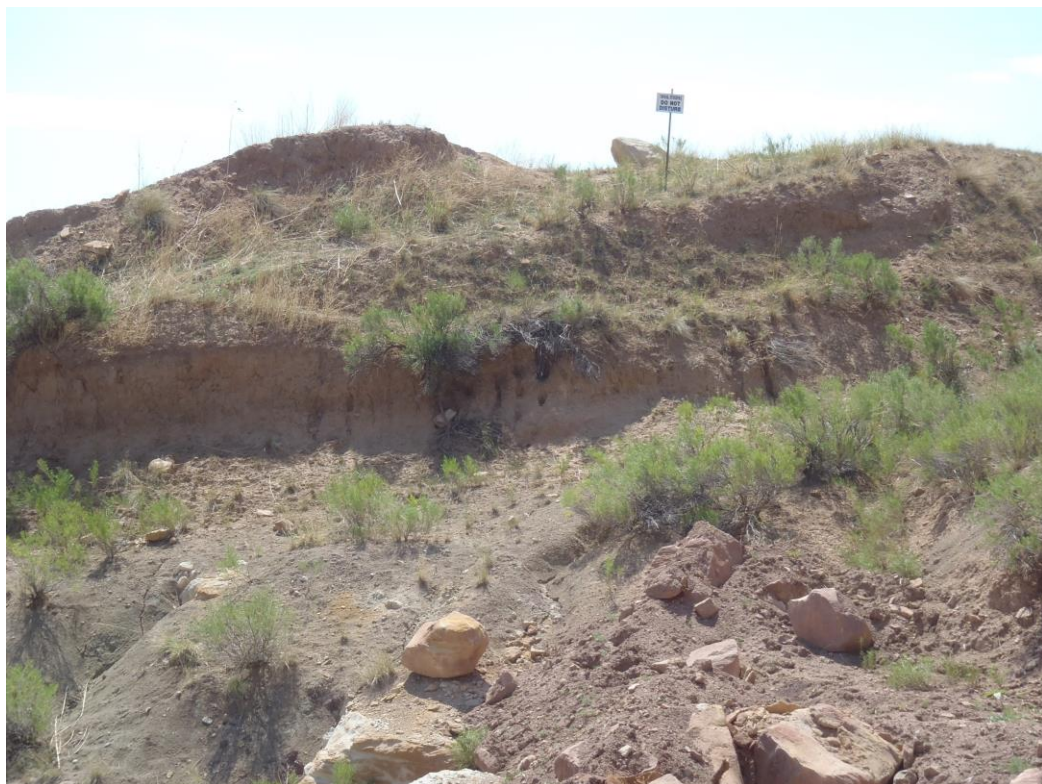
Topsoil: A topsoil stockpile is stable and labeled as such (see **Photo 6**).

Photo 6. Labeled topsoil stockpile.
