MINERALS PROGRAM INSPECTION REPORT
PHONE: (303) 866-3567

MINE NAME: Beaver Crk Clay Mine	MINE/PROSPECTING ID#: M-1977-322	MINERAL: Clay	COUNTY: Fremont
INSPECTION TYPE: Monitoring	INSPECTOR(S): Timothy A. Cazier	INSP. DATE: June 22, 2016	INSP. TIME: 11:55
OPERATOR: Summit Brick & Tile Co.	OPERATOR REPRESENTATIVE: Matt Welte, Mike Leidich	TYPE OF OPERATION: 110c - Construction Limited Impact	
REASON FOR INSPECTION: Normal I&E Program	BOND CALCULATION TYPE: Partial Bond	BOND AMOUNT: \$22,500.00	
DATE OF COMPLAINT: NA	POST INSP. CONTACTS: BLM	JOINT INSP. AGENCY: None	
WEATHER: Clear	INSPECTOR'S SIGNATURE:

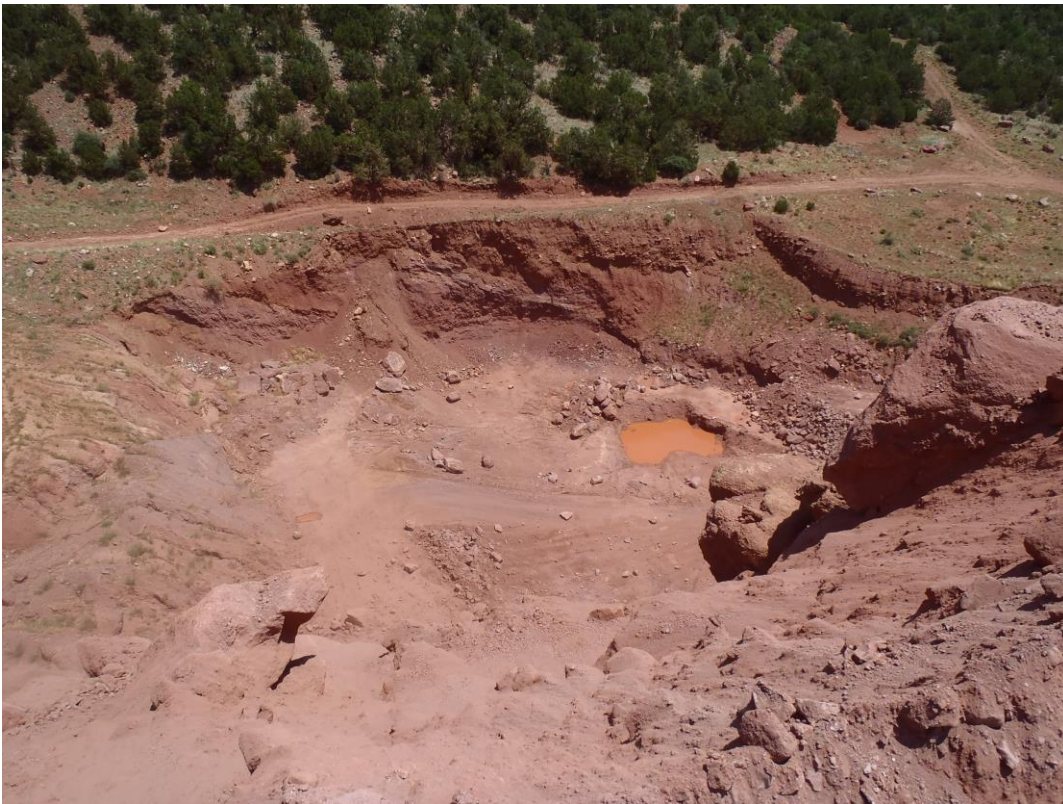
Hydrologic Balance: Standing water observed in the pit (see **Photo 1**) appeared to be stormwater and not groundwater.

Photo 1. Stormwater observed in pit (looking NE from working area above highwall).

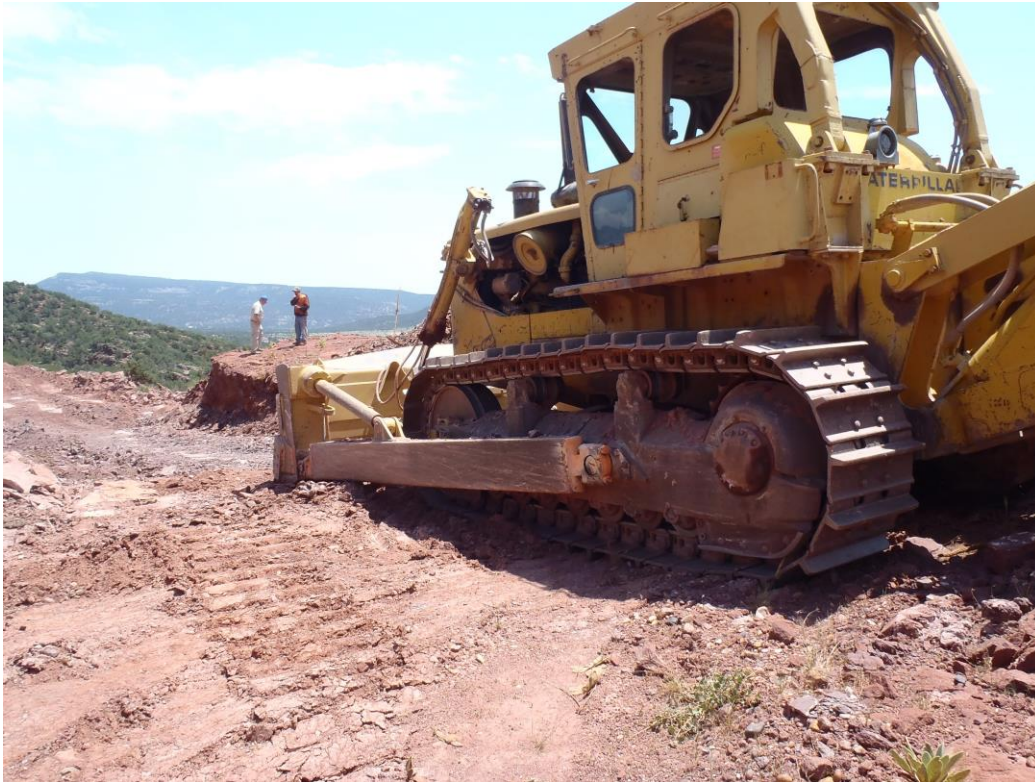
Gen. Compliance with Mine Plan: During the inspection a dozer was being used to push material (see **Photo 2**) over the highwall to be collected at the pit bottom. The operation appeared to be in compliance with the approved mine plan. Google Earth was used to measure the disturbed area, which was estimated to be approximately 6.4 acres (based on a 2011 satellite image). Both the 2016 and 2017 annual reports indicate 7.5 acres of mining disturbance. High walls were estimated to be as high as 80 feet and appeared mostly stable (see **Photos 3 and 4**).

Photo 2. Working bench (looking east).

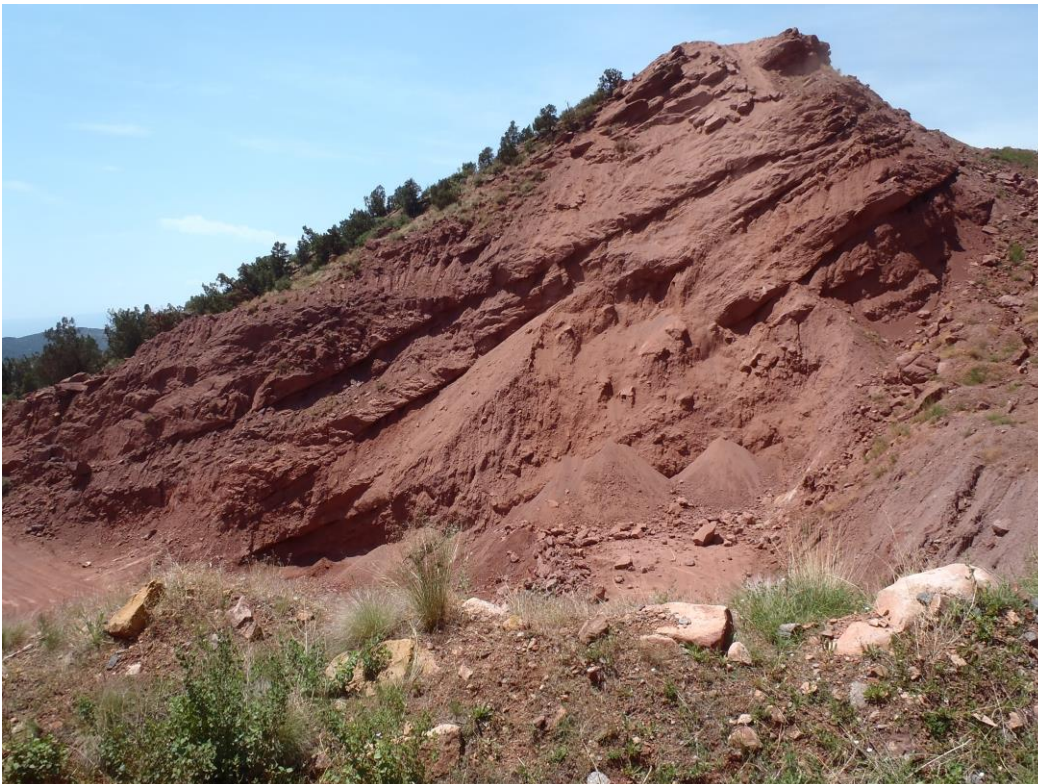
Photo 3. Highwall (1 of 2, looking west).

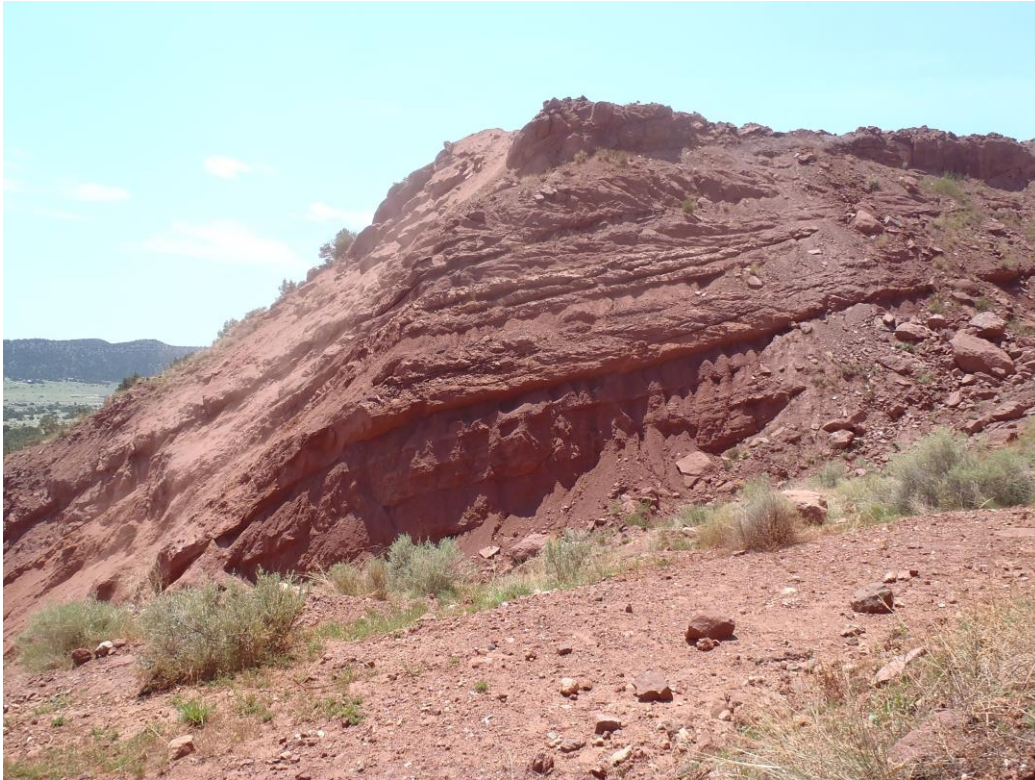
Photo 4. Highwall (2 of 2, looking south).

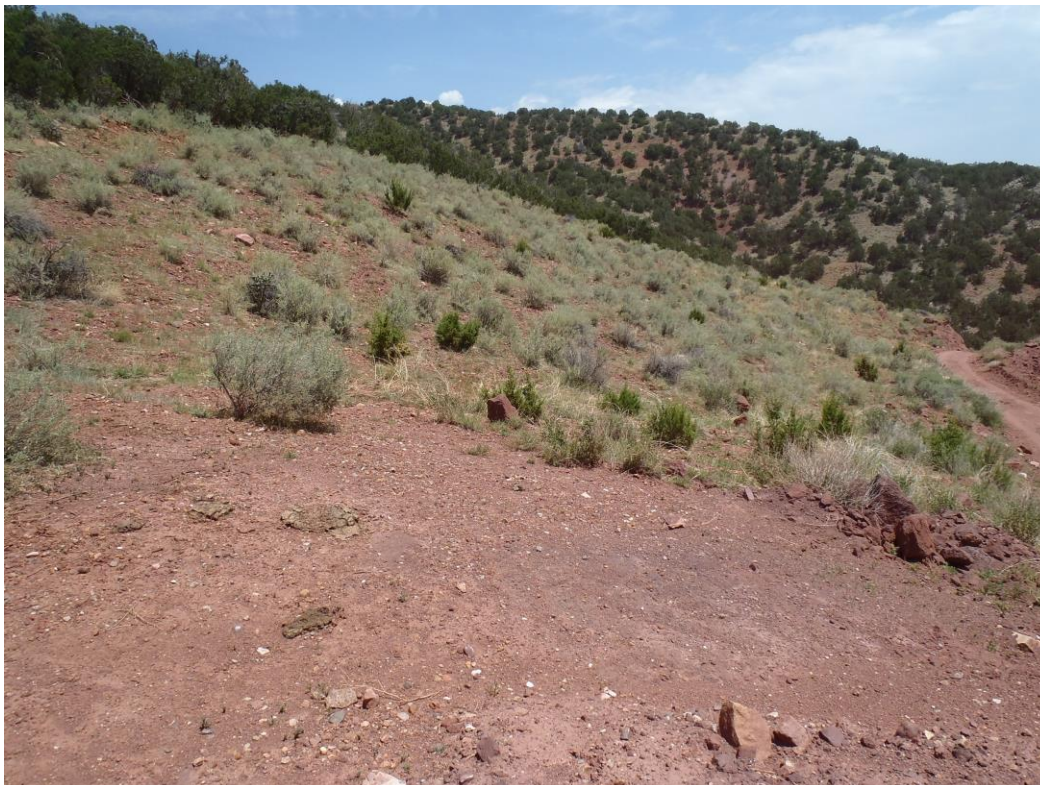
Revegetation: A small amount of Common Mullein was observed in the permitted area. The Division recommends implementing weed management to prevent this List C noxious weed species from becoming a problem. The only area that had been revegetated was the pre-law area north of the north side access road (see **Photo 5**).

Photo 5. Revegetated pre-law disturbance area (NW of pit, north of access road, looking east).

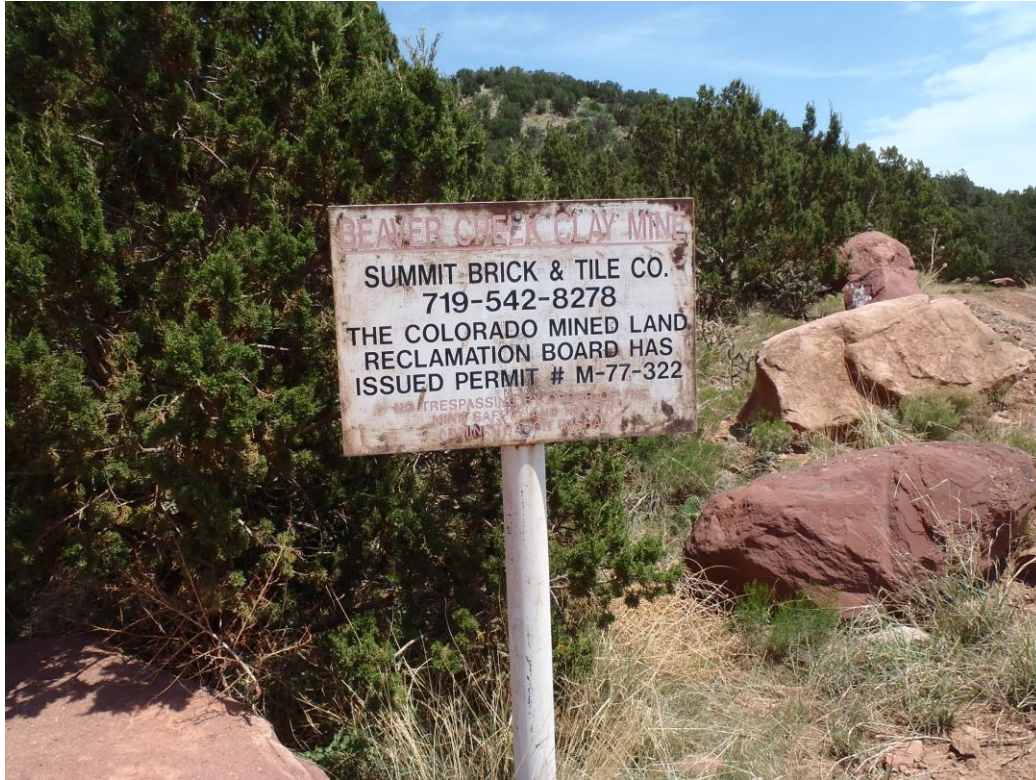
Signs and Markers: The permit sign was properly posted (see **Photo 6**) and boundary markers were observed to delineate the permit boundary (see **Photo 7**).

Photo 6. Permit sign.

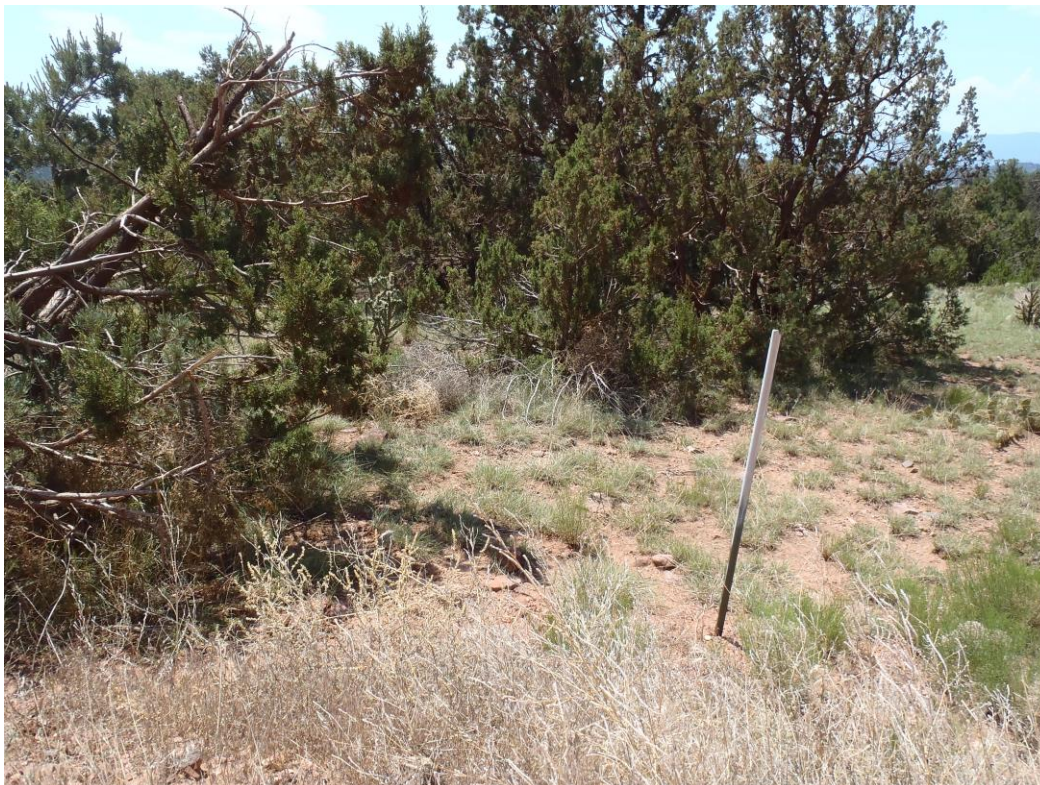
Photo 7. Typical permit boundary marker.
