COLORADO Division of Reclamation, Mining and Safety Department of Natural Resources

MINERALS PROGRAM INSPECTION REPORT PHONE: (303) 866-3567

MINE NAME:	MINE/PROSPECTING ID#:	MINERAL:	COUNTY:	
Hitch Rack Ranch	P-2014-016	Granite, granite gneiss	El Paso	
INSPECTION TYPE:	INSPECTOR(S):	INSP. DATE:	INSP. TIME:	
Monitoring	Timothy A. Cazier	June 13, 2017	10:30	
OPERATOR:	OPERATOR REPRESENTATIVE:	TYPE OF OPERATION:		
Transit Mix Concrete Co.	Brandan Heser, Paul Kos	ME - Mineral Exploration		
REASON FOR INSPECTION:	BOND CALCULATION TYPE:	BOND AMOUNT:		
Normal I&E Program	None	\$12,098.83		
DATE OF COMPLAINT:	POST INSP. CONTACTS:	JOINT INSP. AGE	NCY:	
NA	None	None		
WEATHER:	INSPECTOR'S SIGNATURE:	SIGNATURE DAT	E:	
Clear	Thing age	June 15, 2017

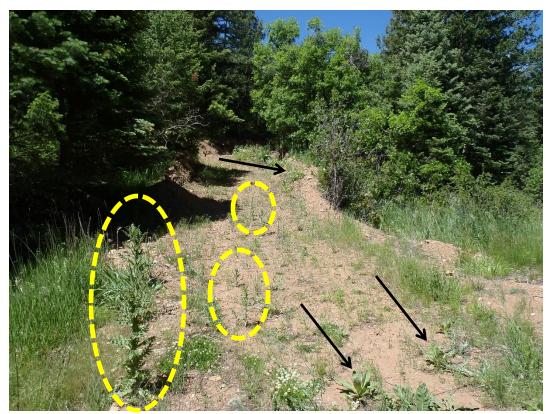
Transit Mix and Division representatives walked the drill road leading from Little Turkey Creek Road to drill holes HC006-15 and B5. What appeared to be scotch thistle (see **Photo 1**) was observed near Little Turkey Creek Road and a few areas up the drill road. Common mullein was also observed in this area. A patch of downy brome (a.k.a. cheatgrass) was observed on the switchback just below borehole HC006-15 (see **Photo 2**). Mr. Heser stated he intended to implement their weed control program as soon as they could get the roads maintained for access. As all three noxious weed species seen were observed in limited numbers and areas, and only the scotch thistle is on the List B for Colorado noxious weeds (common mullein and downy brome are list C species), the presence of these weeds is not cited as a problem. However, Transit Mix should implement their weed control plan as soon as practical to prevent these observed weeds from becoming a problem.

Photo 1. Scotch thistle (circled), common mullein (arrows) (looking west from LTC road).

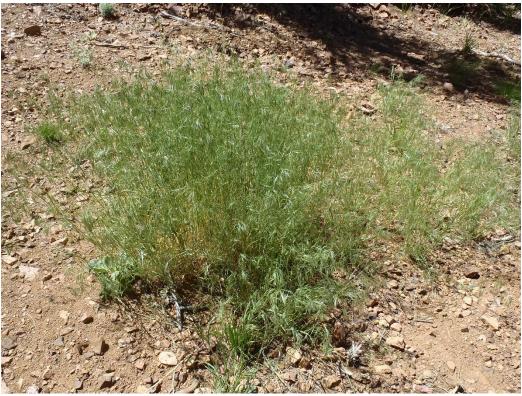
Photo 2. Downy brome at switchback below borehole HC006-15.
