**Locatable Minerals Site Inspection**  
**U.S. Department of the Interior**  
**Bureau of Land Management**  
**Royal Gorge Field Office**

| Date:09/27/2016<br>Time:12:05-12:30 p.m.<br>Weather: Clear<br>Inspection Purpose: General | Project Name: Maars Memorial<br>Case Number: COC 068246<br>Operator: Colorado Quarries<br>Location: Southeast of Cotopaxi |

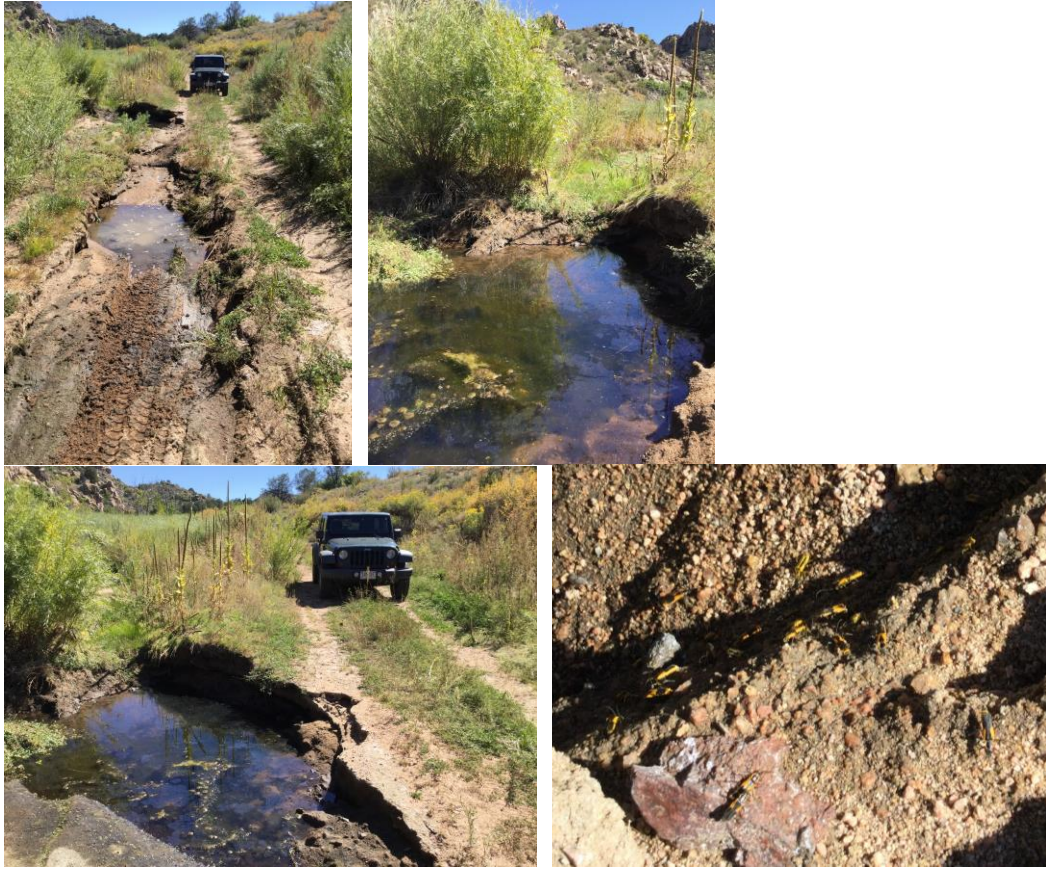
| <p style="text-align: center;"><b>General Comments</b></p> Other observations and notes from the inspection | - There has been a significant amount of erosion to the site's access road since the previous inspection (See Photos). |

Photo 1: The erosion adjacent to the locked gate. Note: insects (yellow soldier beetles) have hatched in the area around the new pond.

| <p style="text-align: center;"><b>Actions to be taken by the Operator</b></p> Operators should read this report carefully because it may require corrective action and/or response to the BLM in order to avoid consideration of possible enforcement action. | The operator should address the hole that has eroded through the site's access road. |

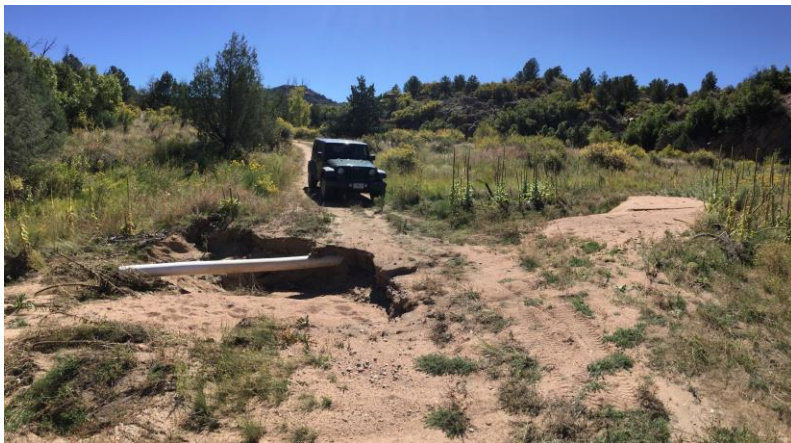
Photo 2: Erosion along the access road further east of the locked gate on private land (on the way to the site). Note the pre-existing PVC pipe which the private landowner might have installed to decrease overland flow.

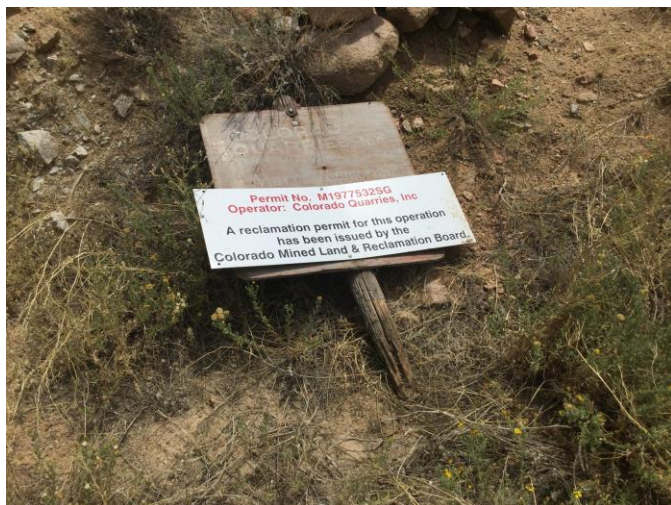
| <u>Claim Markers</u><br><input type="checkbox"/> Claim Signs<br><input type="checkbox"/> Corners<br><input type="checkbox"/> Discovery Post | <input type="checkbox"/> <b>N/A</b><br><div style="border: 1px solid black; padding: 5px;">The sign at the entrance with the quarry name and DRMS permit # was propped against a rock pile, and bears an incorrect permit number - M1977532SG (the correct DRMS number is M-1977-168). The southeast permit corner can be seen from the eastern working area.</div> |

Photo 3: The DRMS sign with the incorrect permit number.

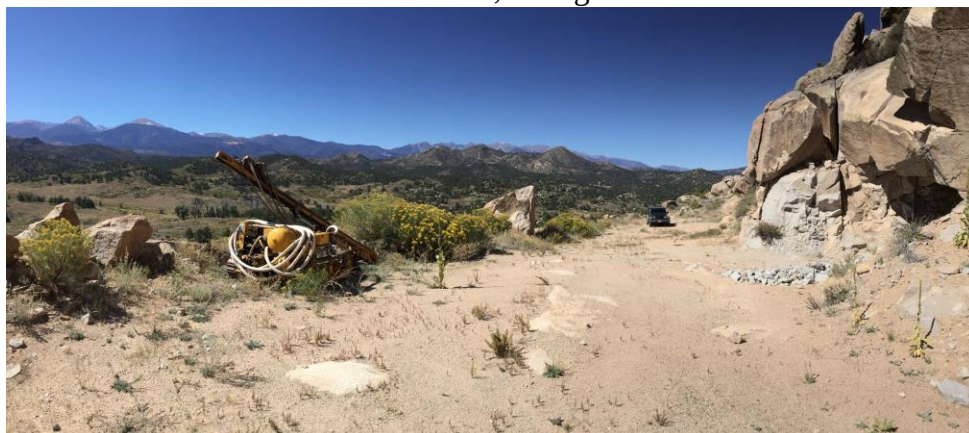
Photo 4: An overview of the mine site, facing west. Note the drill that is used for blasting.

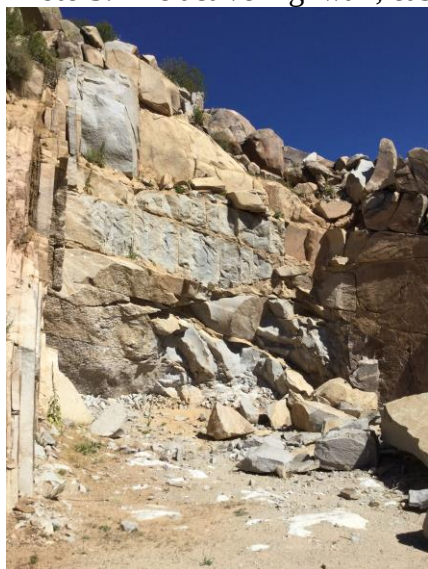
| <p style="text-align: center;"><u>Highwall/Working Face Conditions</u></p> <p style="text-align: center;"> <input checked="" type="checkbox"/> Working <input type="checkbox"/> Reclaimed </p> <p>-Ravelling or rock fall present<br/> -Tension cracks<br/> -Benches (are they clean?)<br/> -Adequate ingress/egress<br/> -Measurements (concurrent with ops - height, depth, slope)</p> | <input type="checkbox"/> <b>N/A</b> <div style="border: 1px solid black; padding: 5px;"> <p>The operator currently works the highwall east of the underground portal. When they are working, the operator removes material from the top down. There appears to be adequate ingress and egress away from the highwall (there is an open floor area), and the operators are not present below the highwall when they are working.</p> </div> |

Photo 5: The active highwall, east of the mine portal.

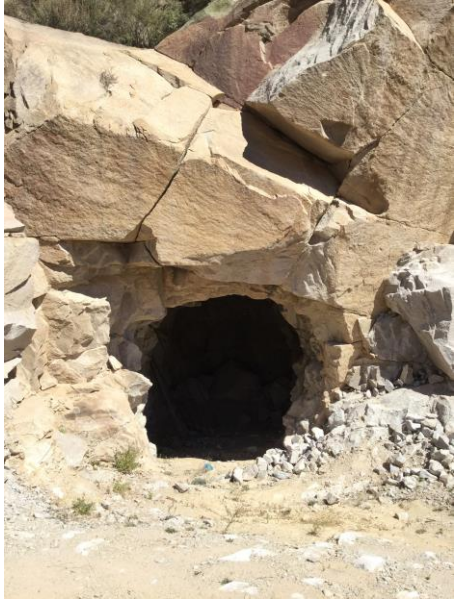
| <p style="text-align: center;"><u>Underground Operations</u></p> <p><input type="checkbox"/> Groundwater (Is there water coming from the adit?)</p> <p><input type="checkbox"/> General Safety (roof stability, ventilation, cribbing condition, monitoring practices, etc.)</p> <p><input type="checkbox"/> Dimensions (Have the adits, shafts, trenches been advanced?)</p> | <p>x N/A</p> <div style="border: 1px solid black; padding: 5px; margin-top: 5px;"> <p>The operator does not work in the existing underground portal.</p> </div> |

Photo 6: The inactive mine portal.

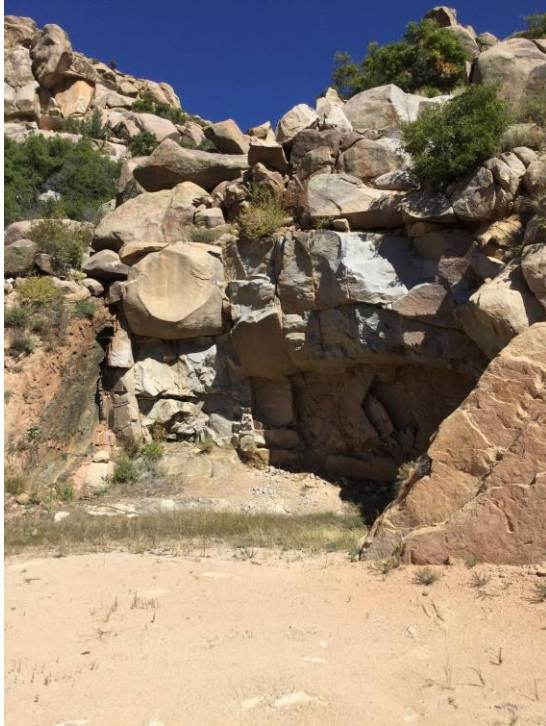
| <u>Erosion Control</u><br><input type="checkbox"/> Grading<br><input type="checkbox"/> Vegetation<br><input type="checkbox"/> Drainage Control | <input type="checkbox"/> <b>N/A</b><br><div style="border: 1px solid black; padding: 5px;">No standing water or recent erosion was observed during the inspection. There was evidence of water</div> |

| <input type="checkbox"/> Best Management Practices (e.g.) | <div style="border: 1px solid black; padding: 5px;"> <p>pooling in the first (western) cut as you enter the site. It appears that it pools during rain events and then drains towards the road, and out the far hillside. This could pose an undercutting issue in the future.</p> <p>Additionally, there has been a significant amount of erosion to the site's access road since the previous inspection.</p> </div> |

Photo 7: The inactive highwall on the west of the site, where rain water pools prior to flowing into the hole going through the access road.
