Mineral Materials Site Inspection
U.S. Department of the Interior
Bureau of Land Management
Royal Gorge Field Office

| Date: 02/16/2017 Time: 10:35 - 11:02 a.m. Weather: Clear, Cold Inspection Purpose: General | Project Name: Indian Sunset Operator: Colorado Quarries Location: Westcliffe, CO BLM COC #: 073192 CDRMS Permit #: M-1987-027 |

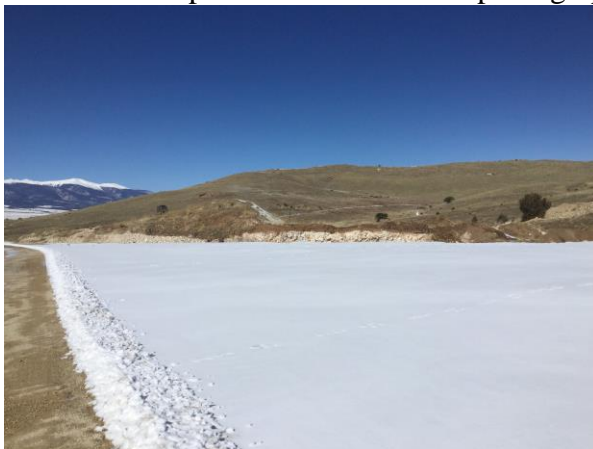
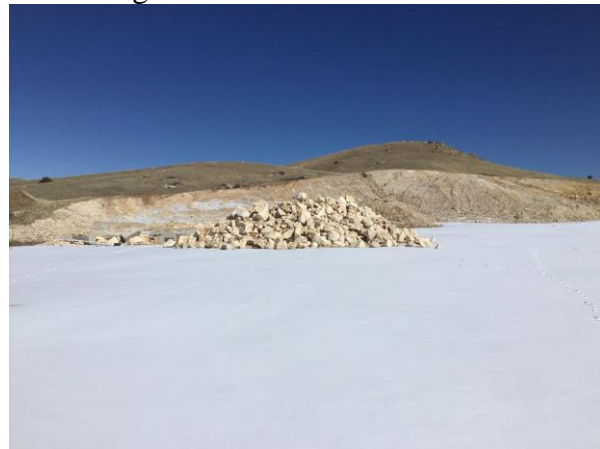
Photo 2. Taken from Placemark 8 along the access road, facing west towards the quarry entrance. Note the stockpile of boulders in the photograph on the right.

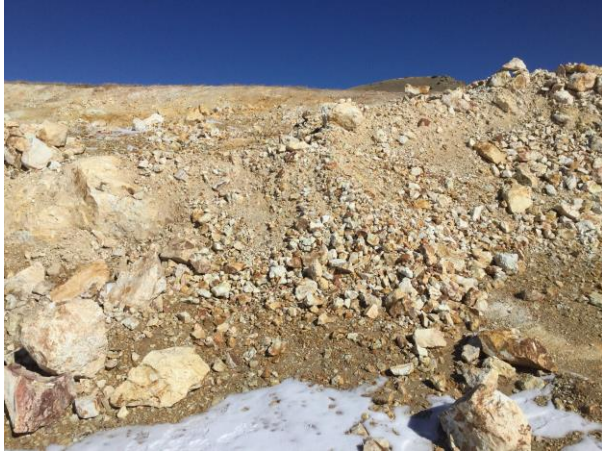
Photo 3. The sloped working face on the eastern side of the quarry (facing north), taken from Placemark 1.

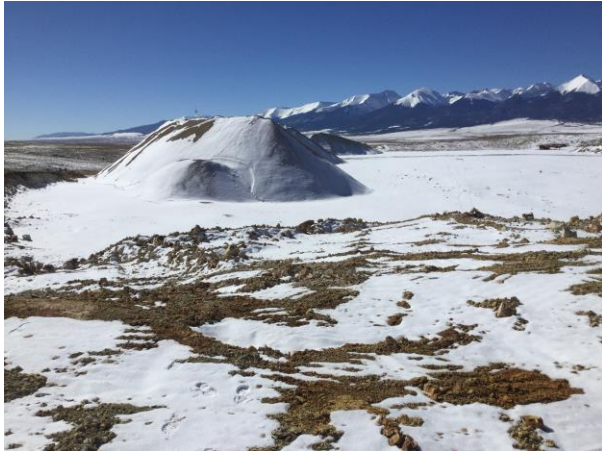
Photo 4. Looking south towards the active floor and product pile (roadbase) from atop the sloped working face, taken from Placemark 2.

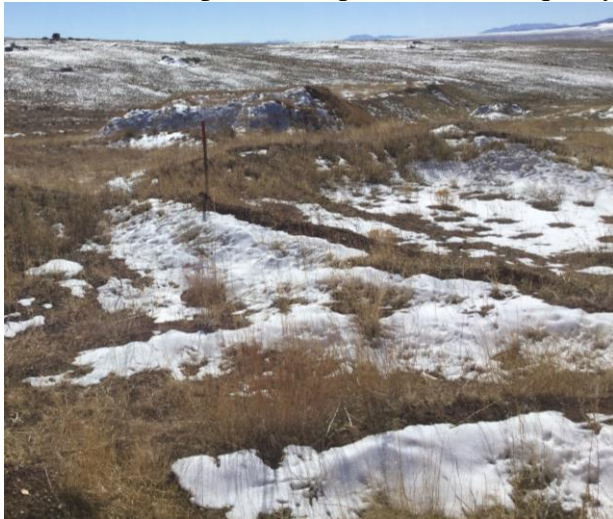
Photo 5. The topsoil stockpile east of the quarry, taken from Placemark 3 (facing southeast).

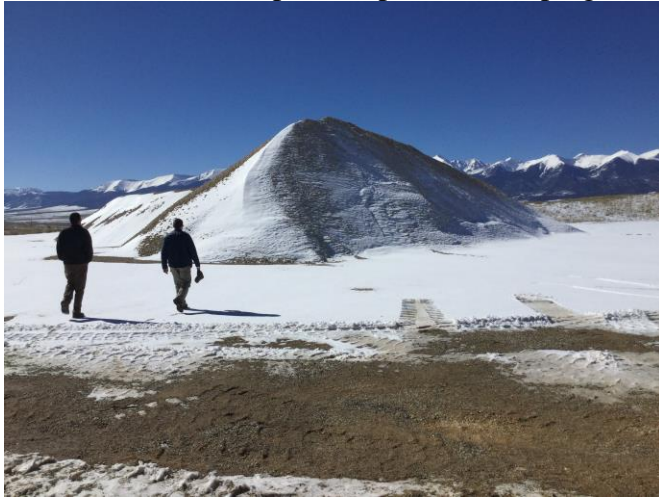
Photo 6. The second product pile (landscaping) facing southwest from Placemark 5.

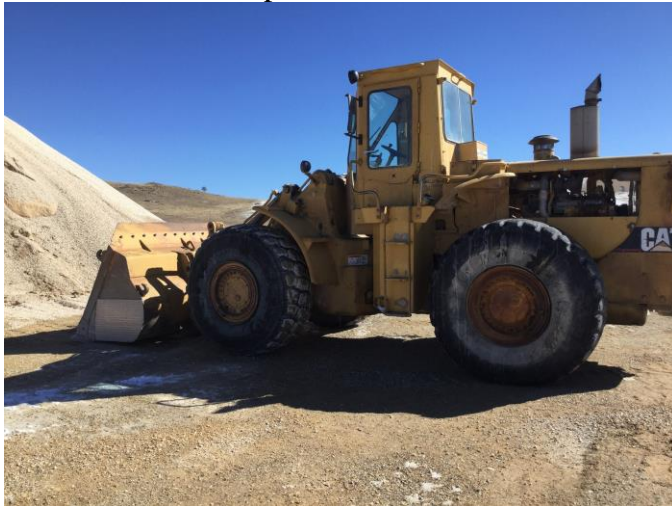
| <u>Material Processing</u> <input type="checkbox"/> Crushing, screening, washing <input type="checkbox"/> Equipment condition, water source | <input type="checkbox"/> N/A The mobile crushing/screening unit was not on site during the inspection. The rubber-tired loader appeared to be in good condition. |

Photo 7. The loader present on site, taken from Placemark 7.
