COLORADO
Division of Reclamation,
Mining and Safety
Department of Natural Resources

Permit Number: C-1981-012 Mine Name: New Elk Mine Operator: New Elk Coal Company, LLC Operator Address: Mr. Louis Head 12250 Highway 12 Weston, CO 81091	County: Las Animas Operation Type: Underground Permit Status: Active Ownership: Private
	Operator Representative Present: Vince Massarotti
Operator Representative Signature: (Field Issuance Only)

Inspection Start Date: June 7, 2017 Inspection Start Time: 13:00 Inspection End Date: June 8, 2017 Inspection End Time: 14:00		Inspection Type: Coal Complete Inspection Inspection Reason: Normal I&E Program Weather: Raining	
Joint Inspection Agency: None		Joint Inspection Contacts:	
Post Inspection Agency: None		Post Inspection Contacts:	
Inspector(s): Robert D. Zuber, P.E.	Inspector's Signature:

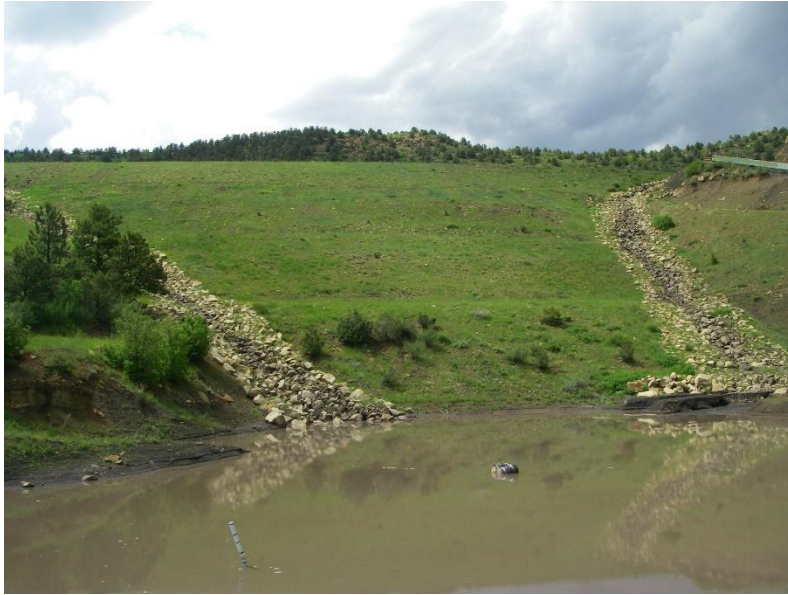
The upper (un-reclaimed) portion of the RDA still requires grading of material. The interface between the upper portion of the RDA and the lower (reclaimed) portion looks good, with the ditch deep enough to prevent flow of runoff over the berm. There is very good vegetation cover on the reclaimed portion of the RDA. During the inspection water was flowing in the western side channel.

RDA from Pond 08

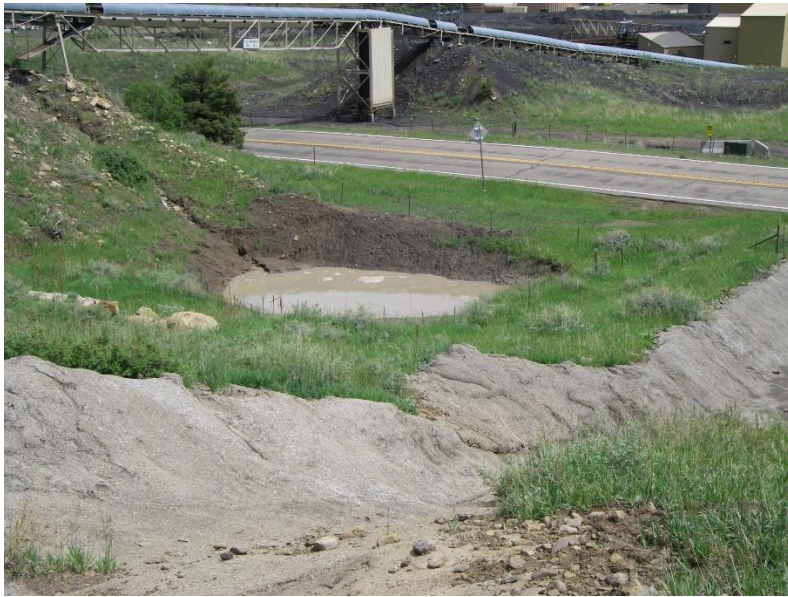
Ponds 001A, 007A, and 08 were inspected, and none of them were discharging. The impounded water was relatively high in all three ponds due to rains. No significant issues were seen with the pond structures.

Containment Area 5 was holding water that was several feet below the top of the structure. There was no sign of problems with this structure.

Pond 08 spillway and Containment Area 5

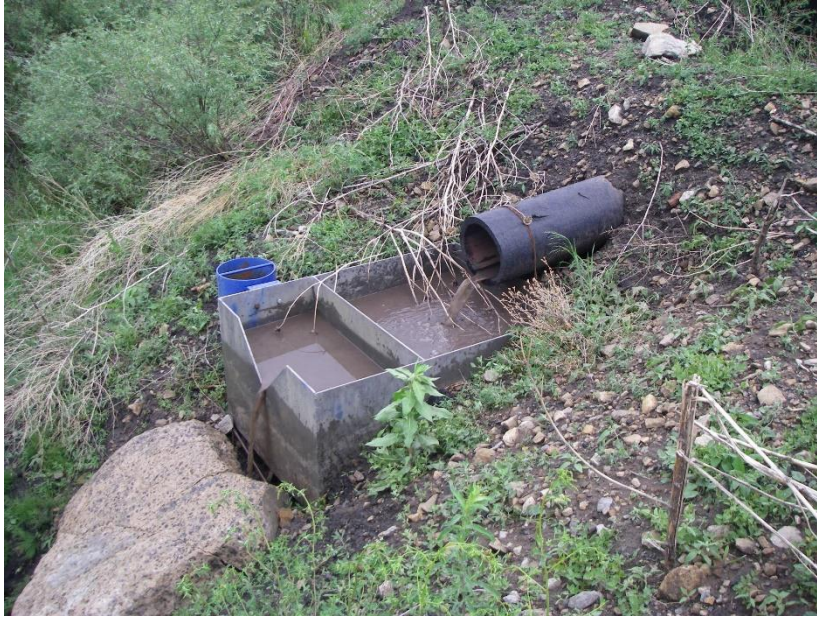
The silt fence below the SAE by Pond 007A appeared to be in good shape, although there was turbid water discharging through the outlet structure for this SAE, and significant water was ponded on the road above.

Discharge from SAE beside Pond 007A

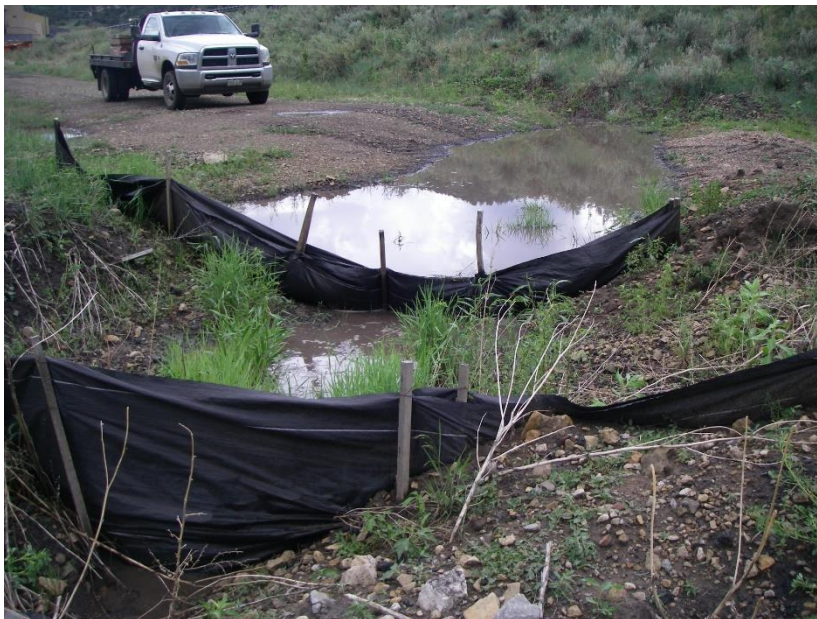
Silt fence below SAE beside Pond 007A

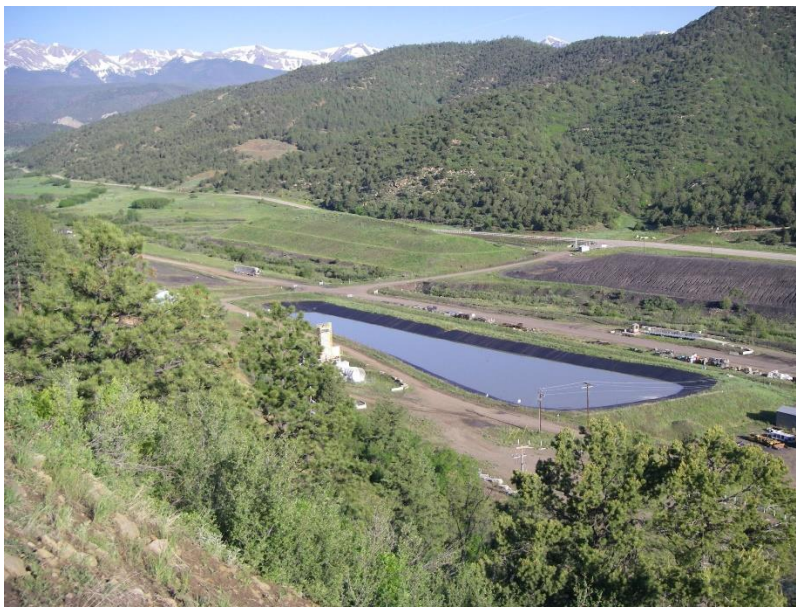
No problems were seen with the Development Coal Waste Pile; the vegetation cover is very good. Erosion on DWDA#2 did not appear to be excessive compared to previous months.

Pond 001A and development waste piles

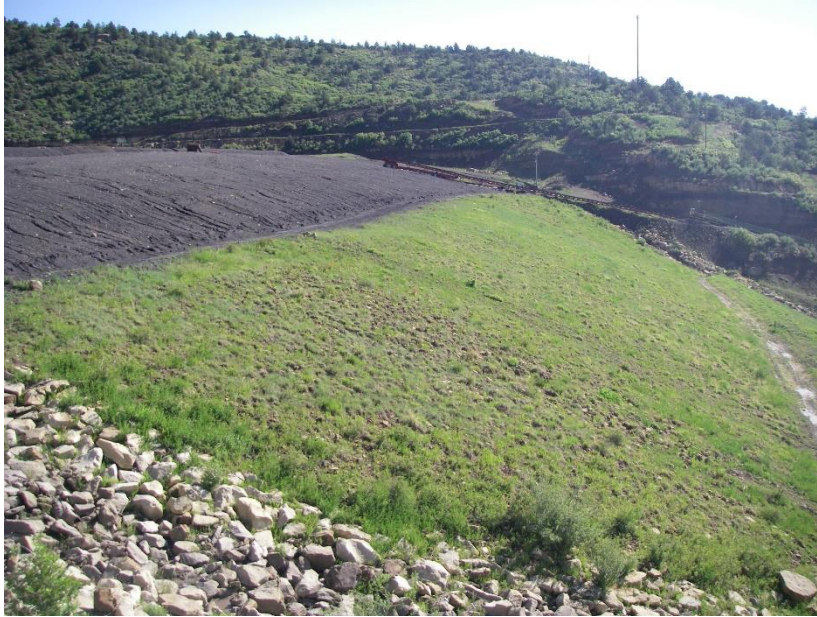
RDA – interface between upper and lower portions

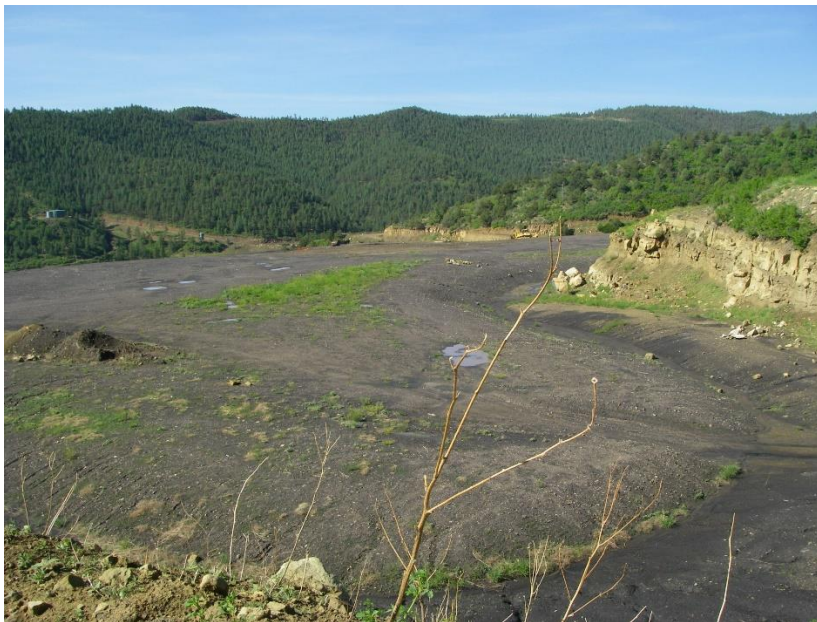
RDA – upper portion
