MINERALS PROGRAM INSPECTION REPORT
PHONE: (303) 866-3567

MINE NAME: Golden Wonder Mine	MINE/PROSPECTING ID#: M-1978-091-UG	MINERAL: Gold	COUNTY: Hinsdale
INSPECTION TYPE: Monitoring	INSPECTOR(S): Travis H. Marshall	INSP. DATE: June 1, 2017	INSP. TIME: 11:00
OPERATOR: LKA International Inc.	OPERATOR REPRESENTATIVE: Kye Abraham	TYPE OF OPERATION: 110d - Designated Limited Impact	
REASON FOR INSPECTION: Normal I&E Program	BOND CALCULATION TYPE: Complete Bond	BOND AMOUNT: \$100,042.00	
DATE OF COMPLAINT: NA	POST INSP. CONTACTS: None	JOINT INSP. AGENCY: None	
WEATHER: Clear	INSPECTOR'S SIGNATURE:

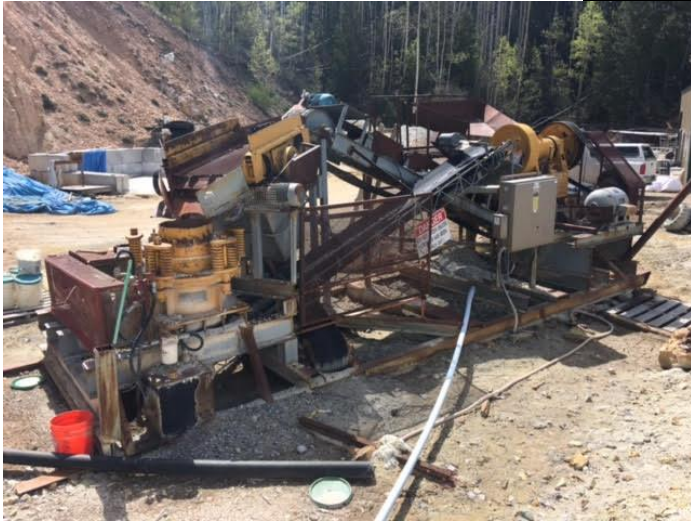
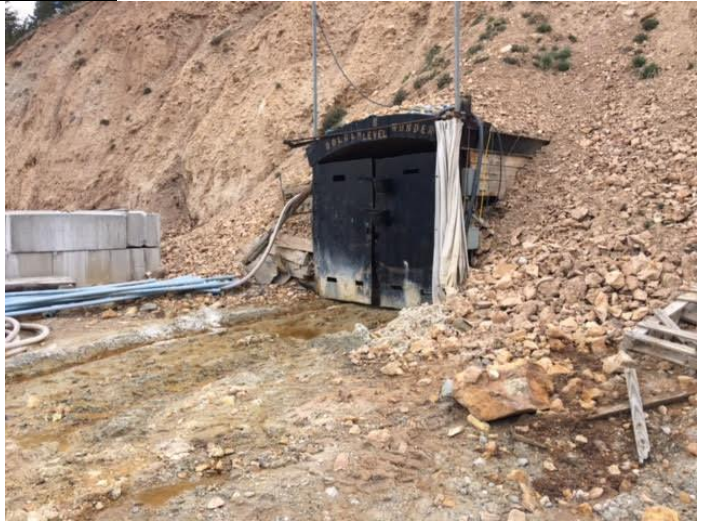
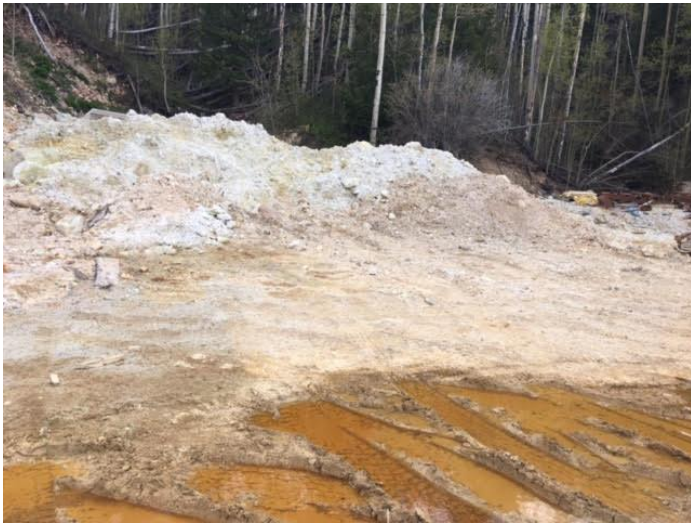
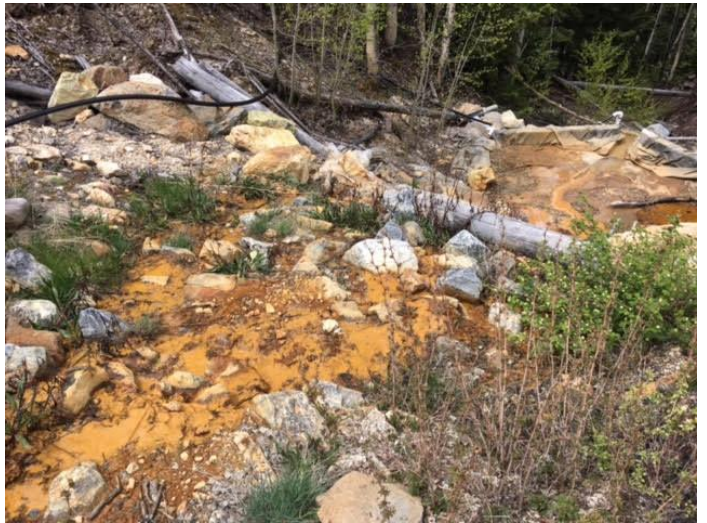
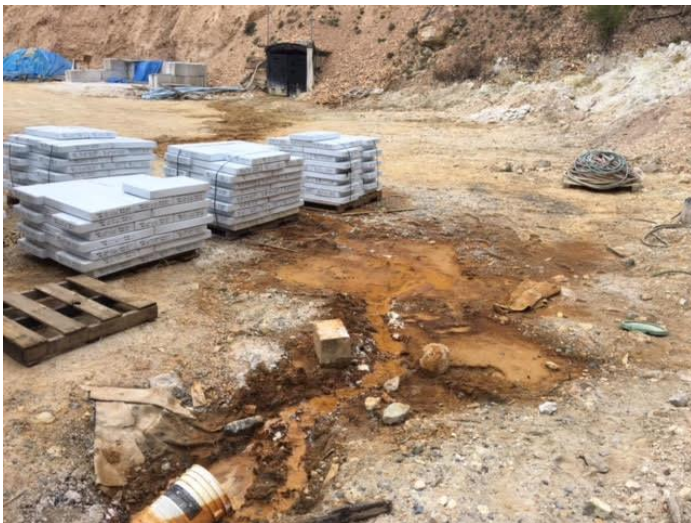
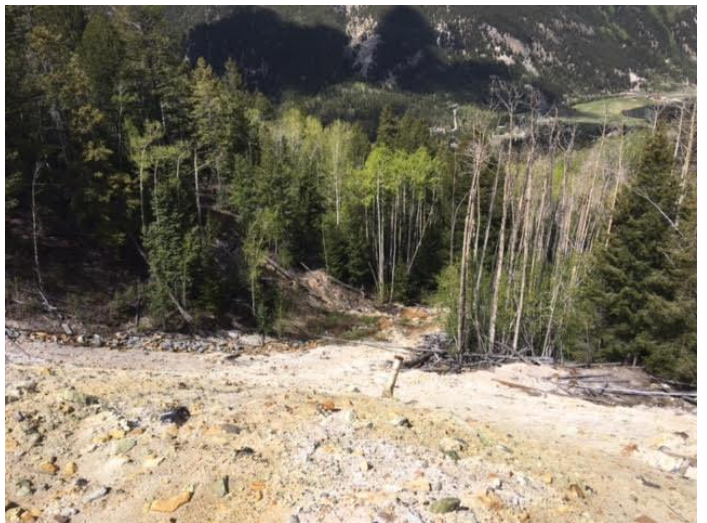
No mining activity was observed. An orange colored mine water discharge was observed exiting the porta. The flow is still estimated to be 0.1 gpm. This discharge was noted as a problem during the October 12, 2016 inspection with a corrective action of a submittal of a technical revision to address the issue submitted no later than May 10, 2017. The technical revision was submitted timely and is currently under technical review. The discharge is still considered a problem but is currently being addressed by the operator through the technical revision submitted.

The passive limestone treatment facility located at the toe of the mine dump was observed. The limestone used for the system is considered spent and is no longer adequately treating the acid drainage coming from the mine. The technical revision under review is to incorporate a pH buffering system on the mine bench that will use slag from a metal smelter to treat the mine discharge. The spent lime stone at the toe of the mine dump may be removed and replaced if needed.
