Permit Number: C-1996-084 Mine Name: Lorencito Canyon Mine Operator: New Elk Coal Company, LLC Operator Address: Mr. Louis Head 12250 Highway 12 Weston, CO 81091 **County:** Las Animas **Operation Type:** Surface **Permit Status:** Permanent Cessation **Ownership:** Private

INSPECTION INFORMATION

Inspection Start Date: June 8, 2017 Inspection Start Time: 09:00 Inspection End Date: June 9, 2017 Inspection End Time: 10:30			Inspection Type: Coal Complete Inspection Inspection Reason: Normal I&E Program Weather: Clear		
Joint Inspection Agency:		Joint Inspection Contacts:			
None					
Post Inspection Agency:		Post Inspection Contacts:			
None					
Inspector(s):	Inspecto	r's Sig	nature: Signature Date:		
Robert D. Zuber, P.E.	Phot	D.	24		
			6/20/2017

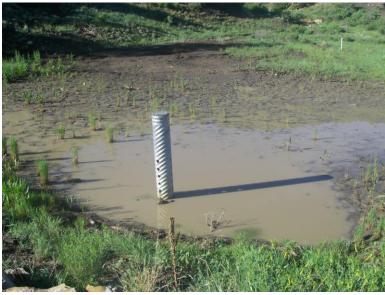
The following ponds were inspected: 5, 6, 7, 8, 9, and 9A. Several of them were discharging relatively clear water. Ponds 6, 7 and 9 were not discharging. Embankments were in good condition. It appears that primary spillways at Ponds 8 and 9A have small leaks that should be sealed as soon as practical, perhaps during the dry season in late summer 2017. Pond 5 appears to be in need of cleaning, as the sediment level is almost up to the lowest holes on the riser of the spillway.

Sediment in Pond 5

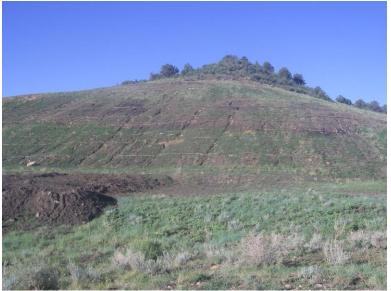
The hill above the pond cleaning dump area continues to have several rills that should be repaired. Vince Massarotti indicated that elk have displaced wattles on this hill, so he will use tree branches for erosion control in this area.

Hill above area where pond cleanings are dumped

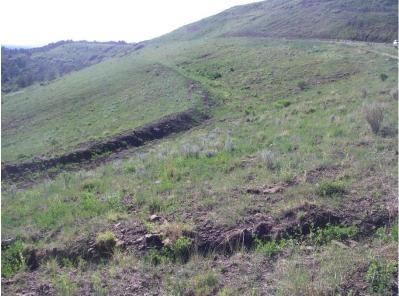
Fill 8

Number of <u>Partial</u> Inspection this Fiscal Year: 9 Number of <u>Complete</u> Inspections this Fiscal Year: 4 Culvert C8 (above Fill 8) is clear of sediment, and the ditch below it is stable.

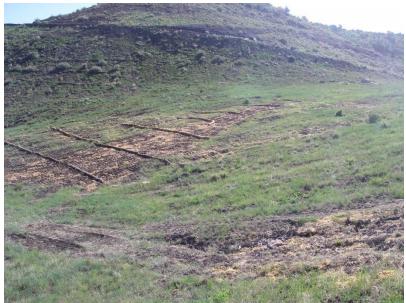
Rills on the west side of "the knob" (large hill in center of site) require repair. Erosion near the shrub plot has been addressed.

Erosion repairs near shrub plot

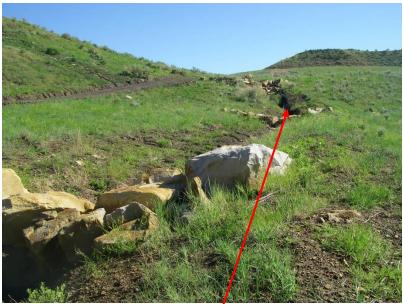
In the channel above Pond 6, check dams appear to be functioning, but more riprap should be added to the channel between the dams, at least in one spot (this was discussed with Vince Massarotti during the inspection).

Channel above Pond 6

Area in need of riprap

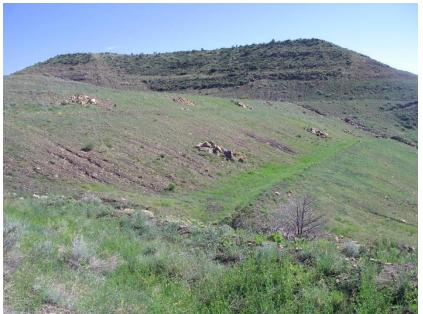
Fills 7, 8, and 9 were inspected. All were generally in good condition, but the following should be addressed. Rills on Fill 7 (as noted in past inspections) may require repair; this remains a judgement call, and NECC should balance the pros and cons of this work. The gully near the bottom of Fill 7 does require repair. Riprap work is needed in down drains for Fill 9.

Rills on Fill 7

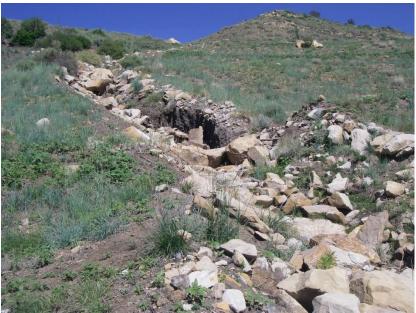
Side channel, aka west down drain, at Fill 9 (need for more riprap)
