COLORADO
Division of Reclamation,
Mining and Safety
Department of Natural Resources

Permit Number: C-1981-035 Mine Name: King Coal Mine Operator: GCC Energy, LLC Operator Address: Mr. Tom Bird 6473 County Road 120 Hesperus, CO 81326	County: La Plata Operation Type: Underground Permit Status: Active Ownership: Federal
	Operator Representative Present: None
Operator Representative Signature: (Field Issuance Only)

Inspection Start Date: June 14, 2017 Inspection Start Time: 10:00 Inspection End Date: Inspection End Time:		Inspection Type: Aerial Inspection Inspection Reason: Normal I&E Program Weather: Clear	
Joint Inspection Agency: None		Joint Inspection Contacts: 	
Post Inspection Agency: None		Post Inspection Contacts: 	
Inspector(s): Harry B. Ranney	Inspector's Signature: <i>Phet D. Zh</i>		Signature Date: 6/20/2017

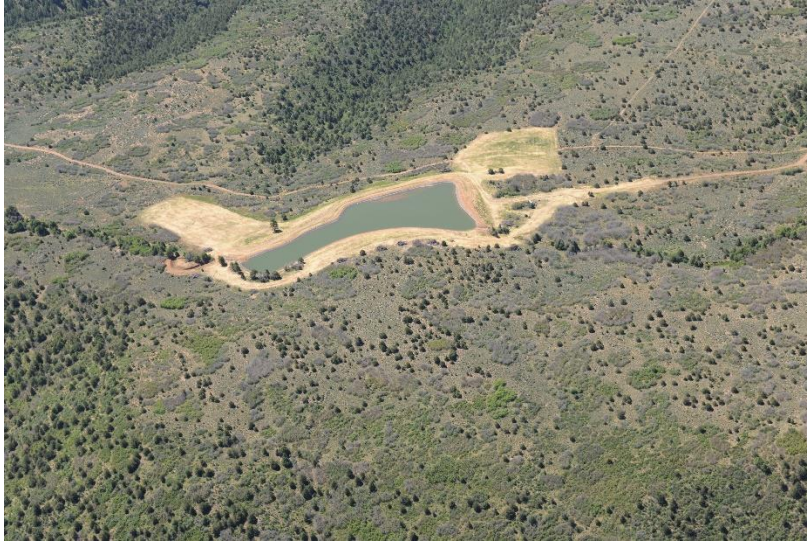
Huntington irrigation pond

No damage from subsidence was seen in any of the affected areas. Roads and reservoirs (especially Huntington irrigation pond) were given extra scrutiny.

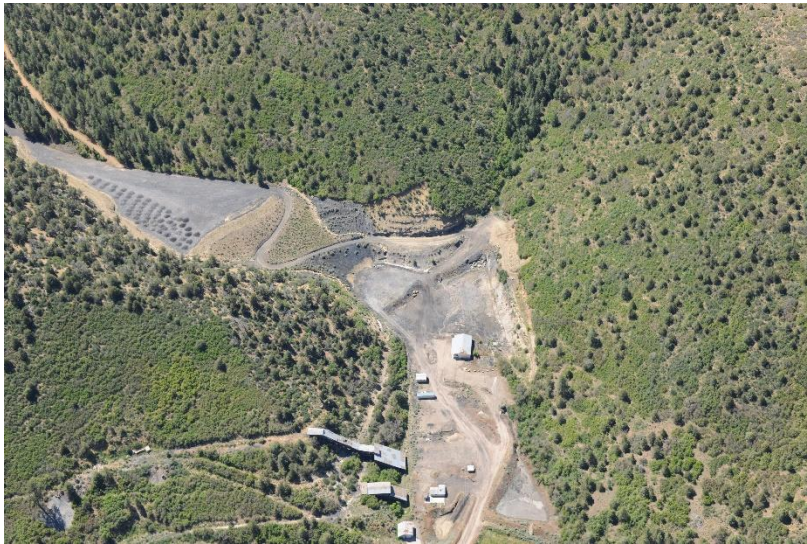
King I surface facilities

No problems were seen at the King I or King II facilities areas.
