MINERALS PROGRAM INSPECTION REPORT
PHONE: (303) 866-3567

MINE NAME: AMSO RDD Project-PHASE 1	MINE/PROSPECTING ID#: P-2008-048	MINERAL: Oil Shale	COUNTY: Rio Blanco
INSPECTION TYPE: Mineral Prospect Inspection	INSPECTOR(S): Travis H. Marshall	INSP. DATE: June 13, 2017	INSP. TIME: 10:30
OPERATOR: American Shale Oil, LLC	OPERATOR REPRESENTATIVE: Bruce Smith	TYPE OF OPERATION: MP - Mineral Prospecting	
REASON FOR INSPECTION: Normal I&E Program	BOND CALCULATION TYPE: None	BOND AMOUNT: \$46,789.00	
DATE OF COMPLAINT: NA	POST INSP. CONTACTS: U.S.BLM	JOINT INSP. AGENCY: None	
WEATHER: Clear	INSPECTOR'S SIGNATURE:

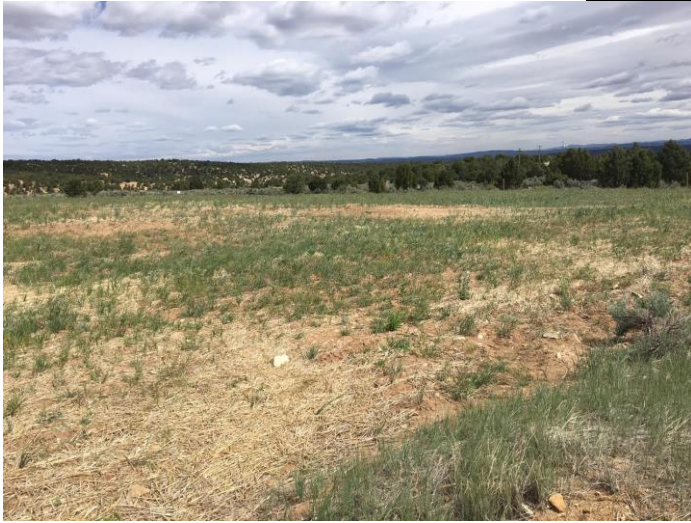
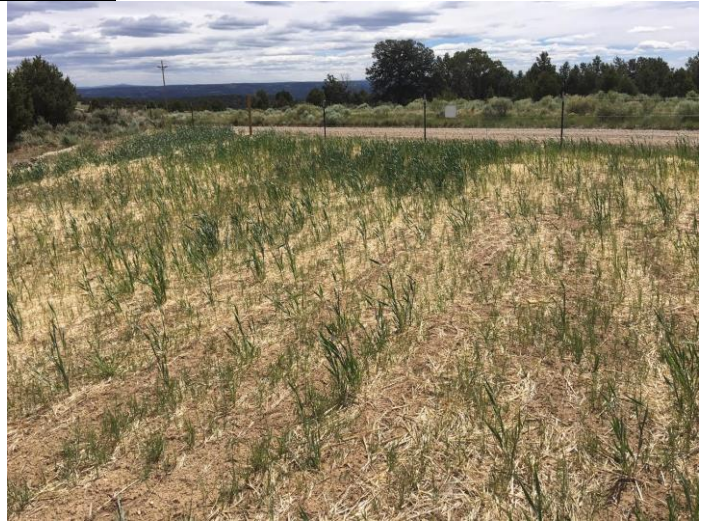
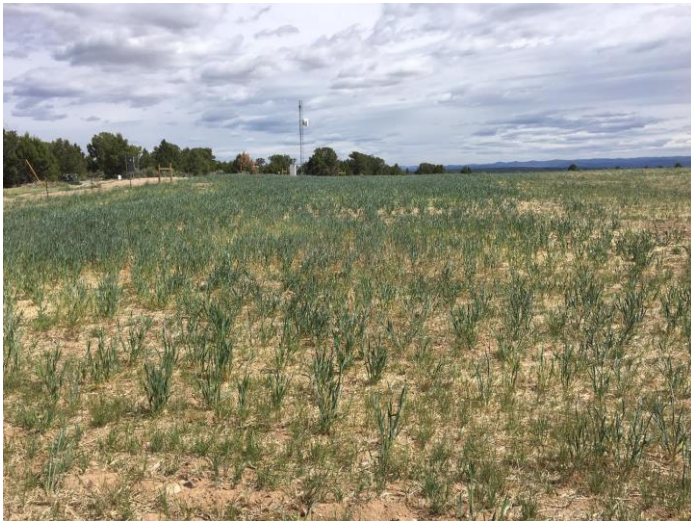
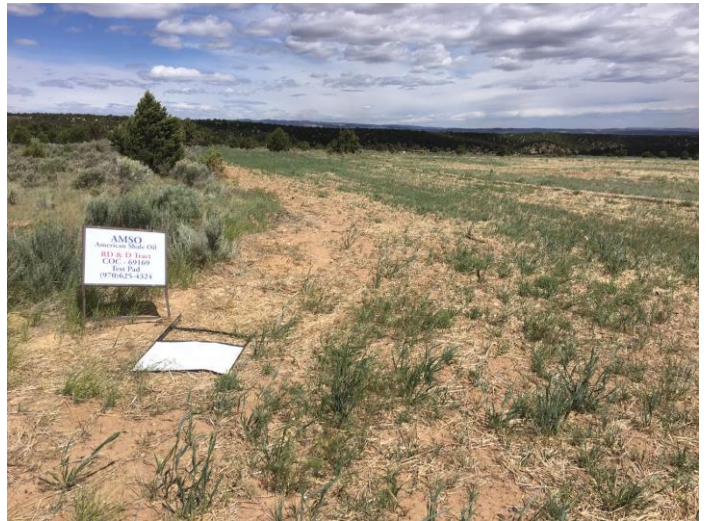
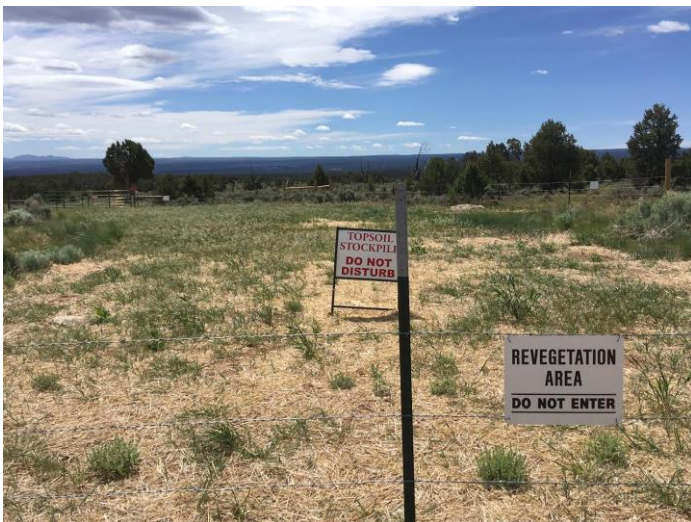
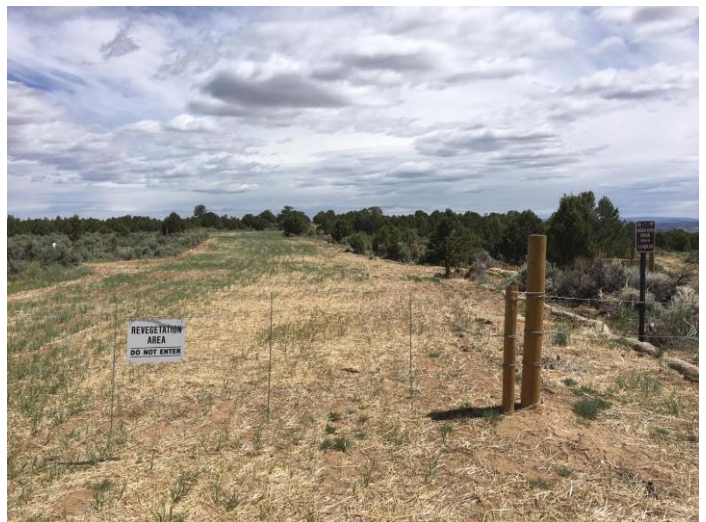
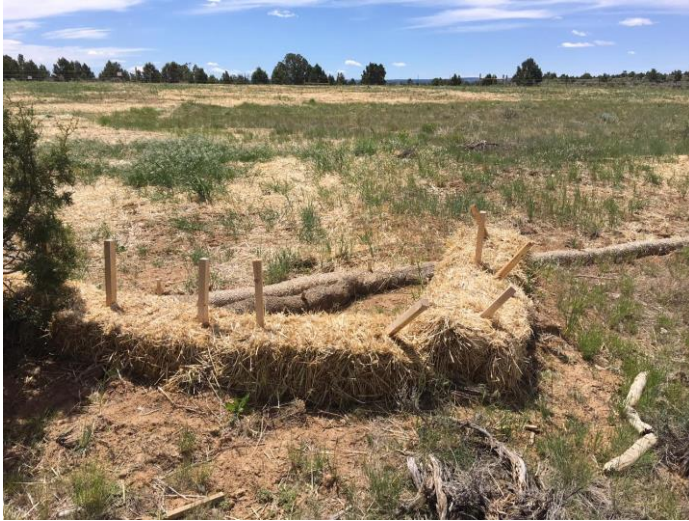
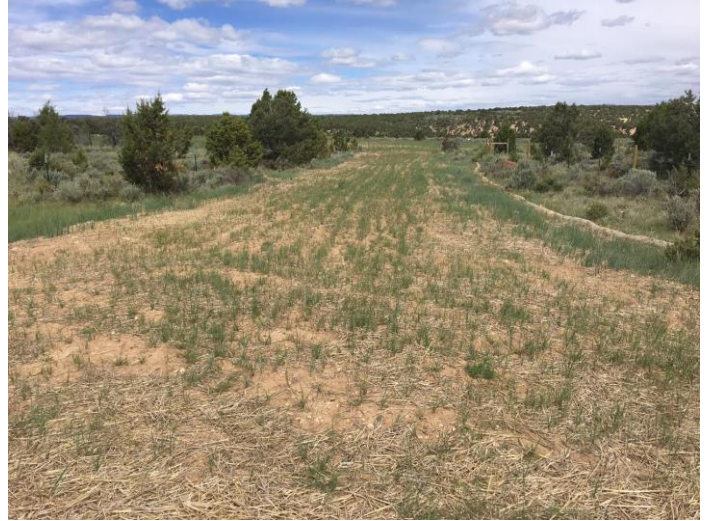
PHOTOGRAPHS

Photos that show the conditions observed during the June 13, 2017 inspection are included at the end of this report.
