MINERALS PROGRAM INSPECTION REPORT

MINE NAME: Gillette Pit	MINE/PROSPECTING ID#: M-1992-009	MINERAL: Gravel	COUNTY: Teller
INSPECTION TYPE: Monitoring	INSPECTOR(S): Elliott R. Russell	INSP. DATE: February 8, 2017	INSP. TIME: 10:00
OPERATOR: Gillette Sand and Gravel, Inc.	OPERATOR REPRESENTATIVE: Chris Pyles	TYPE OF OPERATION: 112c - Construction Regular Operation	
REASON FOR INSPECTION: Normal I&E Program	BOND CALCULATION TYPE: None	BOND AMOUNT: \$37,613.00	
DATE OF COMPLAINT: NA	POST INSP. CONTACTS: None	JOINT INSP. AGENCY: None	
WEATHER: Snowing	INSPECTOR'S SIGNATURE:

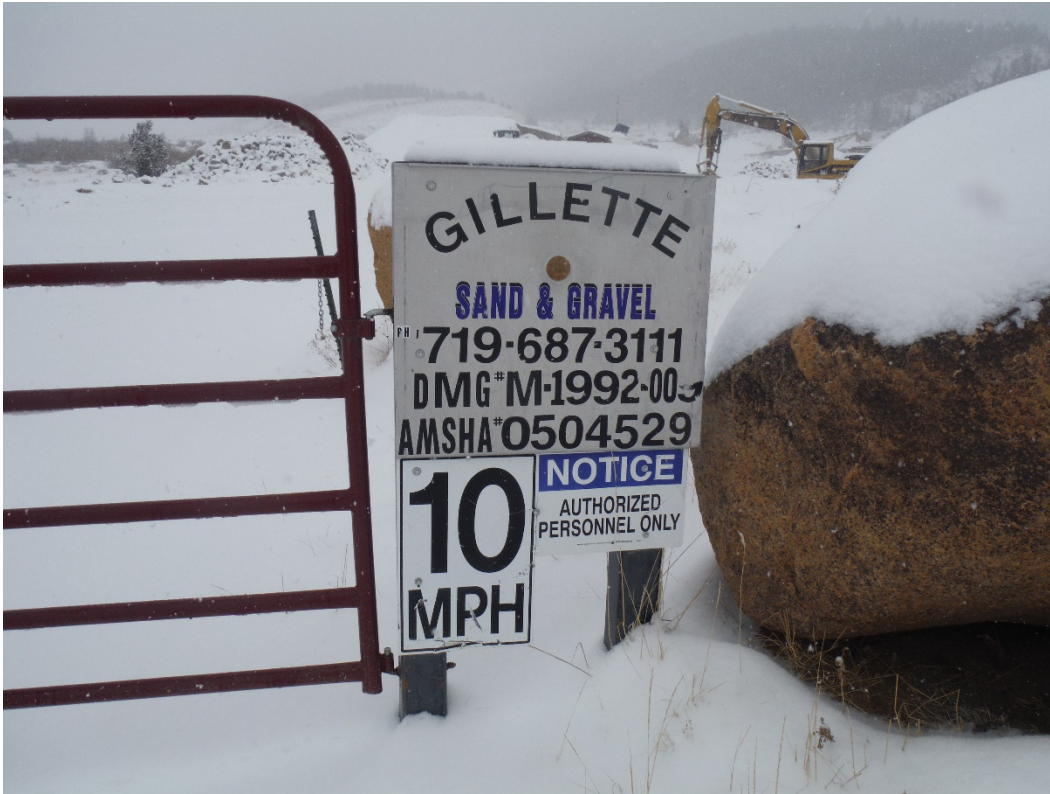
COMPLIANCE PROBLEM #1: The mine identification sign was not in compliance with Rule 3.1.12(1).

The Division met Chris Pyles at the mine site entrance on the east side of County Road 81, approximately ¼ mile south of CO-67. The mine site identification sign was posted at the entrance, however, the last digit of the permit number is illegible. This has been cited as Compliance Problem #1 on page two of this report.

Photo 1. Mine identification sign; looking north.

CORRECTIVE ACTIONS: The operator shall, at the entrance of the mine site, post a sign which shall be clearly visible from the access road with the following: the name of the operator, a statement that a reclamation permit for the operation has been issued by the Colorado Mined Land Reclamation Board; and the permit number. The operator shall submit photo documentation that a proper sign has been posted by the corrective action date.

CORRECTIVE ACTION DUE DATE: July 24, 2017
