COLORADO
Division of Reclamation,
Mining and Safety
Department of Natural Resources

PERMIT INFORMATION

Permit Number: C-1981-008 Mine Name: New Horizon Mine Operator: Elk Ridge Mining and Reclamation, LLC Operator Address: Mr. Tony Tennyson 5731 State Highway 13 Meeker, CO 81641	County: Montrose Operation Type: Surface Permit Status: Active Ownership: Private
	Operator Representative Present: Frank Ferris
Operator Representative Signature: (Field Issuance Only)

Inspection Start Date: June 21, 2017 Inspection Start Time: 15:00 Inspection End Date: June 22, 2017 Inspection End Time: 16:30		Inspection Type: Coal Complete Inspection Inspection Reason: Normal I&E Program Weather: Cloudy	
Joint Inspection Agency: None		Joint Inspection Contacts: 	
Post Inspection Agency: None		Post Inspection Contacts: 	
Inspector(s): Brock F. Bowles	Inspector's Signature:

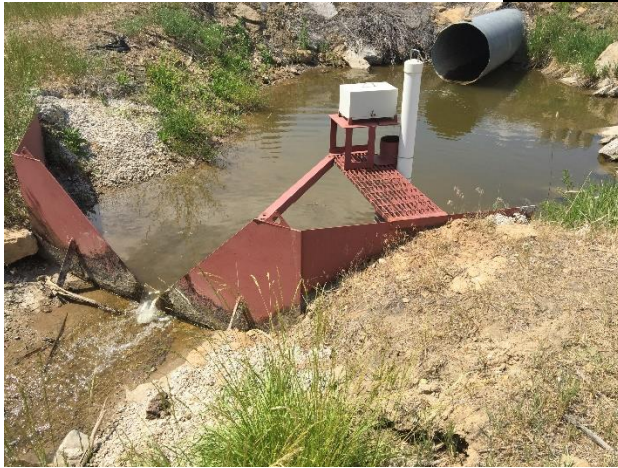
Photo 1 – Pond 007 Discharge

Pond 007 contained water and was discharging. The CO2 aerator was in operation (photo 1).

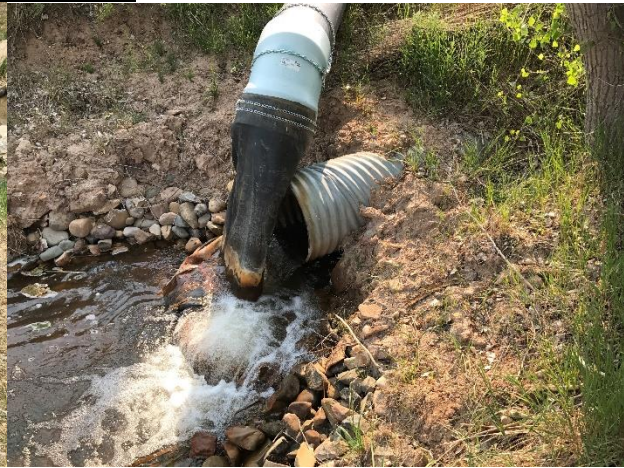
Photo 2 – Pond 013 Discharge

Pond 013 contained water and was discharging. The trench drain was also discharging (photo 2). The emergency culverts and discharge structure were free and clear of obstructions.

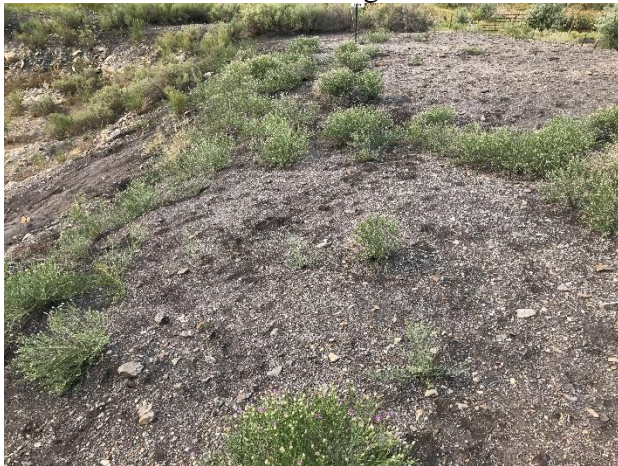
Photo 3 – Knapweed at Pond 15

Some patches of knapweed were noted on the north embankment of Pond 9, the SE inlet of Pond 9, along the old BB Road Detour on the Benson East property and on the west side of the Pond 015 (photo 3). Knapweed is a noxious weed and needs to be treated.

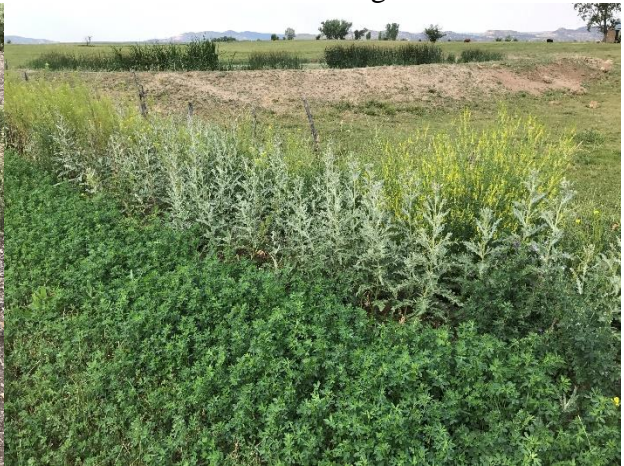
Photo 4 – Canada Thistle at Field Edge

A large patch of Canada thistle was noted on the western edge of the Morgan alfalfa field (photo 4). Canada thistle is a noxious weed and needs to be treated. The treatment method will have to be coordinated with the Morgans.

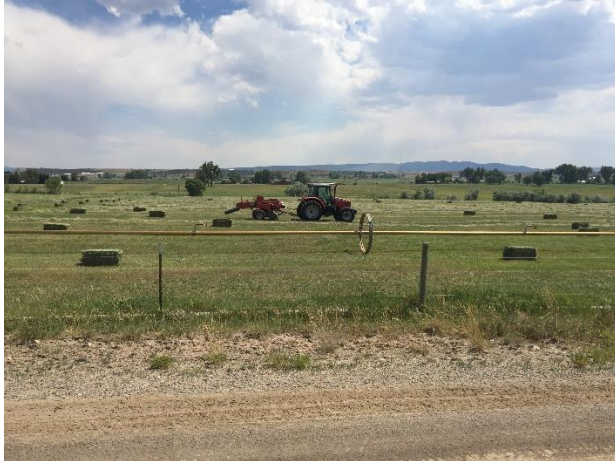
Photo 5 – South of 5th Road

The vegetation on the south side of 5th Rd was being baled into small square bales (photo 5).

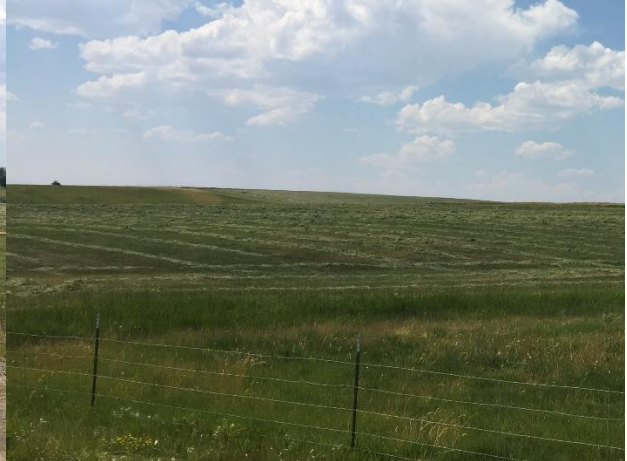
Photo 6 – North of 5th Road

The vegetation in the irrigated pastures on the north side of 5th Rd was being cut and baled (photo 6). The areas where the bales have already been removed were being irrigated.

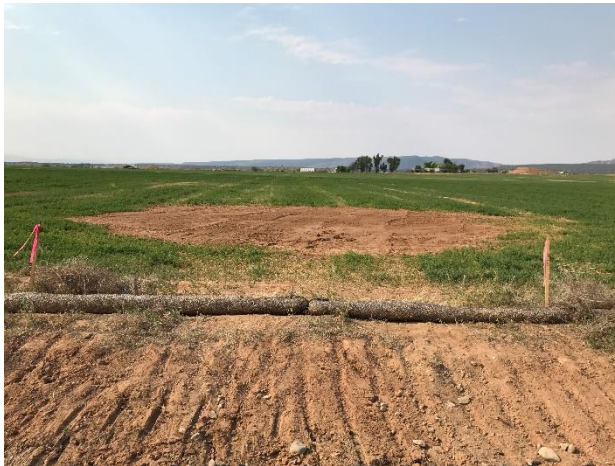
Photo 7 – Topsoil Depression Repair

A topsoil depression was repaired on the Morgan field. The repair is located along the BB Road (photo 7).

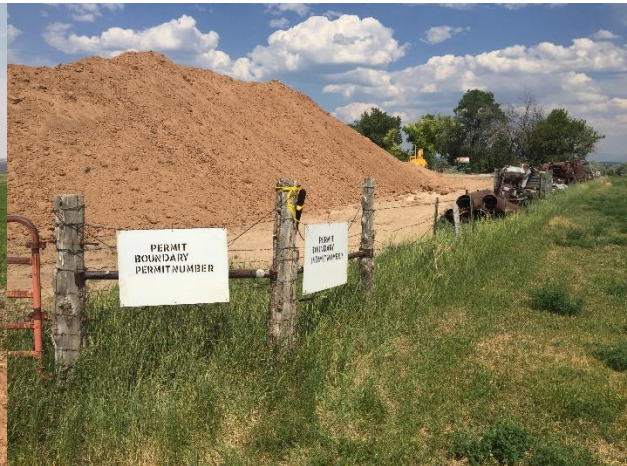
Photo 8 – Permit Boundary Signs Installed

The permit boundary signs were installed around the new topsoil location on the Slash M property (photo 8).

The Morgan topsoil pile Lift A was being moved from the ERMR-Johnson property by Pond 16 to the Morgan (Slash M) property (photos 8 & 9). The topsoil was approved to be relocated in TR79. The Lift B pile will be moved after the A lift relocation is complete.

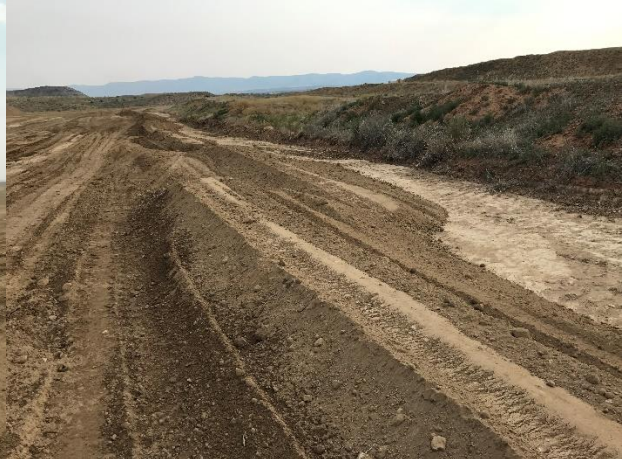
Photo 10 – Ring Ditch Repair

The topsoil ring ditch was being repaired on the western side of stockpile 12 (photo 10). The ring ditch was

damaged during the relocation of the Morgan topsoil piles.
