**PERMIT INFORMATION**

| <b>Permit Number:</b> C-2010-089<br><b>Mine Name:</b> New Horizon North Mine<br><b>Operator:</b> Elk Ridge Mining and Reclamation, LLC<br><b>Operator Address:</b><br>Mr. Tony Tennyson<br>5731 State Highway 13<br>Meeker, CO 81641 | <b>County:</b> Montrose<br><b>Operation Type:</b> Surface<br><b>Permit Status:</b> Active<br><b>Ownership:</b> Private |

| <b>Inspection Start Date:</b> June 22, 2017<br><b>Inspection Start Time:</b> 12:00<br><b>Inspection End Date:</b> June 22, 2017<br><b>Inspection End Time:</b> 16:30 | | <b>Inspection Type:</b> Coal Partial Inspection<br><b>Inspection Reason:</b> Normal I&E Program<br><b>Weather:</b> Clear | |

**Inspection Topic Summary**

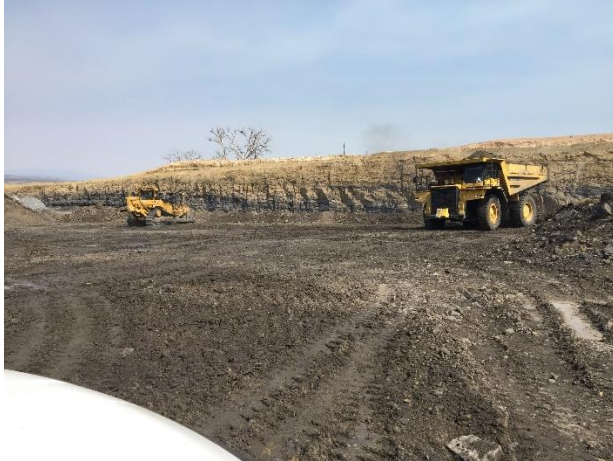
Three haul trucks were moving spoil from the large spoil pile north of Pond 001 to the main pit area. A bulldozer was positioning the spoil in the pit (photo 1). A road grader and water truck were maintaining the road for the haul trucks.

Photo 1 – Backfilling Main Pit

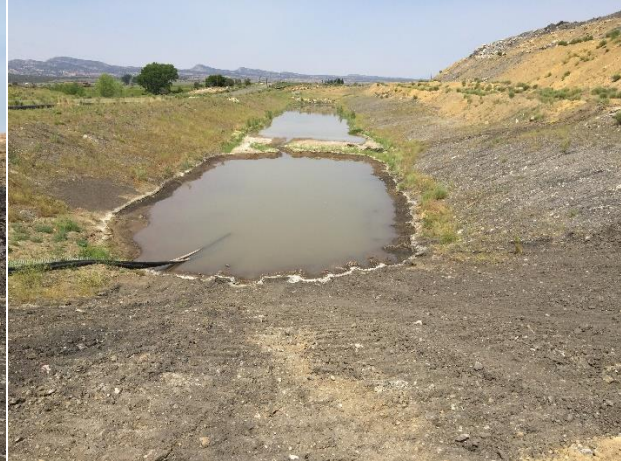
Pond 001 contain water but was not discharging. The discharge structure was free and clear of obstructions. Water was being pumped from the pit to Pond 001. The west ditch was in good condition. Sediment was recently removed from Pond 001 (photo 2).

Photo 2 – Pond 001

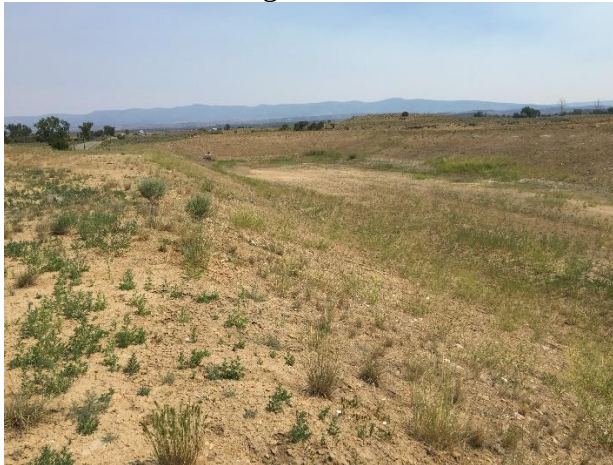
Pond 002 contained a small amount of water but was not discharging (photo 3). The discharge structure was free and clear of obstructions.

Vegetation was growing on the Pond 001 and 002 (photo 3) embankments. The vegetation was noticeably denser than this same time last year.

Photo 3 – Pond 002

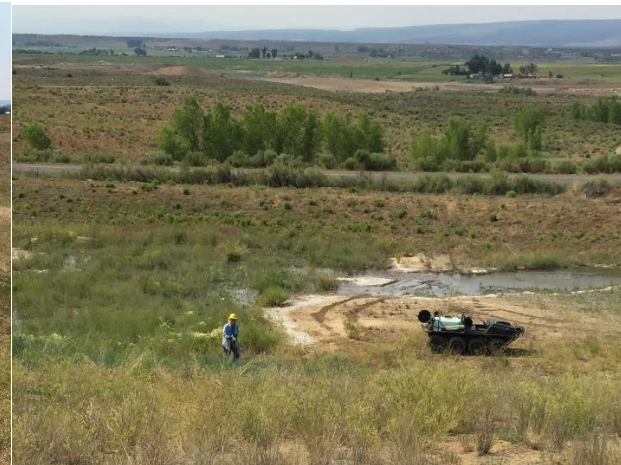
Knapweed was being sprayed by a subcontractor on the minesite (photo 4).

Photo 4 – Spraying Knapweed
