MINERALS PROGRAM INSPECTION REPORT

MINE NAME: Builders Aggr Pit	MINE/PROSPECTING ID#: M-1981-112	MINERAL: Sand and gravel	COUNTY: Morgan
INSPECTION TYPE: Surety-Related Inspection	INSPECTOR(S): Jared L. Ebert	INSP. DATE: June 22, 2017	INSP. TIME: 10:50
OPERATOR: Builder's Aggregate, Inc.	OPERATOR REPRESENTATIVE: James Miner	TYPE OF OPERATION: 112c - Construction Regular Operation

REASON FOR INSPECTION: Surety Release Requested	BOND CALCULATION TYPE: Complete Bond	BOND AMOUNT: \$11,750.00
DATE OF COMPLAINT: NA	POST INSP. CONTACTS: None	JOINT INSP. AGENCY: None
WEATHER: Clear	INSPECTOR'S SIGNATURE:

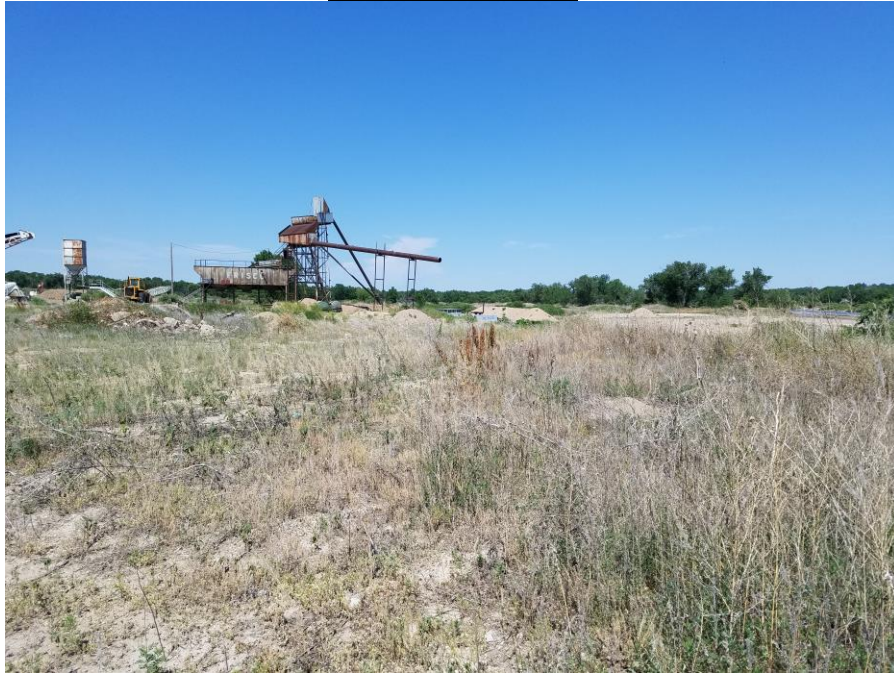
Figure 1. Southern portion of the acreage reduction area from the east end looking west.

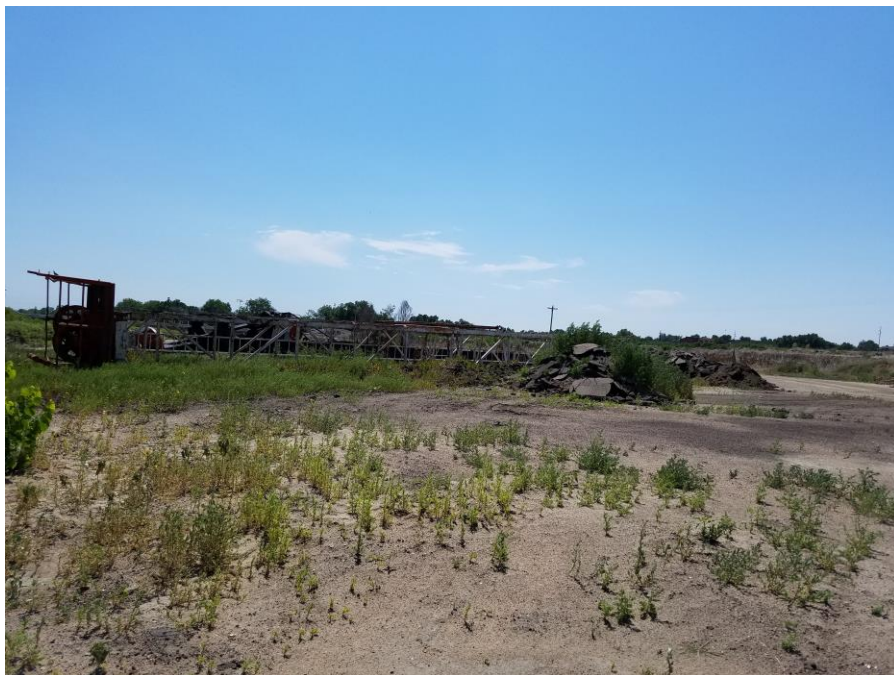
Figure 2. Southern portion of acreage reduction area from the center of the area looking east.

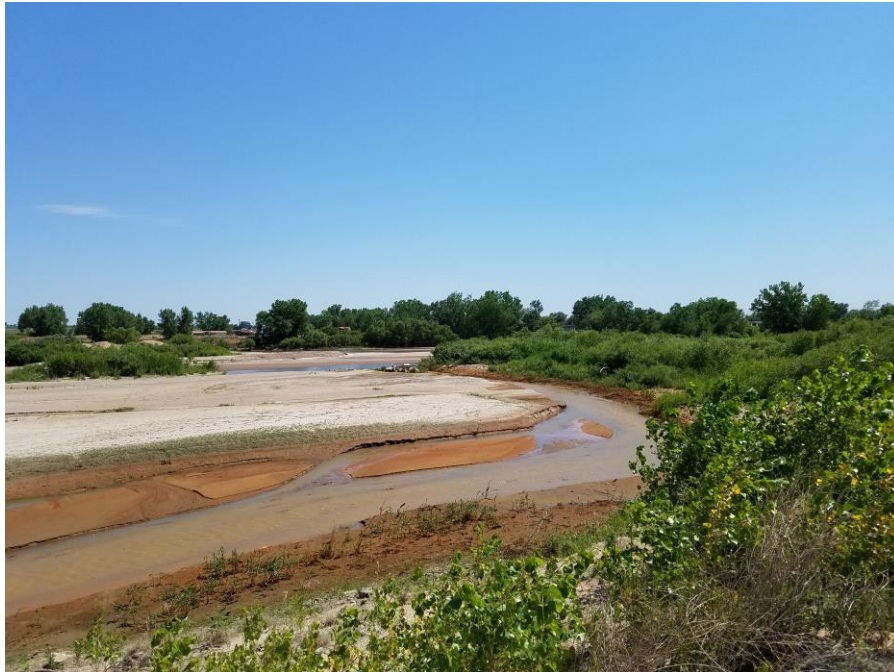
Figure 3. Drainage from the southwest corner of the site entering the South Platte River.

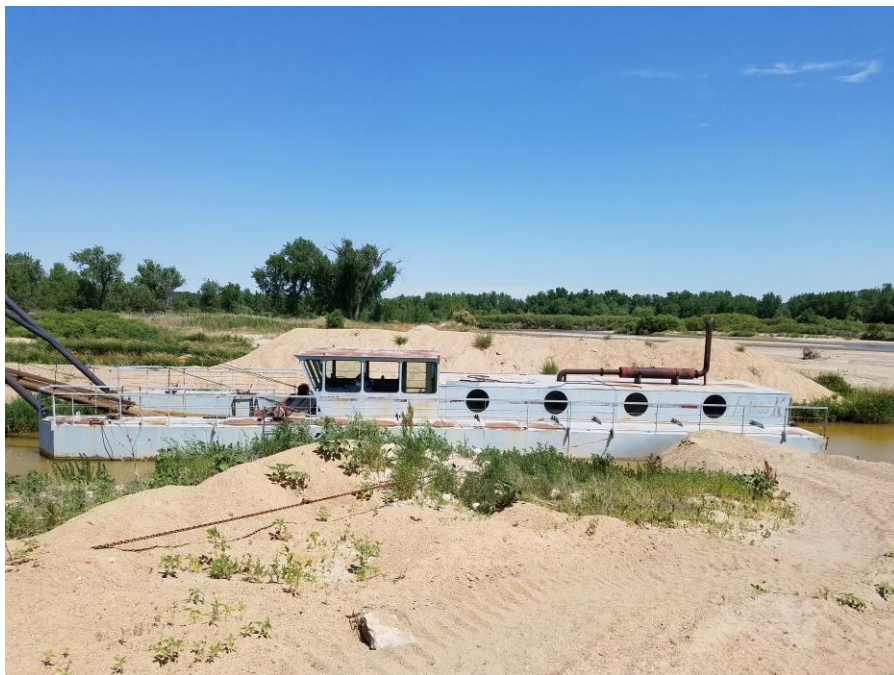
Figure 4. Dredge sitting in the drainage discussed within the body of this report.

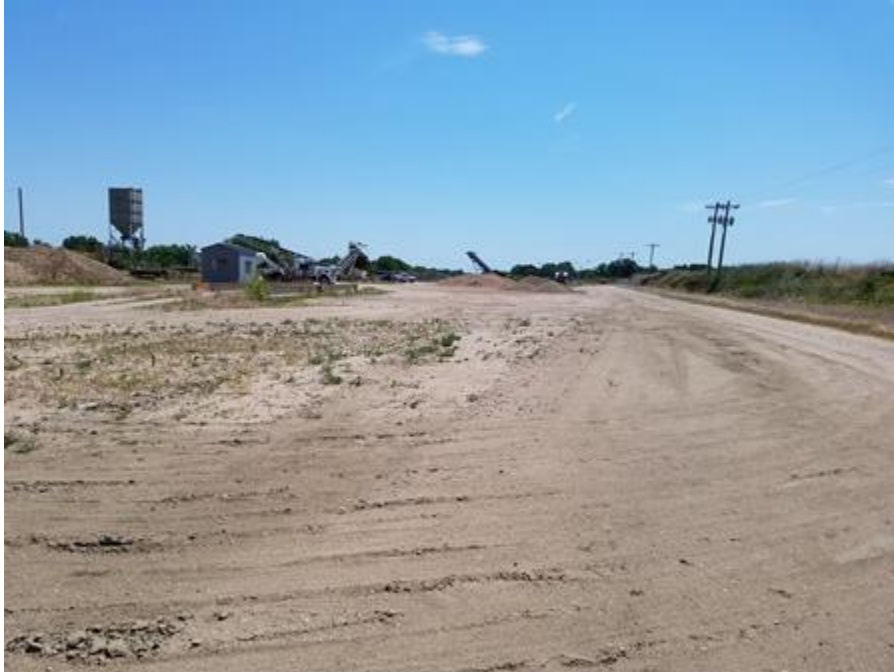
Figure 5. Southern acreage reduction area from the west end of the site looking east.

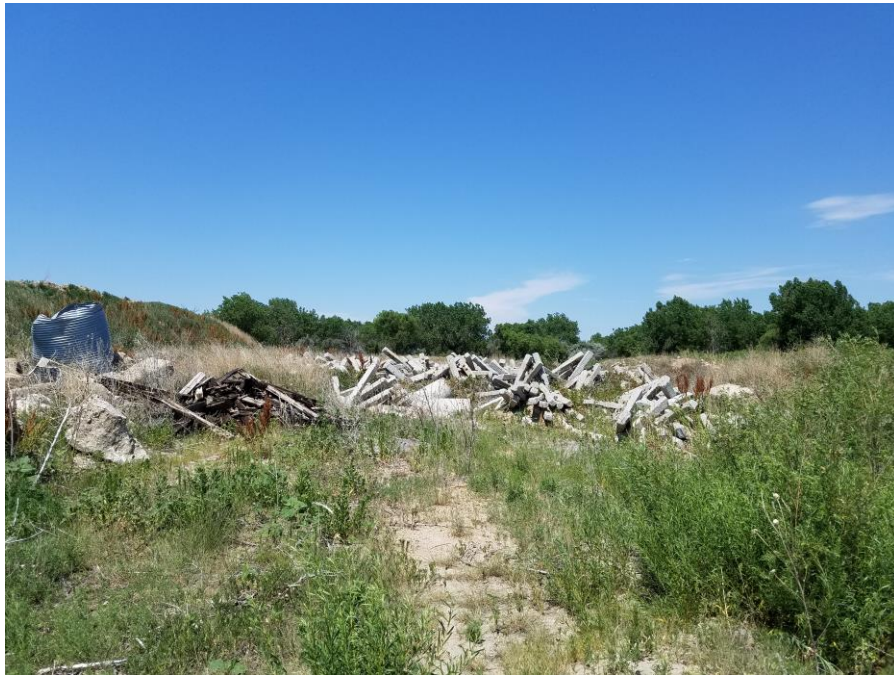
Figure 6. Concrete stored at the site.

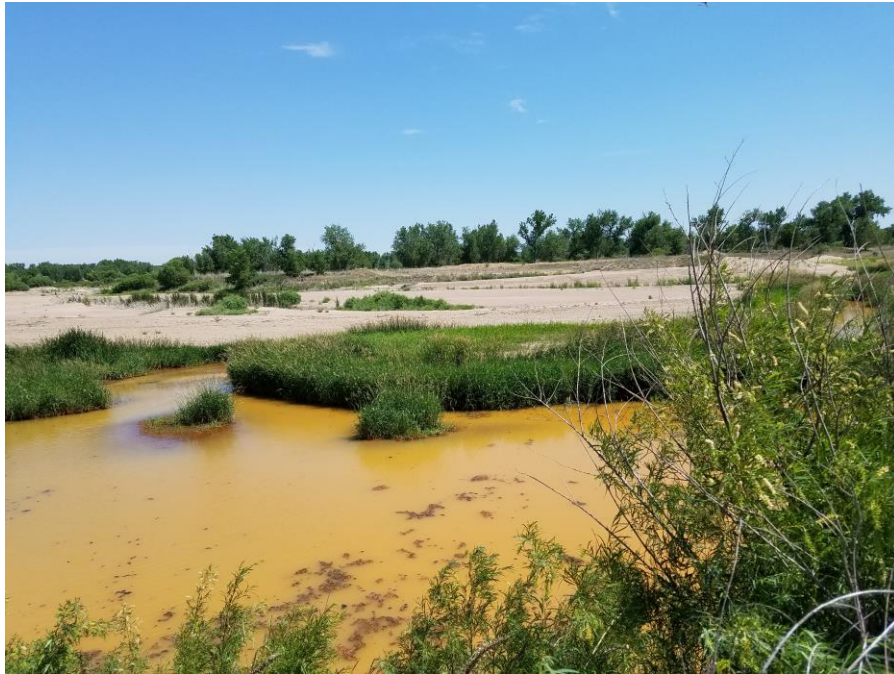
Figure 7. Water within the drainage that enters the site from the southwest corner of the property and flows to the South Platte River.

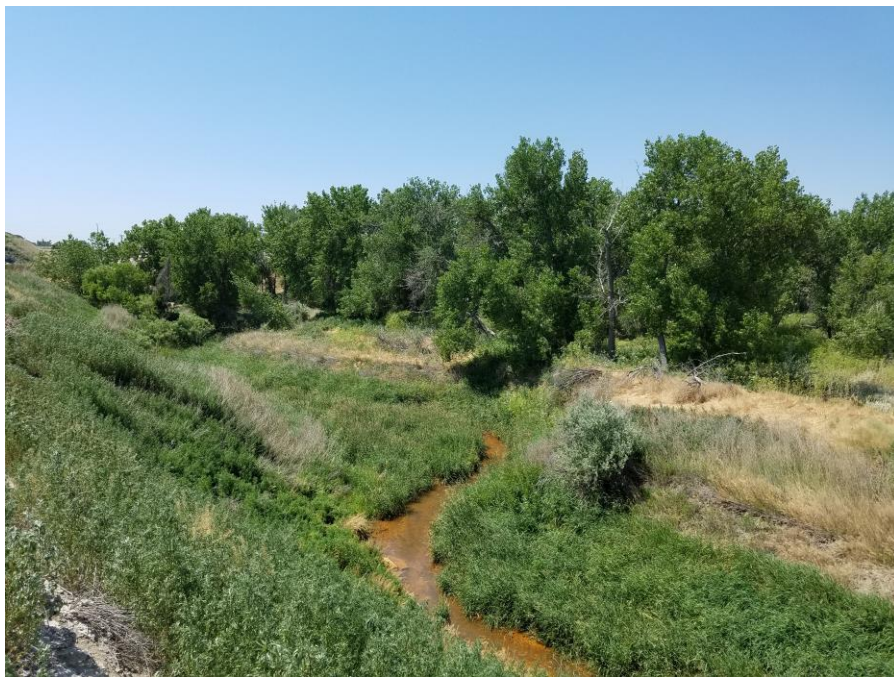
Figure 8. From the southwest corner of the site looking south up the drainage.

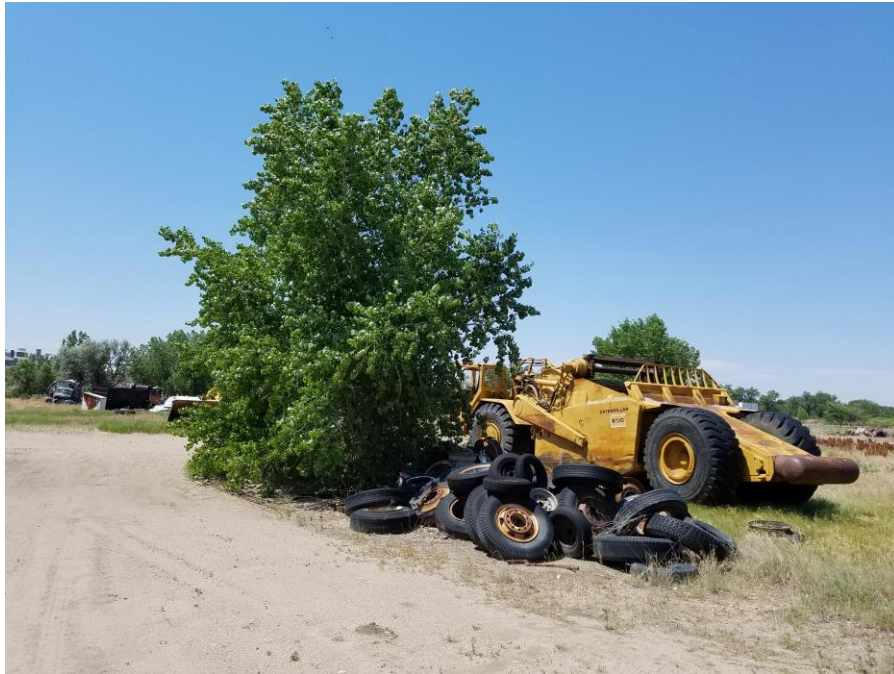
Figure 9. North acreage reduction area. From the west end of the site looking southeast.

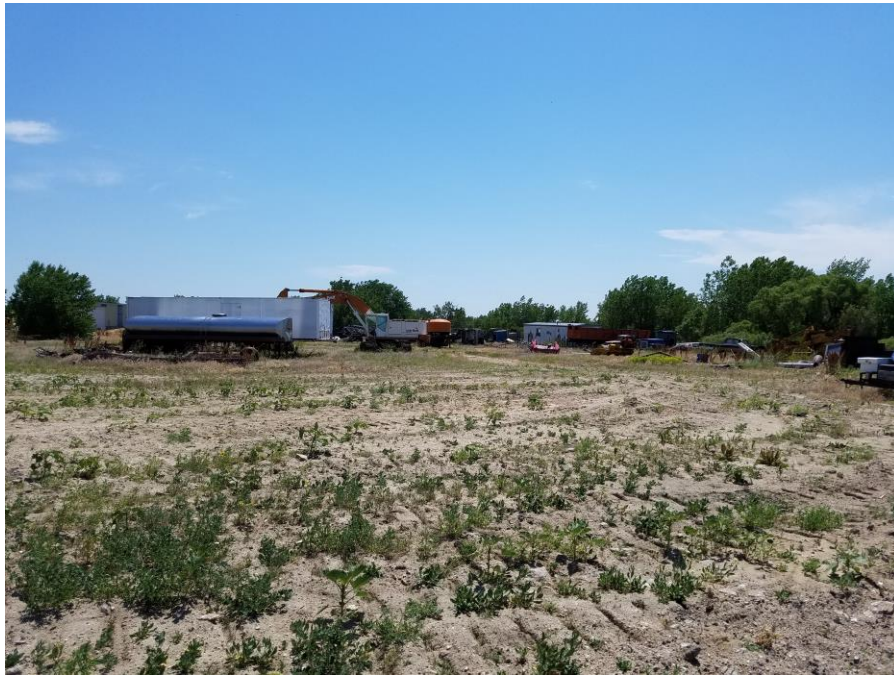
Figure 10. North acreage reduction area. From the west end of the site looking east.

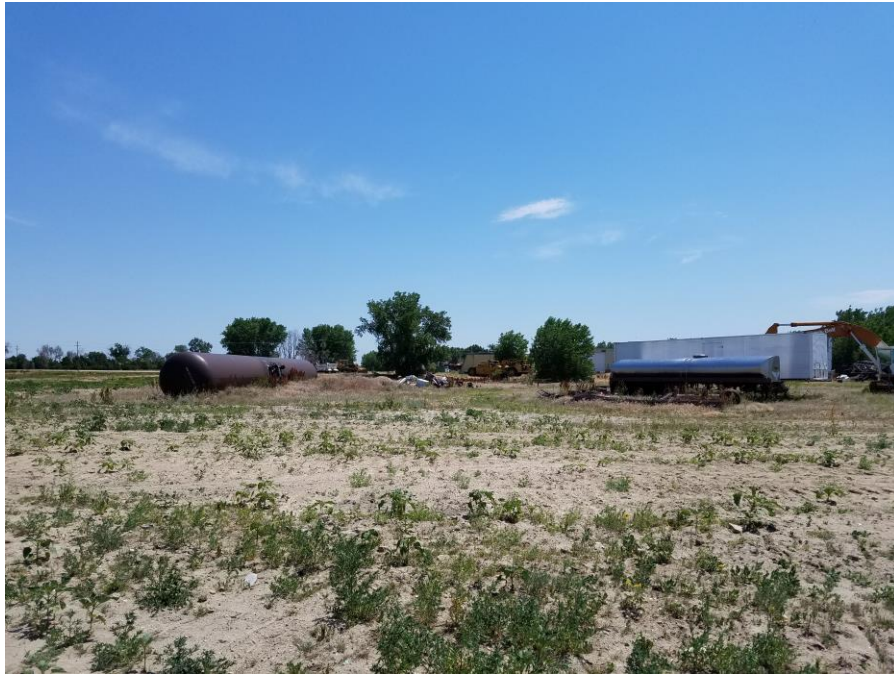
Figure 11. North acreage reduction area. From the west end of the site looking northeast.
