MINERALS PROGRAM INSPECTION REPORT
PHONE: (303) 866-3567

MINE NAME: Inspiration Point	MINE/PROSPECTING ID#: M-1995-004	MINERAL: Gravel	COUNTY: Grand
INSPECTION TYPE: Monitoring	INSPECTOR(S): Peter S. Hays	INSP. DATE: May 23, 2017	INSP. TIME: 10:30
OPERATOR: Grand County	OPERATOR REPRESENTATIVE: Bill Clark	TYPE OF OPERATION: 112c - Construction Regular Operation	
REASON FOR INSPECTION: Normal I&E Program	BOND CALCULATION TYPE: None	BOND AMOUNT: \$0.00	
DATE OF COMPLAINT: NA	POST INSP. CONTACTS: U.S.BLM	JOINT INSP. AGENCY: None	
WEATHER: Clear	INSPECTOR'S SIGNATURE:

May 23, 2017 Inspection Map

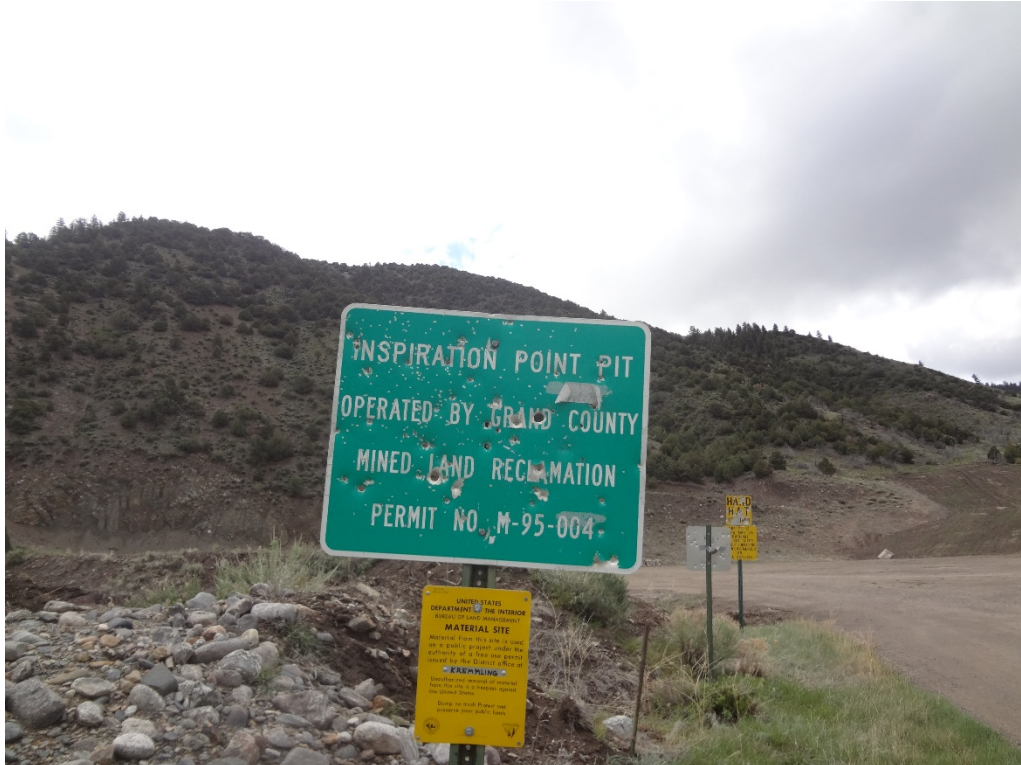
An entrance sign was posted and permit boundary markers were observed as required by Rule 3.1.12. The site was well organized and maintained by Grand County Department of Road and Bridge. No problems were noted during the inspection. The disturbed mining area was GPS surveyed by the Division using a Trimble Juno 3B. A map of the GPS survey results are attached. The survey indicated a disturbance area of 9.88 acres.

Inspiration Point mine sign

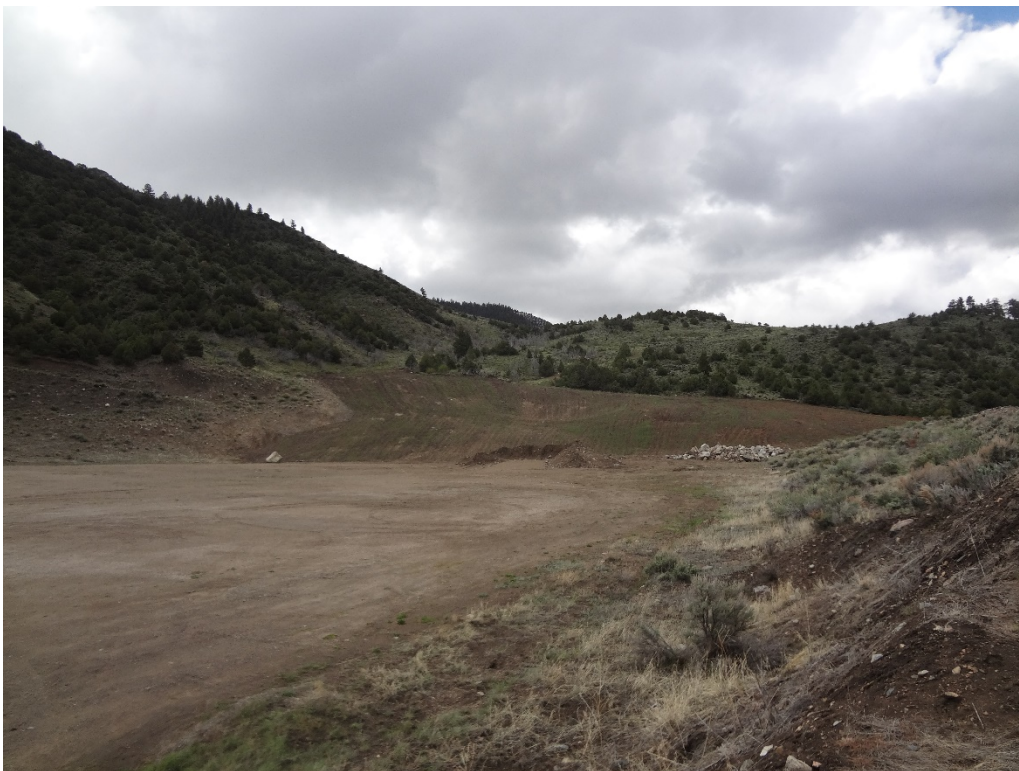
View of pit floor and reclaimed south slope from the pit entrance looking southeast

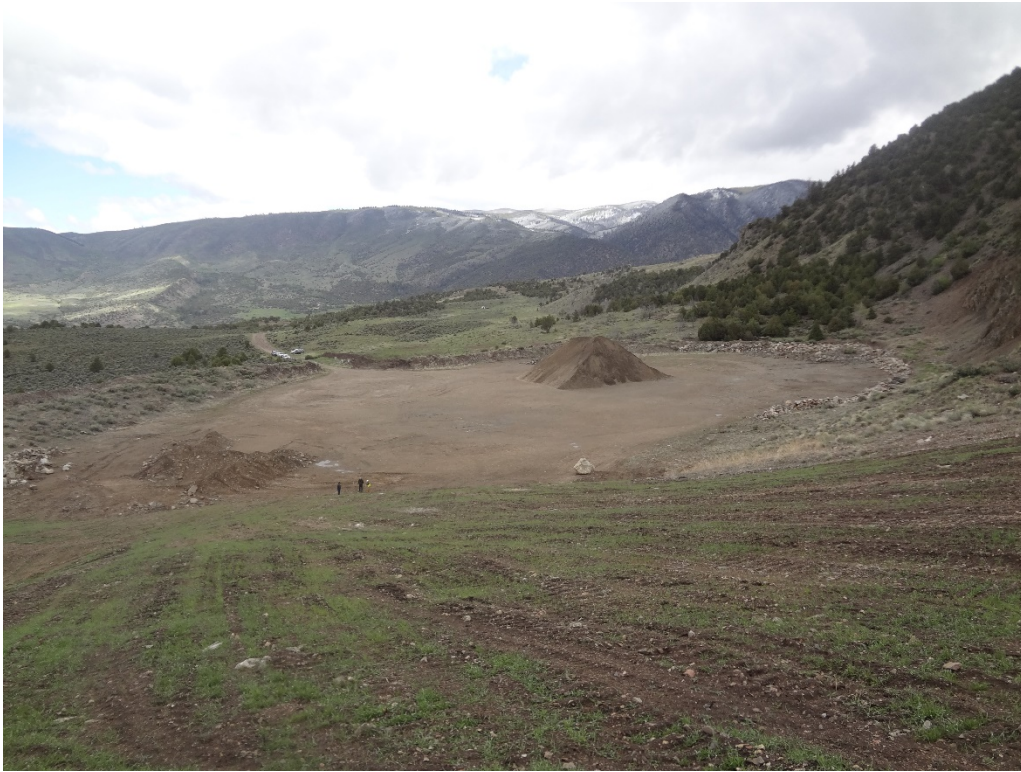
View of site from the south slope looking north

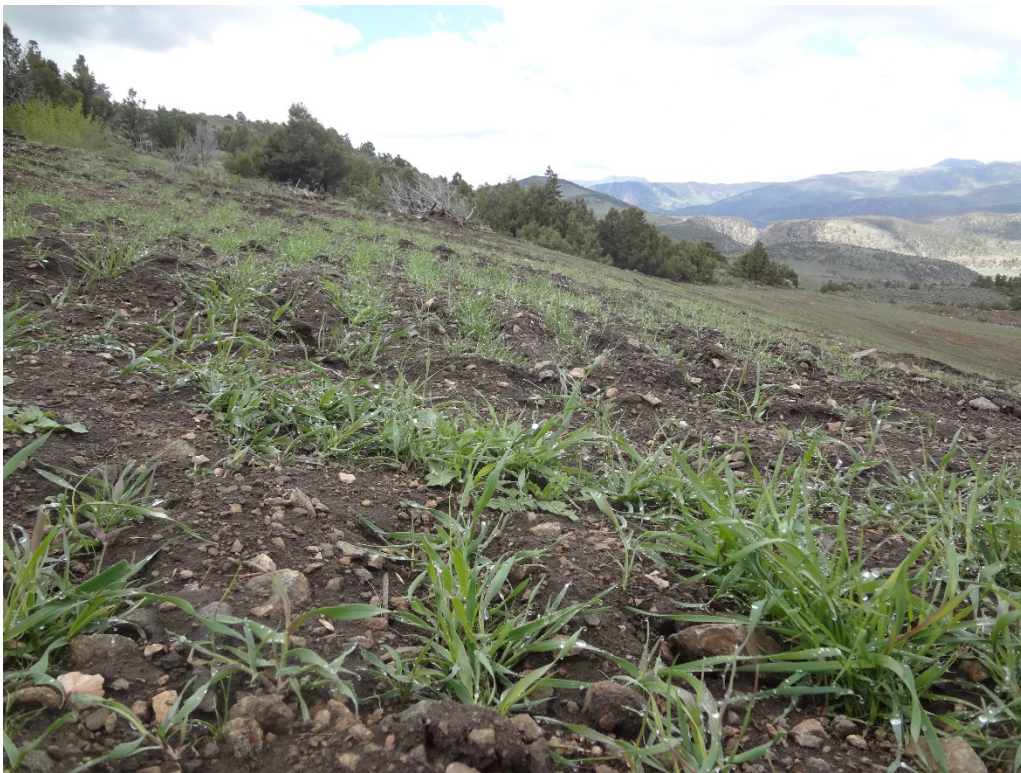
Since the last inspection, the south mining area was reclaimed by regrading and reseeding the area. The approved Reclamation Plan allows for slopes no greater than 2H:1V. The Division estimated the reclaimed slopes at 2.5H:1V to 3H:1V. The slope was contour graded to match the topography of the surrounding area. The slope was broadcast seeded in the fall of 2016. The grasses were establishing well on the dozer tracked slope. The pit floor contained a large product stockpile in the northern portion of the floor and other smaller stockpiles were observed on the pit floor.

View of reclamation grasses on the south slope looking west

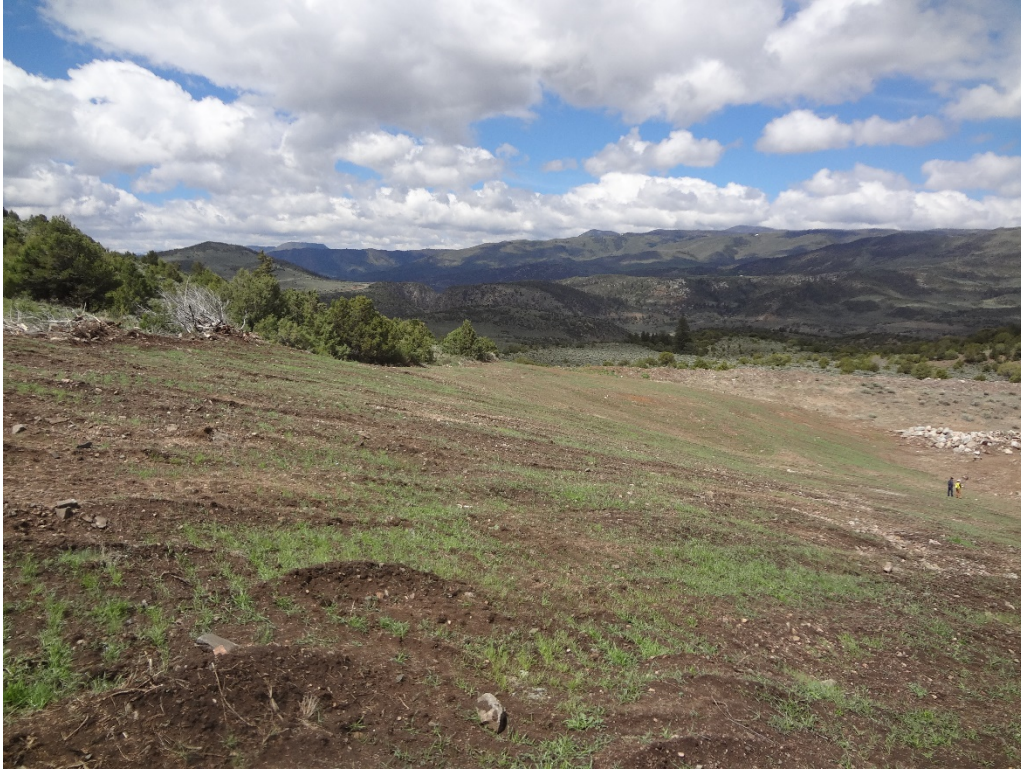
View of the south slope from the east side of the slope looking west

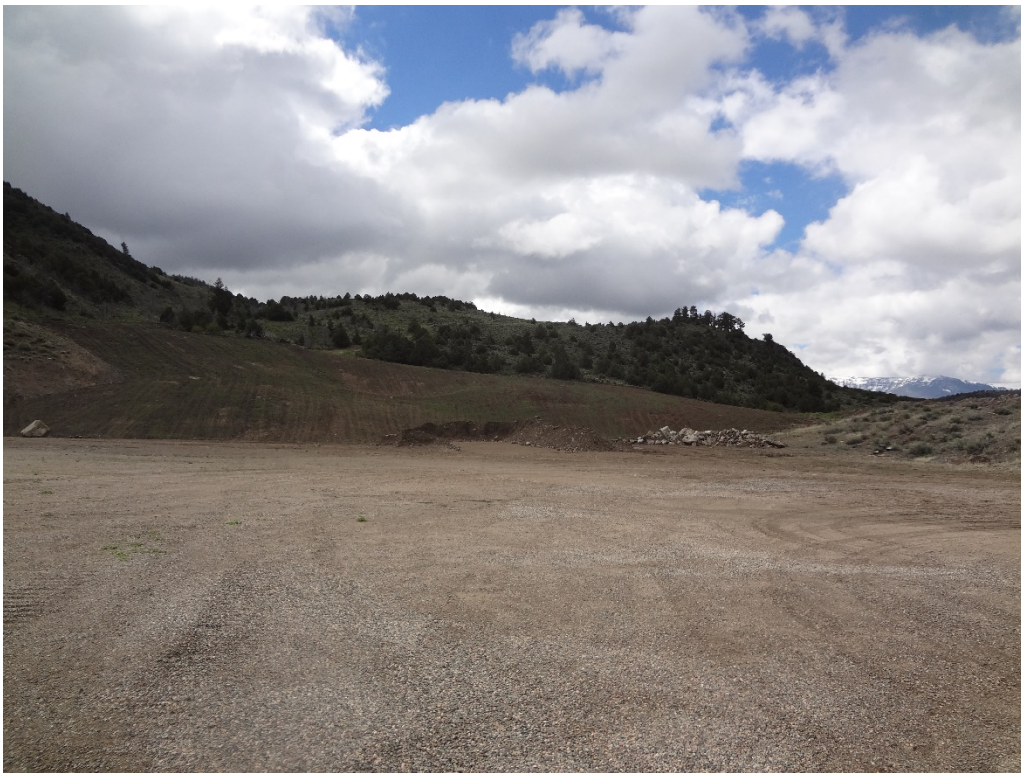
View of south slope and pit floor from middle of pit floor looking south
