MINERALS PROGRAM INSPECTION REPORT
PHONE: (303) 866-3567

MINE NAME: Priola Pit	MINE/PROSPECTING ID#: M-2007-087	MINERAL: Sand and gravel	COUNTY: Adams
INSPECTION TYPE: Monitoring	INSPECTOR(S): Jared L. Ebert	INSP. DATE: June 26, 2017	INSP. TIME: 10:00
OPERATOR: Albert Frei & Sons Inc.	OPERATOR REPRESENTATIVE: Ben Frei	TYPE OF OPERATION: 112c - Construction Regular Operation	
REASON FOR INSPECTION: Normal I&E Program	BOND CALCULATION TYPE: Partial Bond	BOND AMOUNT: \$77,000.00	
DATE OF COMPLAINT: NA	POST INSP. CONTACTS: None	JOINT INSP. AGENCY: None	
WEATHER: Clear	INSPECTOR'S SIGNATURE:

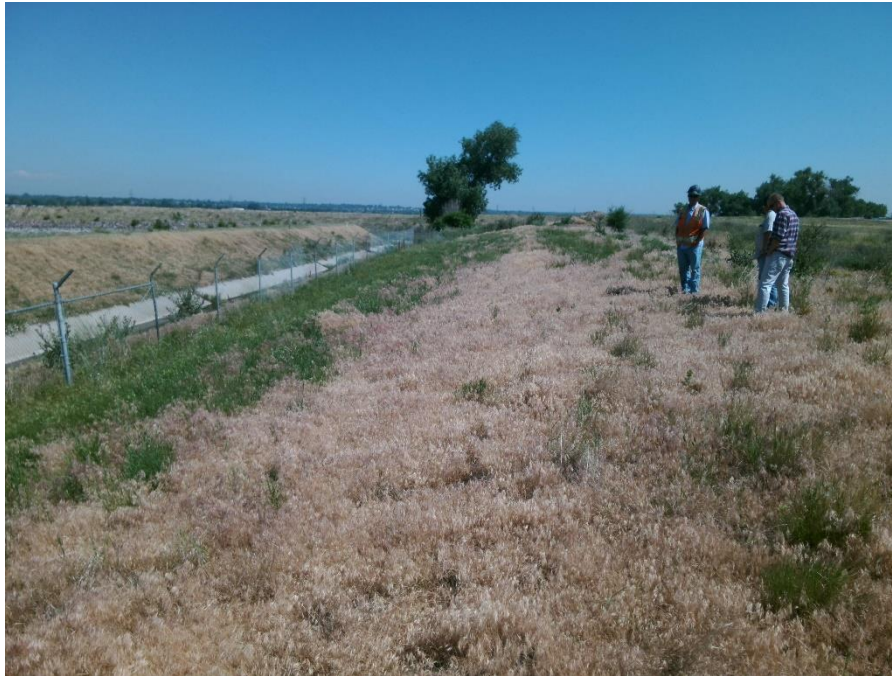
Figure 2. Southwest fill slope. From the south end looking north.

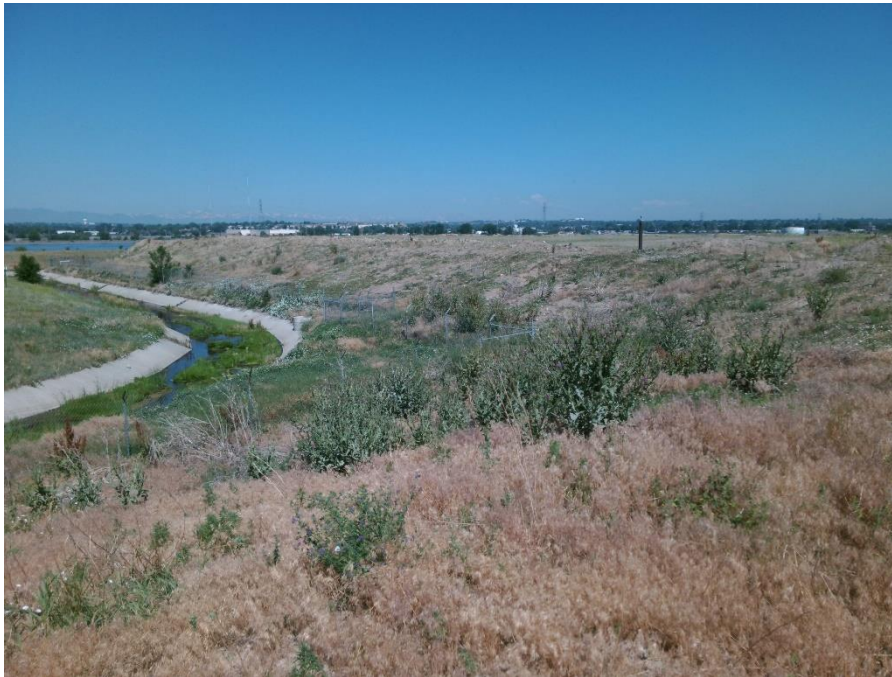
Figure 3. North central corner looking northwest.

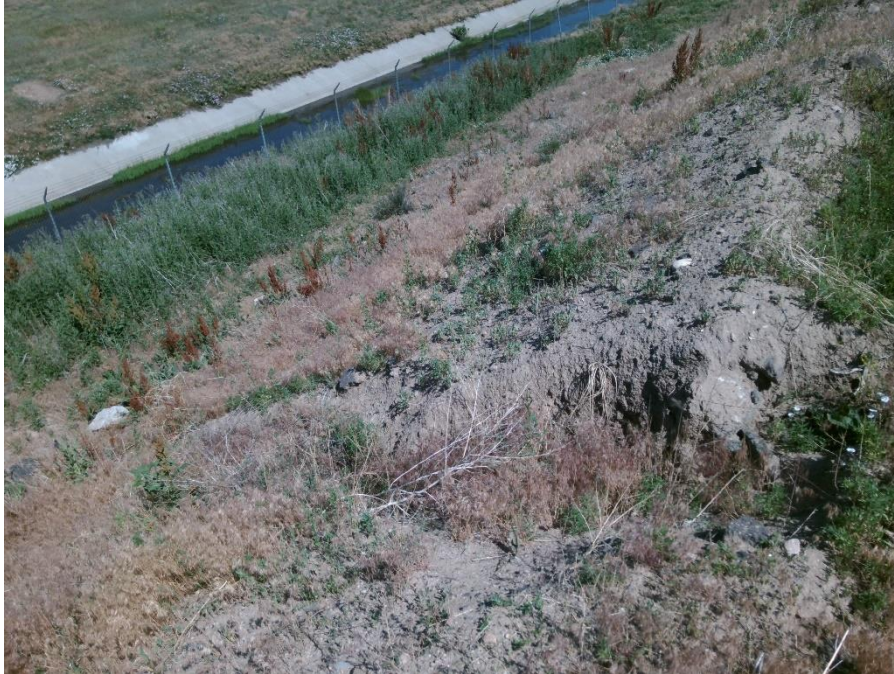
The side slopes of the backfilled embankment were observed. The side slopes appeared to be graded to a 3H:1V slope with the exception of one portion of the embankment on the western most end of the northern portion of the site. The slope at this location appears to be steeper than a 3H:1V slope and appeared to be closer to a 2H:1V slope. Several erosion gullies were observed on the slopes of the embankment that will need to be repaired and stabilized.

Several rills and gullies were noted along the embankment slopes that will need to be repaired and the area stabilized.

Figure 4. Erosion gully on fill embankment.

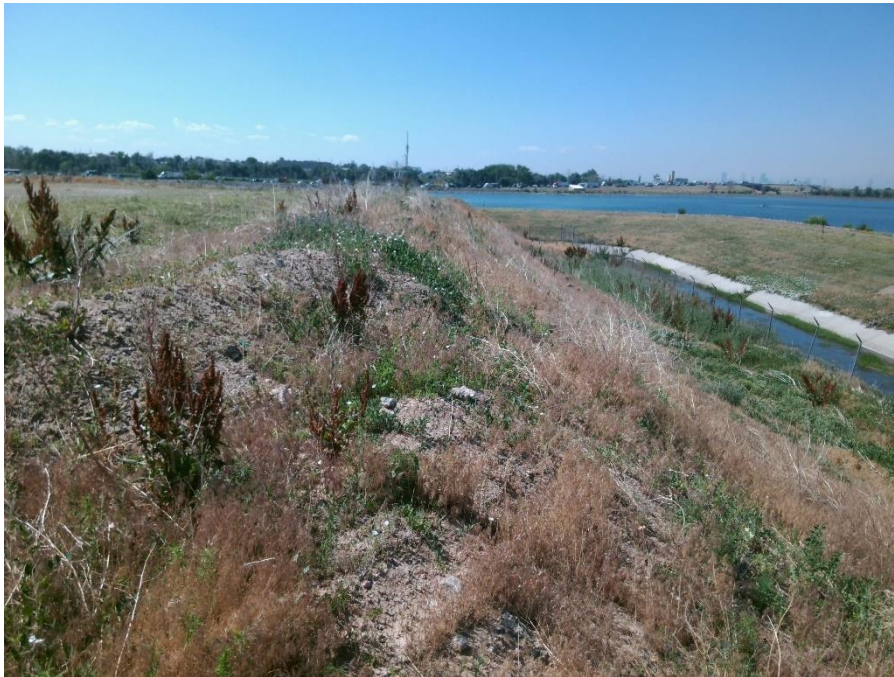
Figure 5. Western most fill slopes on the north side of the site. Greater than 3H:1V slope.

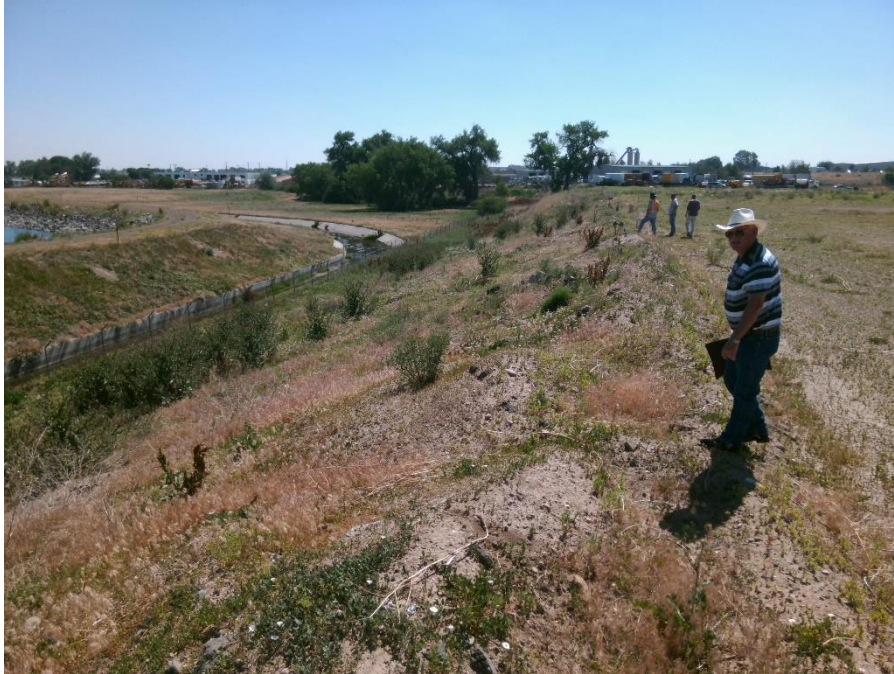
Figure 6. Northern most fill slope. From the west side looking east.

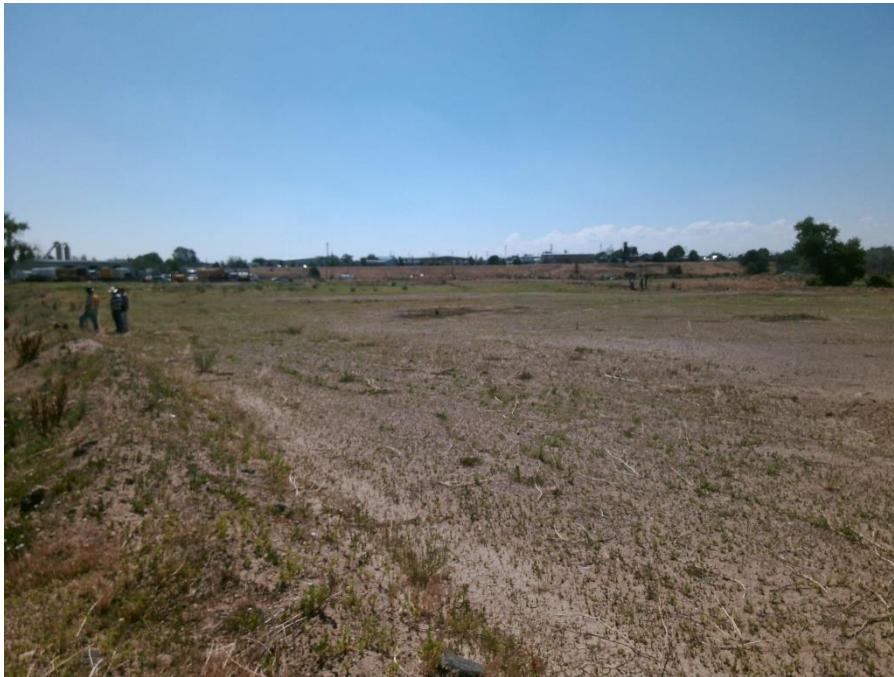
Figure 7. From the northwest end of the site looking southeast.

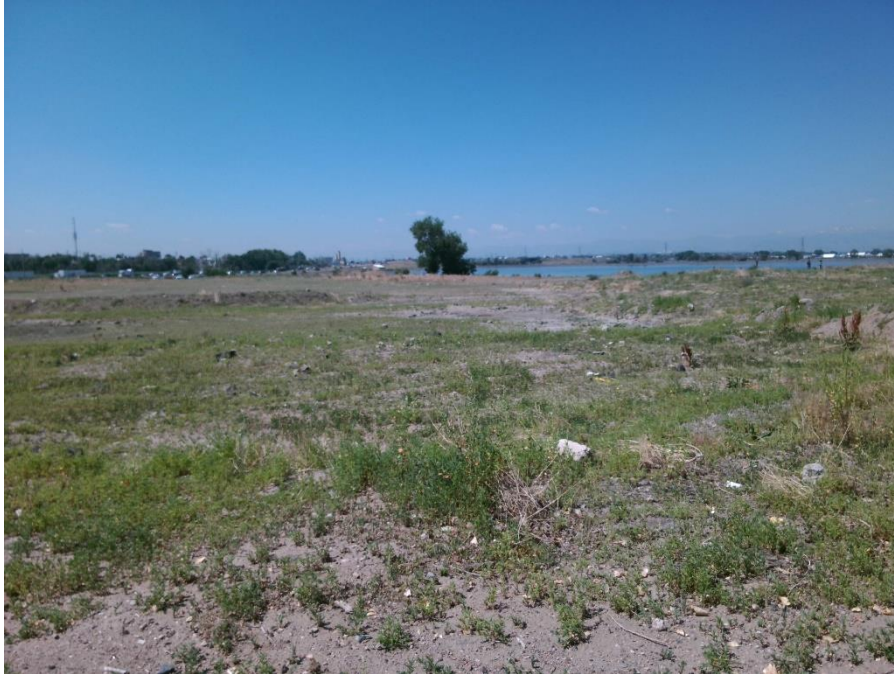
Figure 8. From the north end of the site looking south.
