## MINERALS PROGRAM INSPECTION REPORT

<b>MINE NAME:</b> Red Jasper Granite	<b>MINE/PROSPECTING ID#:</b> M-1982-200	<b>MINERAL:</b> Granite	<b>COUNTY:</b> Teller
<b>INSPECTION TYPE:</b> Monitoring	<b>INSPECTOR(S):</b> Elliott R. Russell	<b>INSP. DATE:</b> April 19, 2017	<b>INSP. TIME:</b> 12:00
<b>OPERATOR:</b> Colorado Quarries Inc	<b>OPERATOR REPRESENTATIVE:</b> John Ready	<b>TYPE OF OPERATION:</b> 110c - Construction Limited Impact

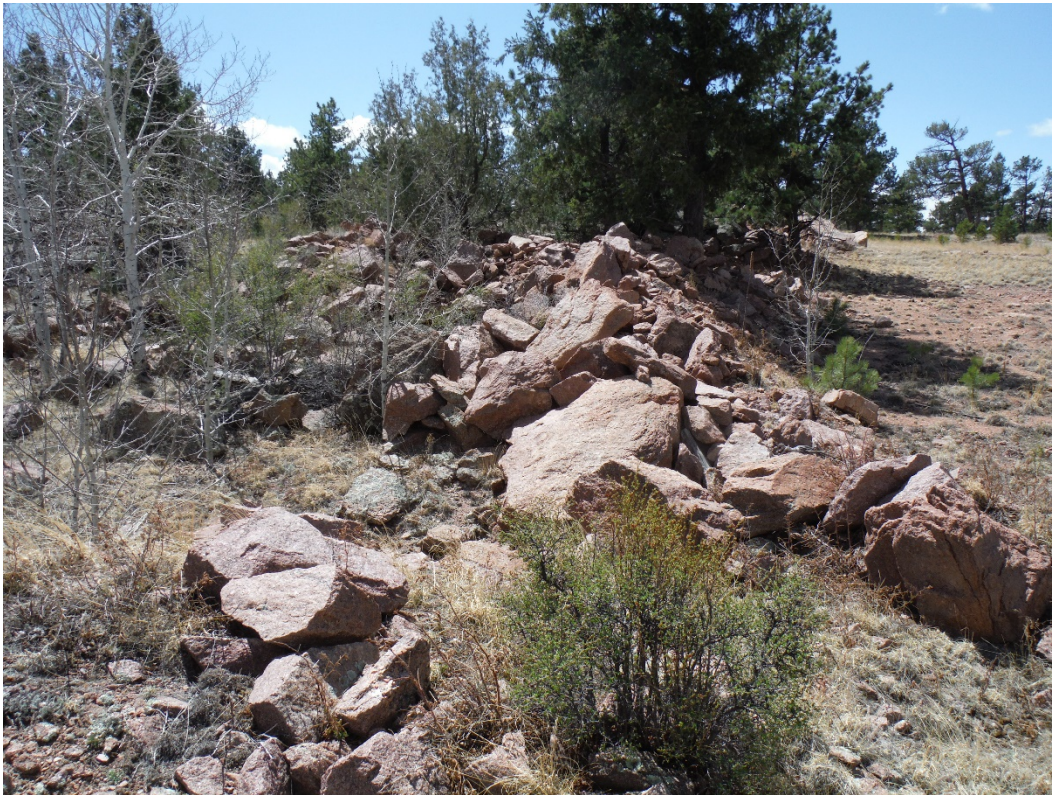
Excess Spoil and Development Waste: Various stockpiles of what appeared to be discarded granite where located around the site (see **Photos 1-3**). Although it is not discussed in the permit documents, this material, if not used as product, would likely be used as backfill against final highwall configurations.

**Photo 1.** Stockpiled material located southeast of the south quarry; looking south.

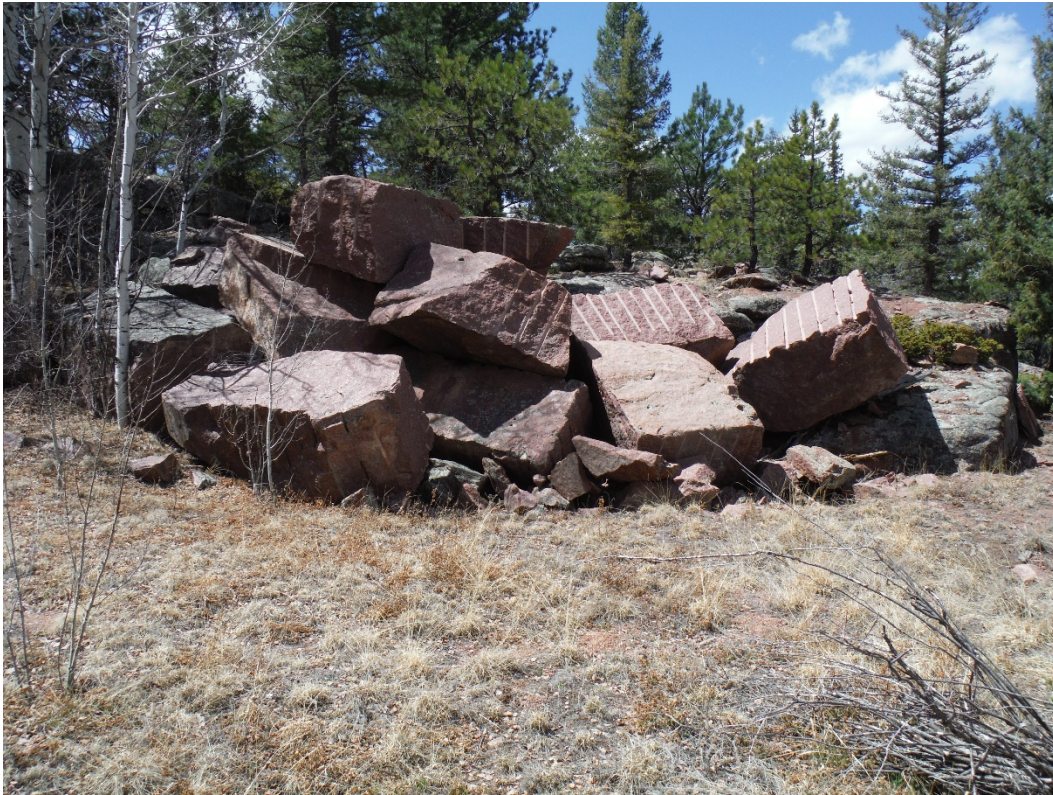
**Photo 2.** Stockpiled material located west of the north quarry; looking west.

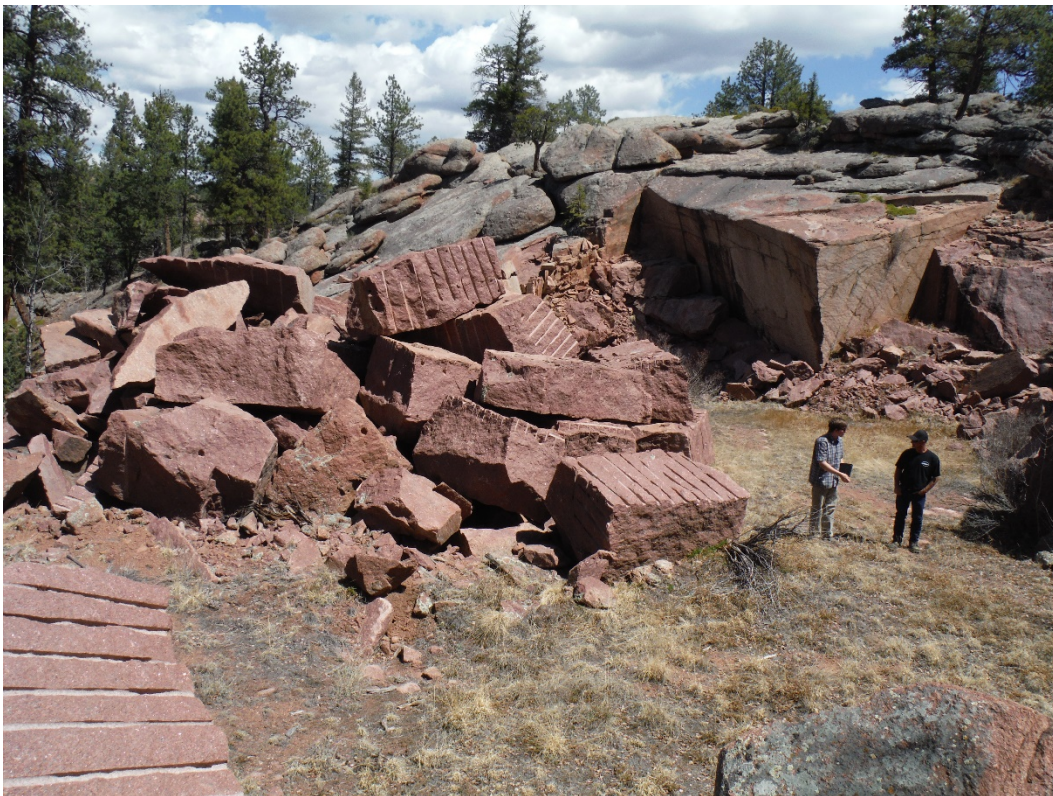
**Photo 3.** Stockpiled material located at the north quarry; looking northeast.

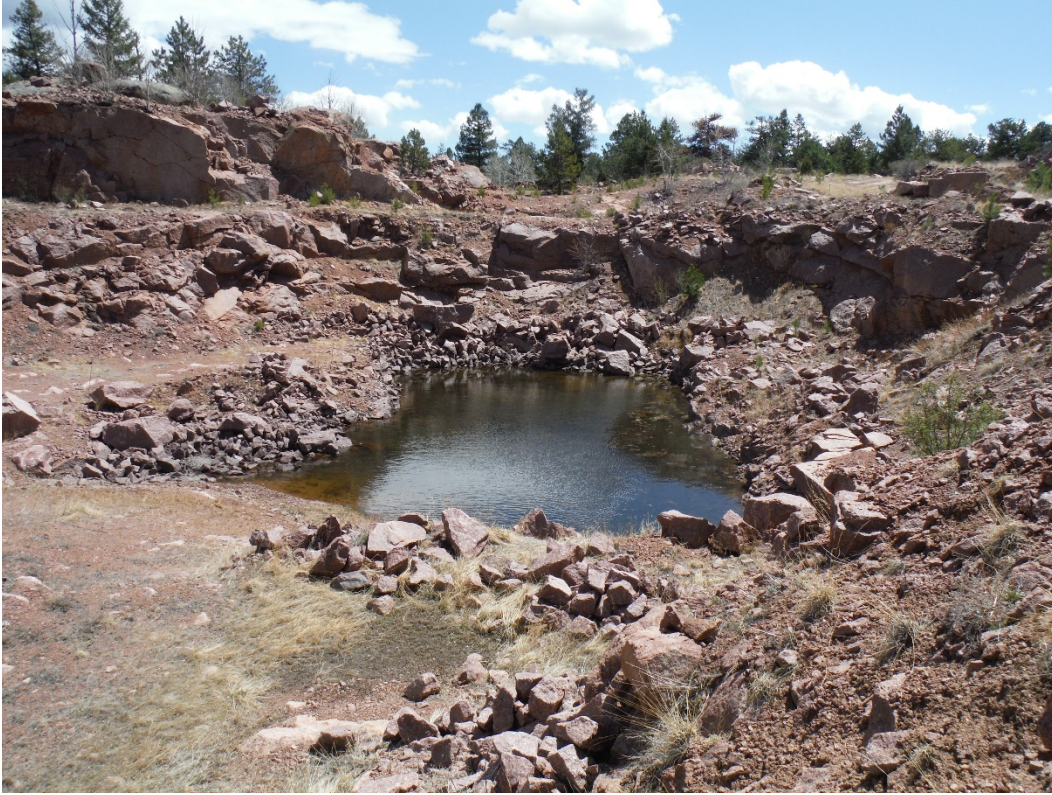
**COMPLIANCE PROBLEM #2:** The site is not in compliance with applicable Colorado water laws pursuant to Rule 3.1.6(1)(a). Stormwater is intercepted at the site and not being released to the stream system within 72 hours.

Hydrologic Balance: Standing water was observed in the sediment pond, approximately 2,100 sq. ft. in size, located on the south quarry's lower pad level (see **Photo 4 and 5**). In addition, evidence of recent standing water was observed on the upper pad level of the south quarry (see **Photo 6**). After a review of google earth imagery and past inspection report photographs, the Division has determined the standing water in these two locations is a persistent issue which must be resolved before proceeding with TC-02. The Division has cited this as Compliance Problem #2 on page two of this report.

**Photo 4.** Standing water located on the lower pad of the south quarry; looking southeast.

**CORRECTIVE ACTIONS:** The operator shall demonstrate the site is in compliance with the Division of Water Resources (DWR) by the corrective action date.

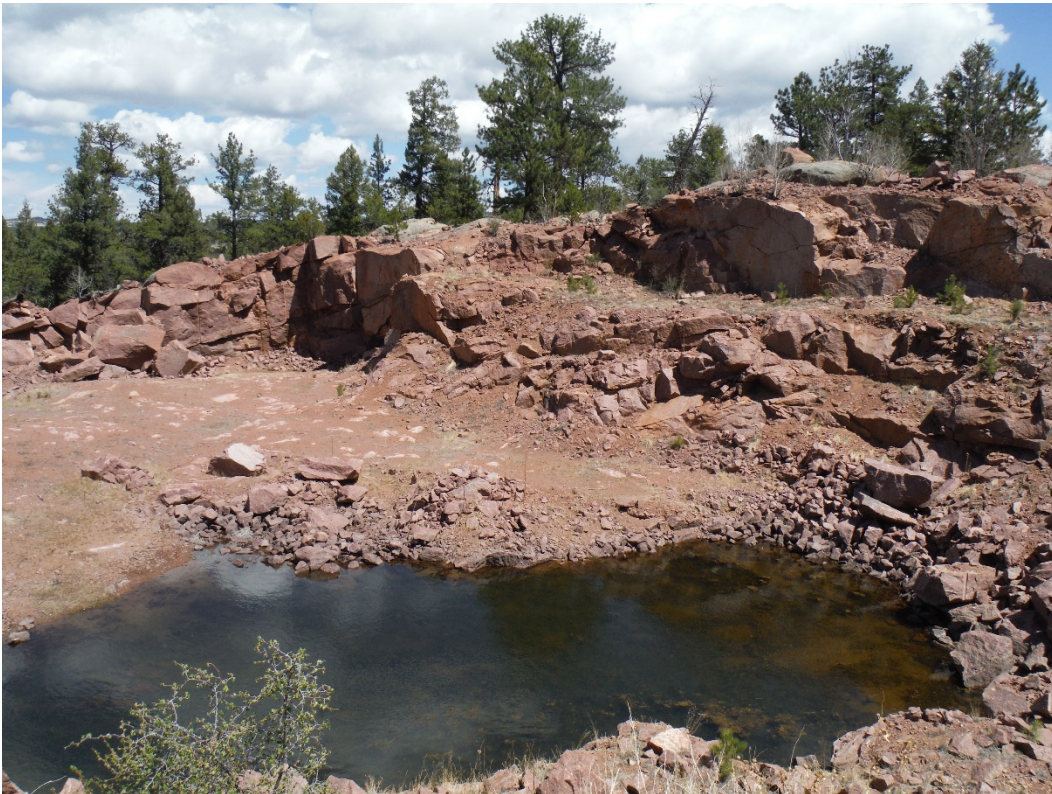
**Photo 5.** Standing water located on the lower pad of the south quarry; looking north.

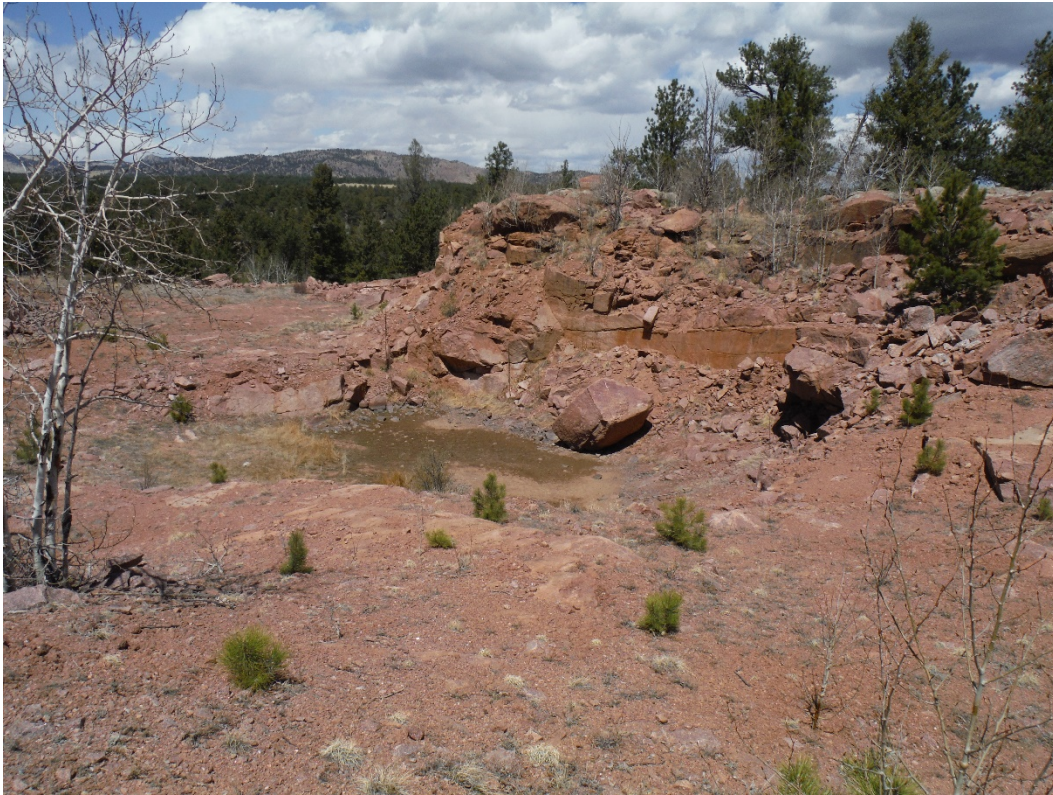
**Photo 6.** Evidence of recent standing water located on the upper pad of the south quarry; looking northwest.

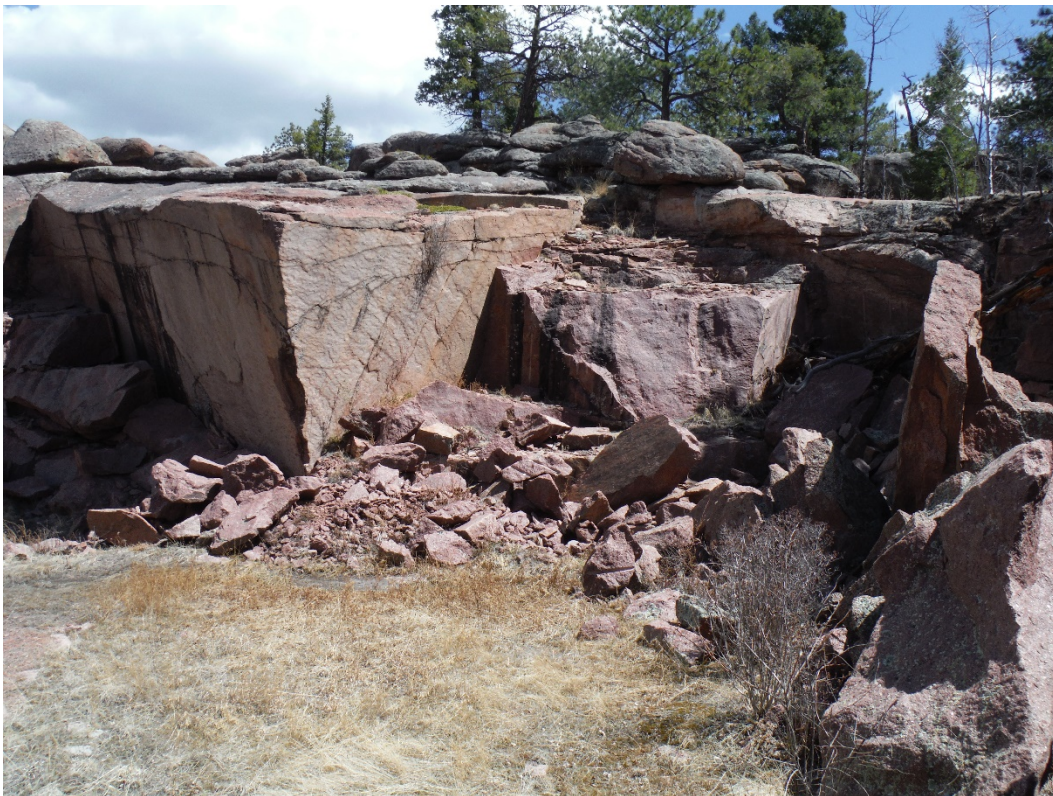
General Compliance with Mine Plan: As discussed above, the site consists of two separate mining areas referenced within this report as the north quarry and south quarry. However, the permit file describes only a single rock outcrop to be mined. Based on limited permit maps and possibly incorrect permit markers locations, the permitted operation was unclear and will need to be revised. This has been cited as Compliance Problem #3 on page two of this report. The near vertical high walls of both the north and south quarries were estimated to vary between 15 and 20 feet in height and contained fractures and loose rock (see **Photos 7 and 8**).

**Photo 7.** Highwall at the north quarry; looking east.

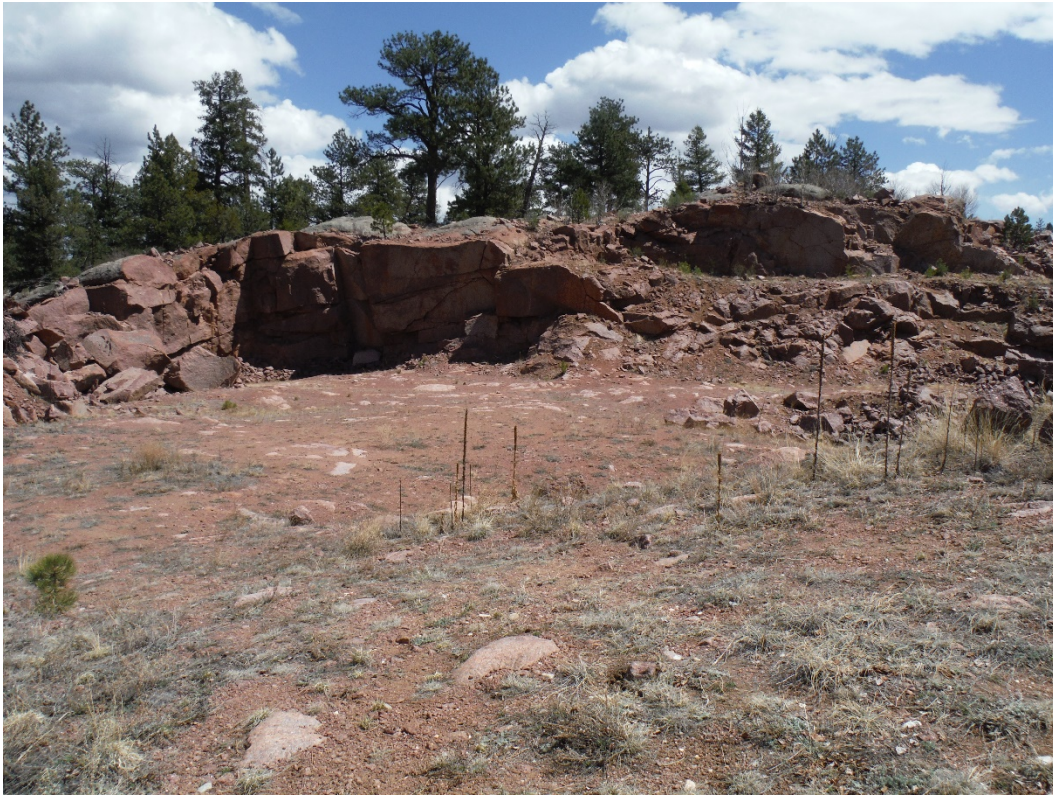
**Photo 8.** Highwall (benched on right portion) at the north quarry; looking east.

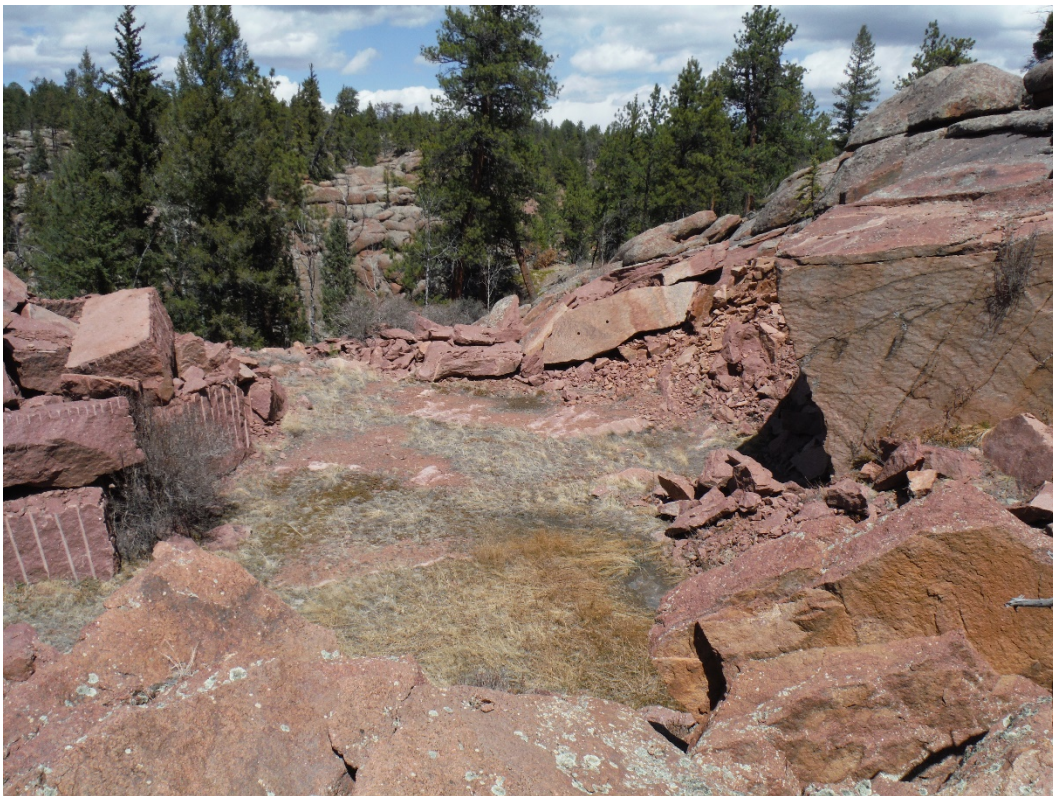
Revegetation: The north quarry contained well established vegetation on the quarry pad (see **Photo 9**), due to a long period of inactivity, while very little revegetation was observed at the more recently active south quarry. No noxious weeds were observed at the site.

**Photo 9.** Portions of the vegetated north quarry pad; looking north.

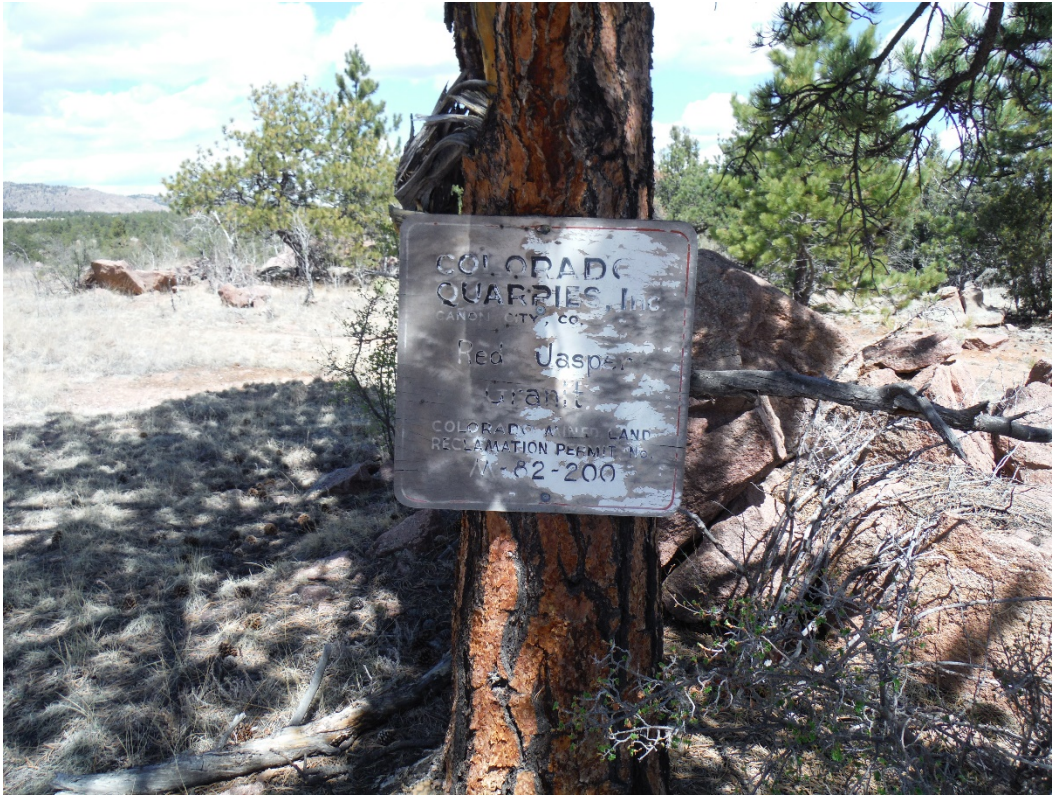
**COMPLIANCE PROBLEM #4:** The mine identification sign needs to be refreshed.

Signs and Markers: The permit sign was posted along the access road just south of the south quarry (see **Photo 10**). The sign is worn and faded and will need to be replaced in accordance with Rule 3.1.12(1). This has been cited as Compliance Problem #4 on page two of this report. To achieve the intent of the mine identification sign, the Division recommends the Operator post an additional mine identification sign along County Road 102 where the private access road starts.

**Photo 10.** Permit identification sign located along the access road south of the south quarry; looking northeast.

**CORRECTIVE ACTIONS:** The operator must post a sign at the entrance to the mine site which shall be clearly visible from the access road and specify the following:

- the name of the operator
- the permit number
- indicate that a reclamation permit for the operation has been issued by the Colorado Mined Land Reclamation Board

The operator shall submit photo documentation of a posted mine identification sign by the corrective action date.
