**COLORADO**Division of Reclamation,
Mining and Safety

MINERALS PROGRAM INSPECTION REPORT**PHONE: (303) 866-3567**

MINE NAME: Pitch Project	MINE/PROSPECTING ID#: M-1977-004	MINERAL: Uranium	COUNTY: Saguache
INSPECTION TYPE: Monitoring	INSPECTOR(S): Dustin M. Czapla	INSP. DATE: June 14, 2017	INSP. TIME: 08:30
OPERATOR: Homestake Mining Company	OPERATOR REPRESENTATIVE: Dale Davis	TYPE OF OPERATION: 112d-1 - Designated Mining Operation	
REASON FOR INSPECTION: Normal I&E Program	BOND CALCULATION TYPE: None	BOND AMOUNT: \$2,263,000.00	
DATE OF COMPLAINT: NA	POST INSP. CONTACTS: None	JOINT INSP. AGENCY: None	
WEATHER: Clear	INSPECTOR'S SIGNATURE:

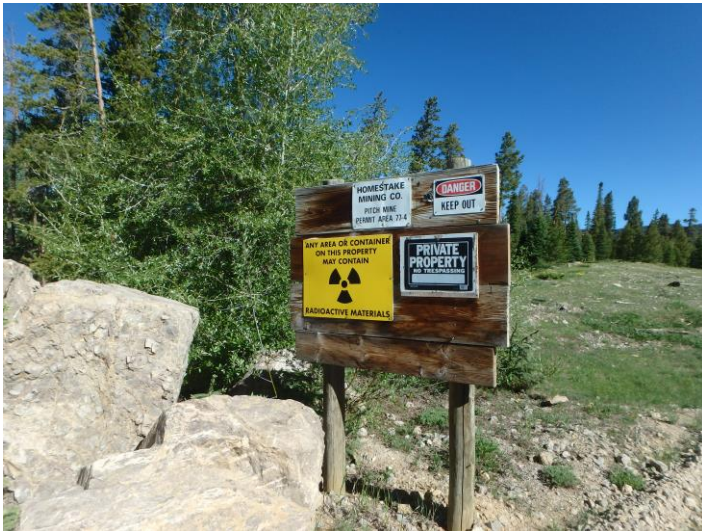
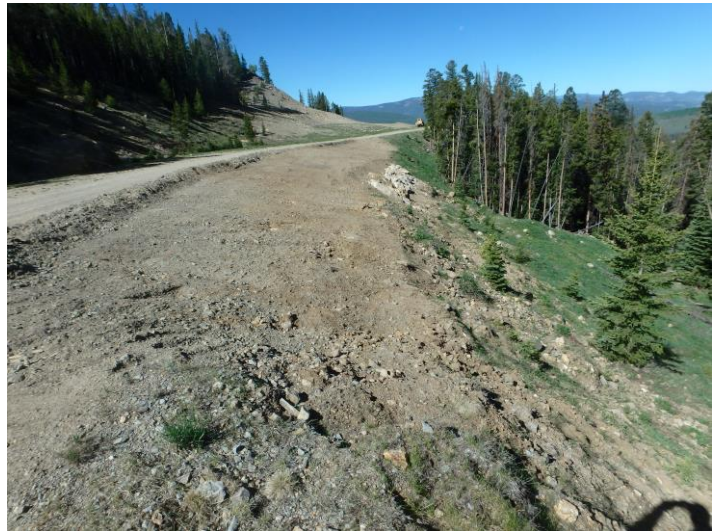
Roads: No problems were noted with any of the internal roads. The roads are well maintained. The repair work completed in 2015 on the failed portion of the access road appears stable. The repair area has been seeded, but vegetation is not yet well established.

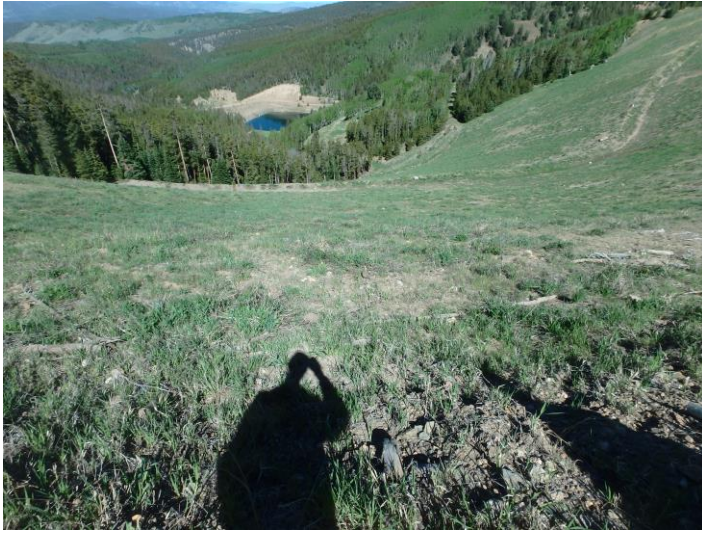
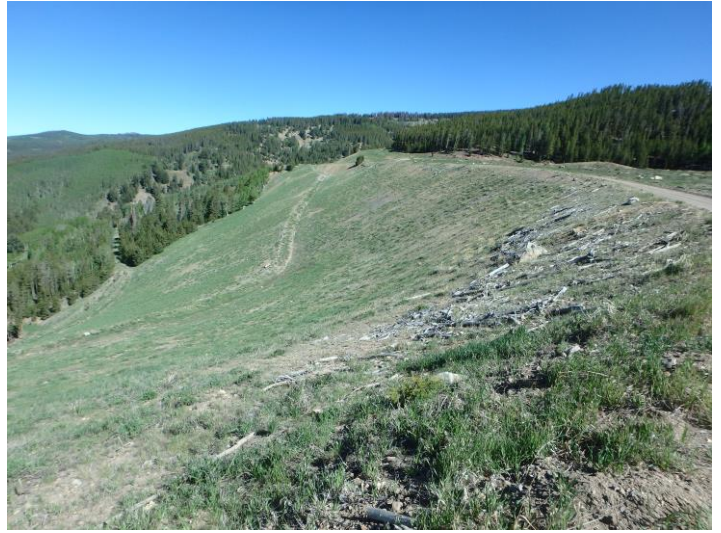
Tie Camp Rock Dump: The slope below the access road still appears stable. Vegetation is well established on the slope.

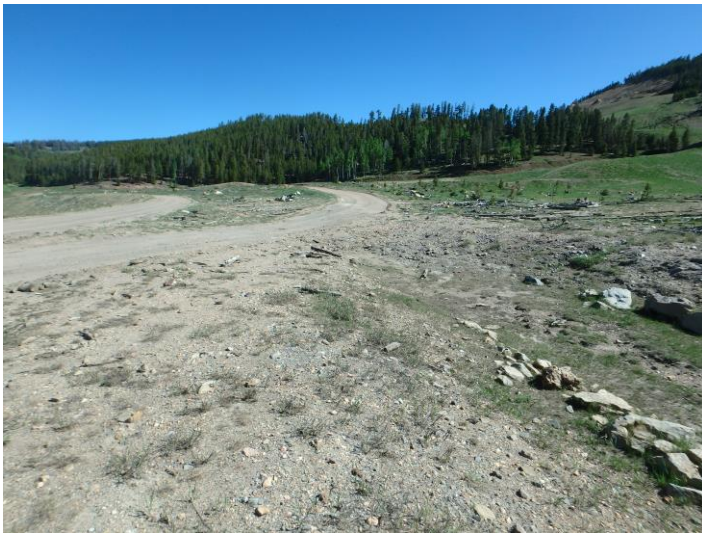
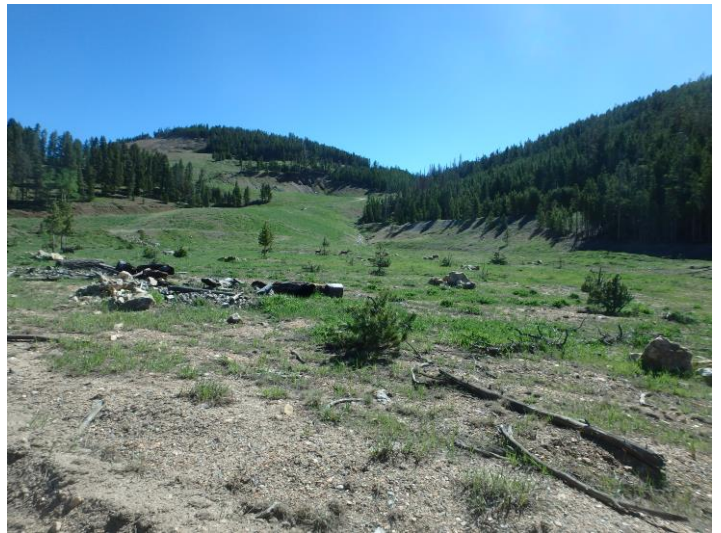
Tie Camp Disposal Cell: Slopes are stable in this area and vegetation is well established. Several mule deer were feeding in this area during the inspection.

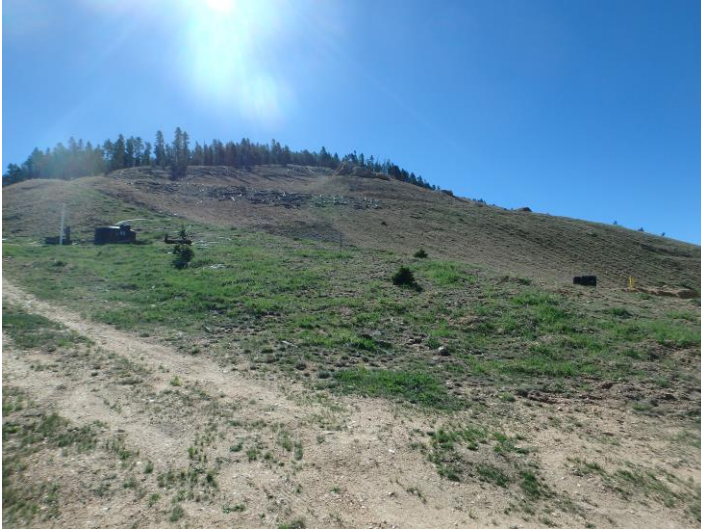
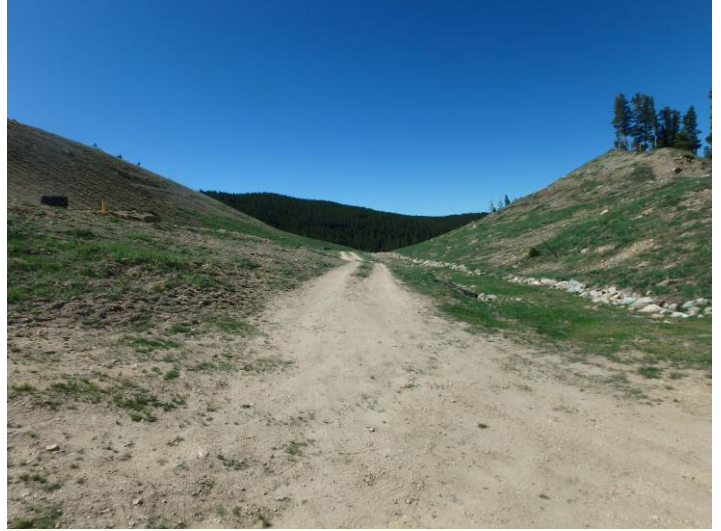
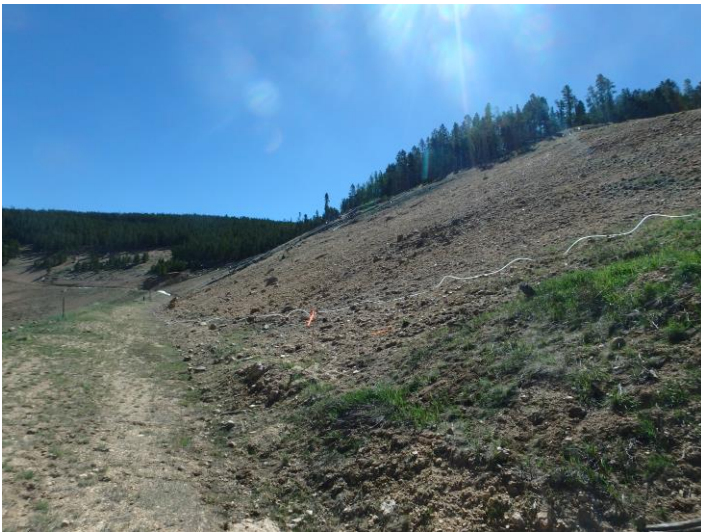
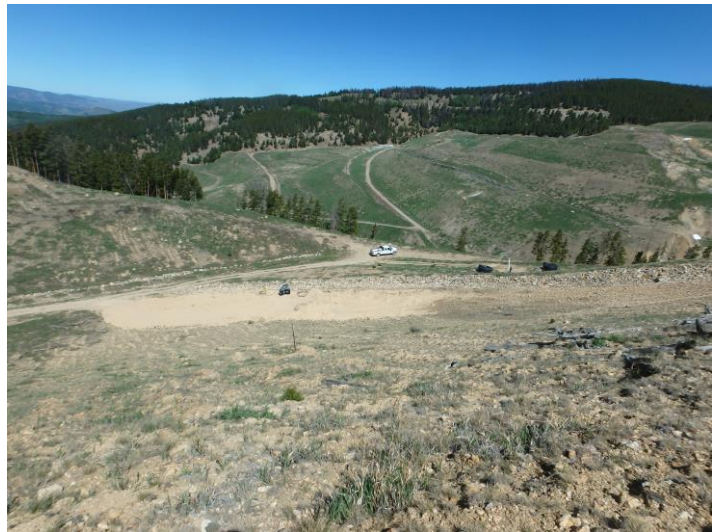
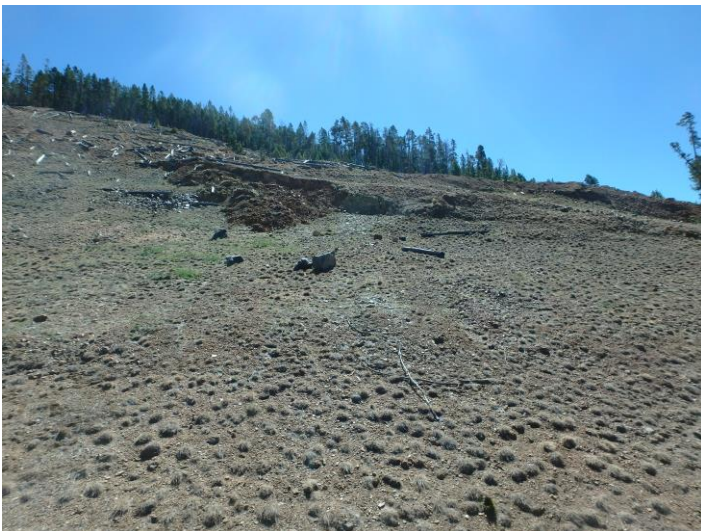
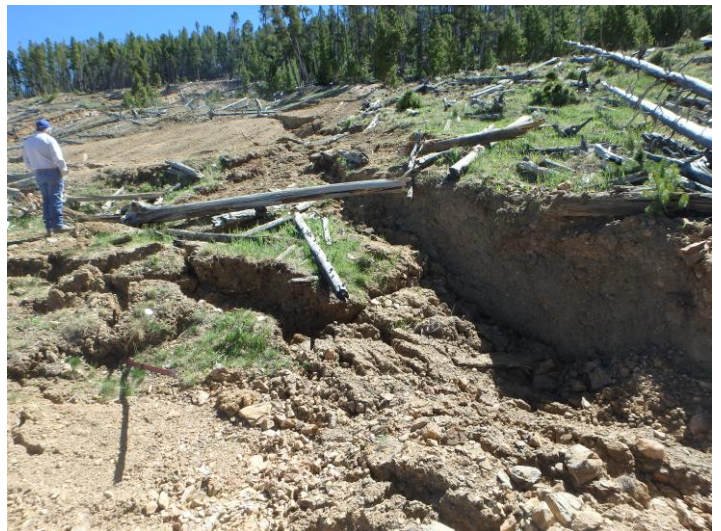
South Pit: The phosphate injection program continues in this area. Several more boreholes, as approved through TR-8, are to be drilled this season in this area. There has been some slope failure in the upper part of the south pit area. The failure affects approximately 0.75 acres. This is an area of recurring failure, so the operator plans to drill a borehole in the slope this season in order to better understand the failure so that a more permanent fix can be developed. The failure poses no risk to public safety.

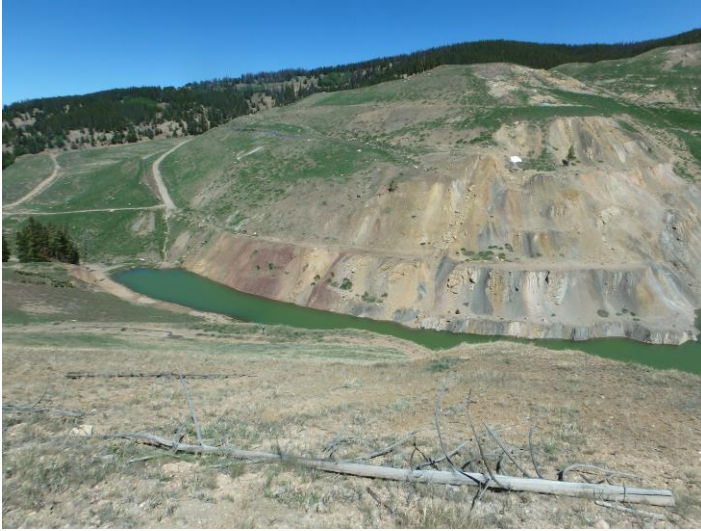
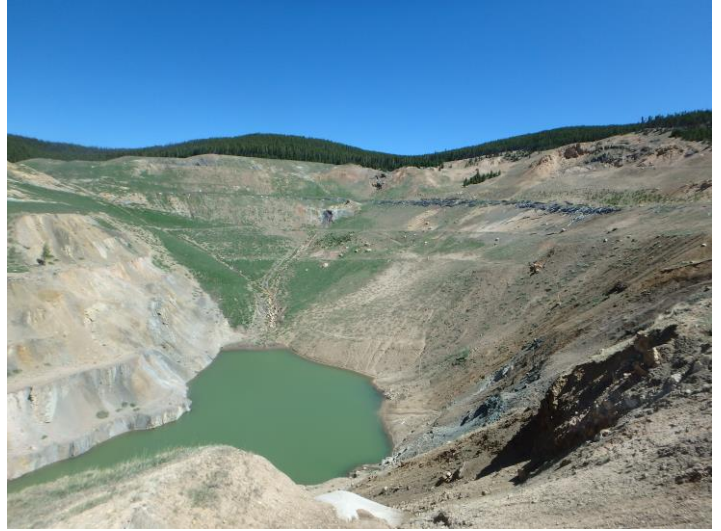
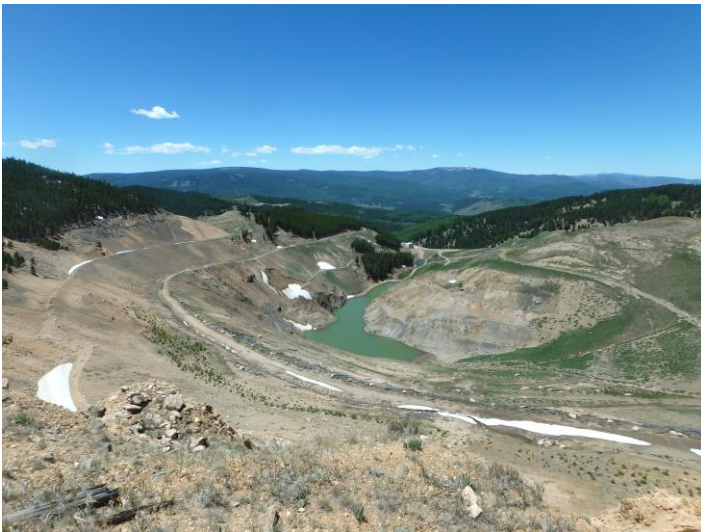
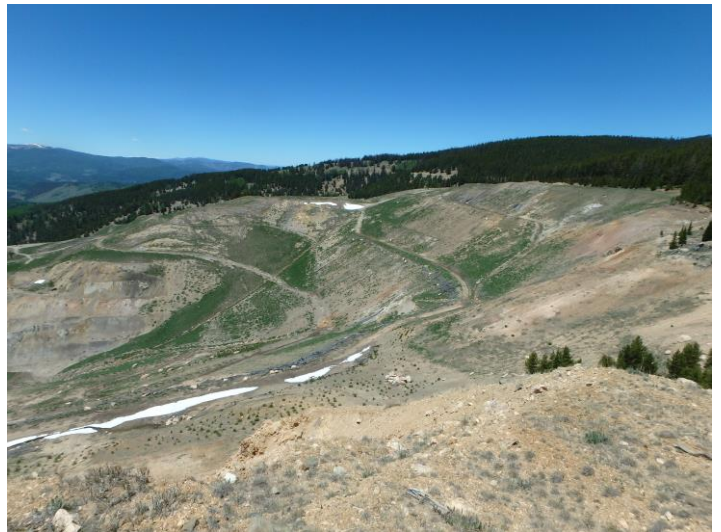
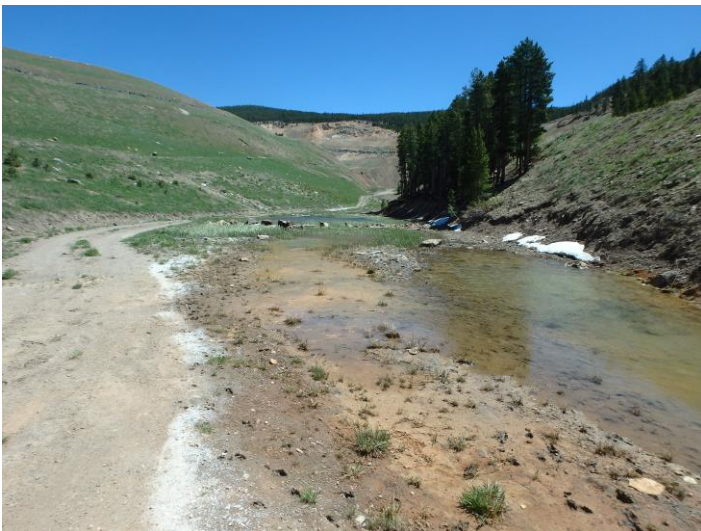
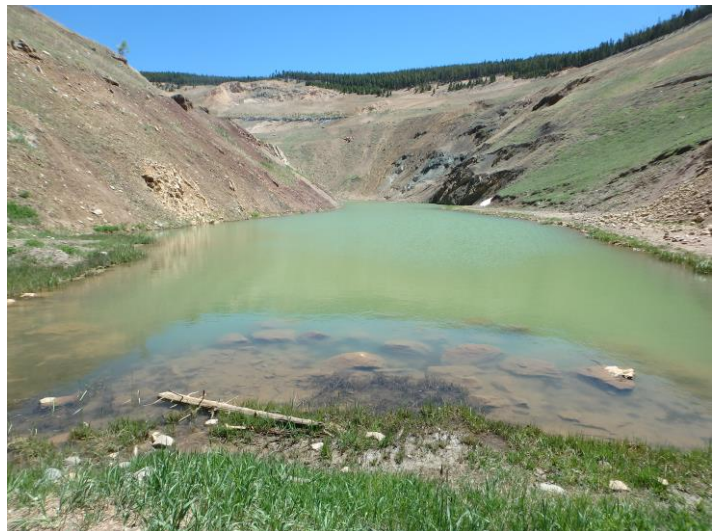
North Pit: Slope movement above the North Pit continues to be monitored. A final reclamation/stabilization plan is not yet developed for this area. Efforts are ongoing to control erosion and drainage on the east wall of the north pit.

Discharge from the North Pit Lake flows through the valve and culvert as designed. The Pinnacle Portal continues to discharge and flow is measured through a v-notch weir. The discharge reports to a marsh area above the facilities shop building.

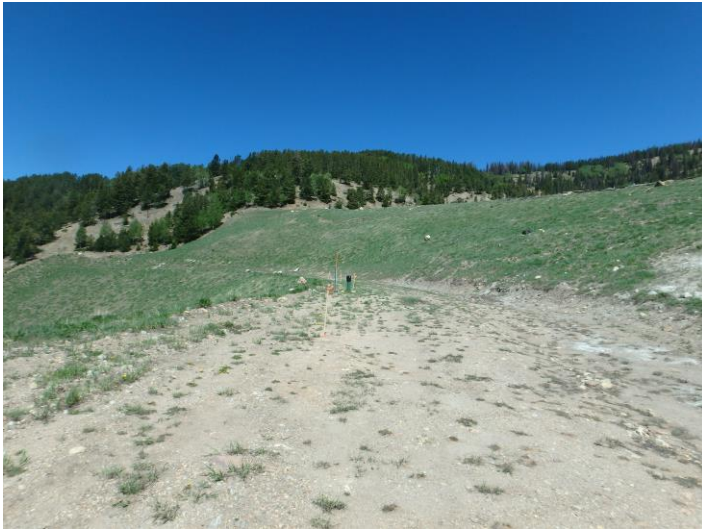
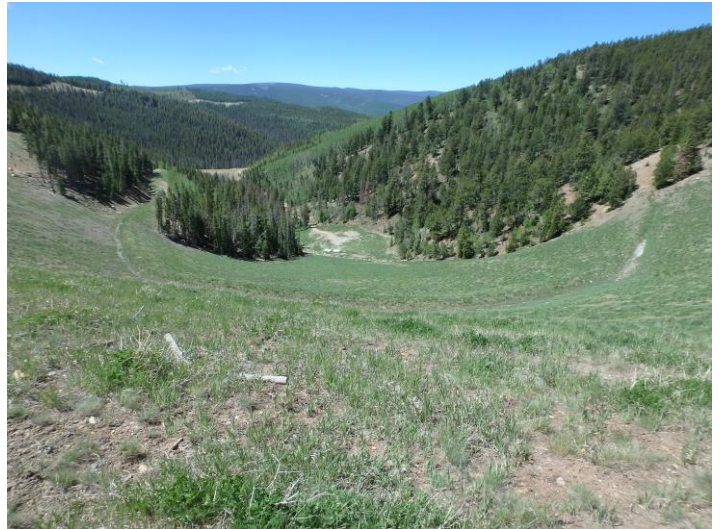
Indian Rock Dump: Slopes appear stable and vegetation is becoming well established. No significant erosional features were noted. Additional drilling will take place on the slope this season as part of the phosphate injection program. Inclinometers are to be installed on the slope as well, as proposed in TR-8.

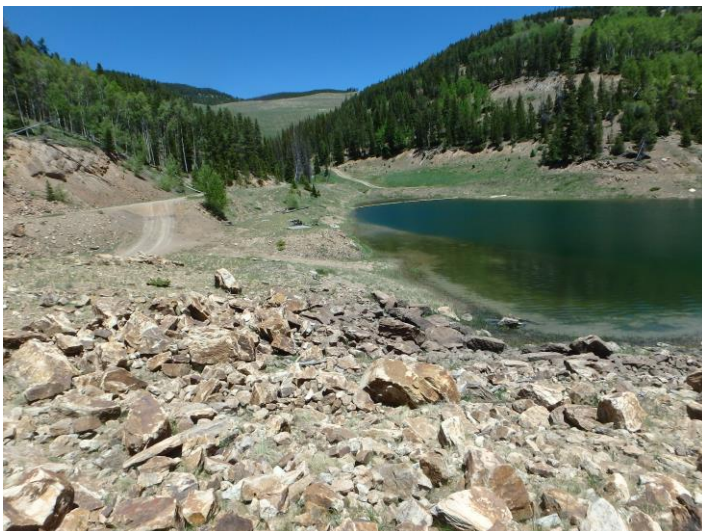
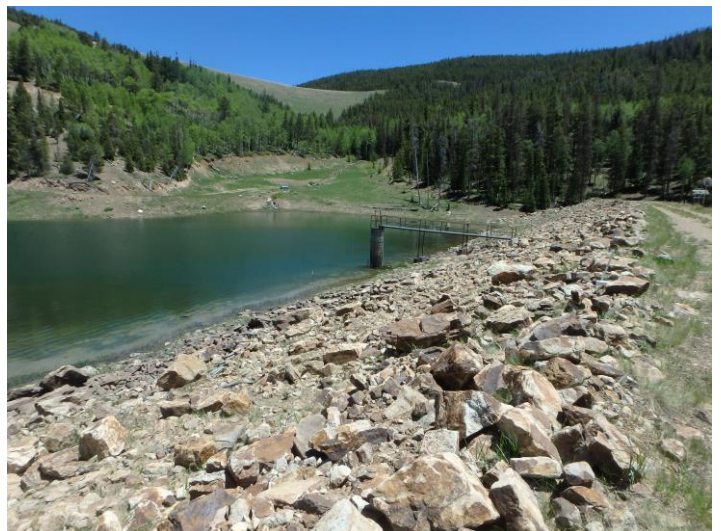
Sediment Pond: The sediment pond appears functional and the pond slopes appear stable. A surface filter boom placed at the upper end of the pond is maintained and still in place. No seepage or stability concerns were noted around the dam.
