Re: Garrett Pit, Mine ID# M-1978-271
Field Inspection, May 15, 2017

MINERALS PROGRAM INSPECTION REPORT**PHONE: (303) 866-3567**

MINE NAME: Garrett Pit	MINE/PROSPECTING ID#: M-1978-271	MINERAL: Gravel	COUNTY: Conejos
INSPECTION TYPE: Monitoring	INSPECTOR(S): Dustin M. Czaplá	INSP. DATE: May 15, 2017	INSP. TIME: 13:00
OPERATOR: Asphalt Gravel Products, Inc.	OPERATOR REPRESENTATIVE: Alonzo Salazar	TYPE OF OPERATION: 112c - Construction Regular Operation

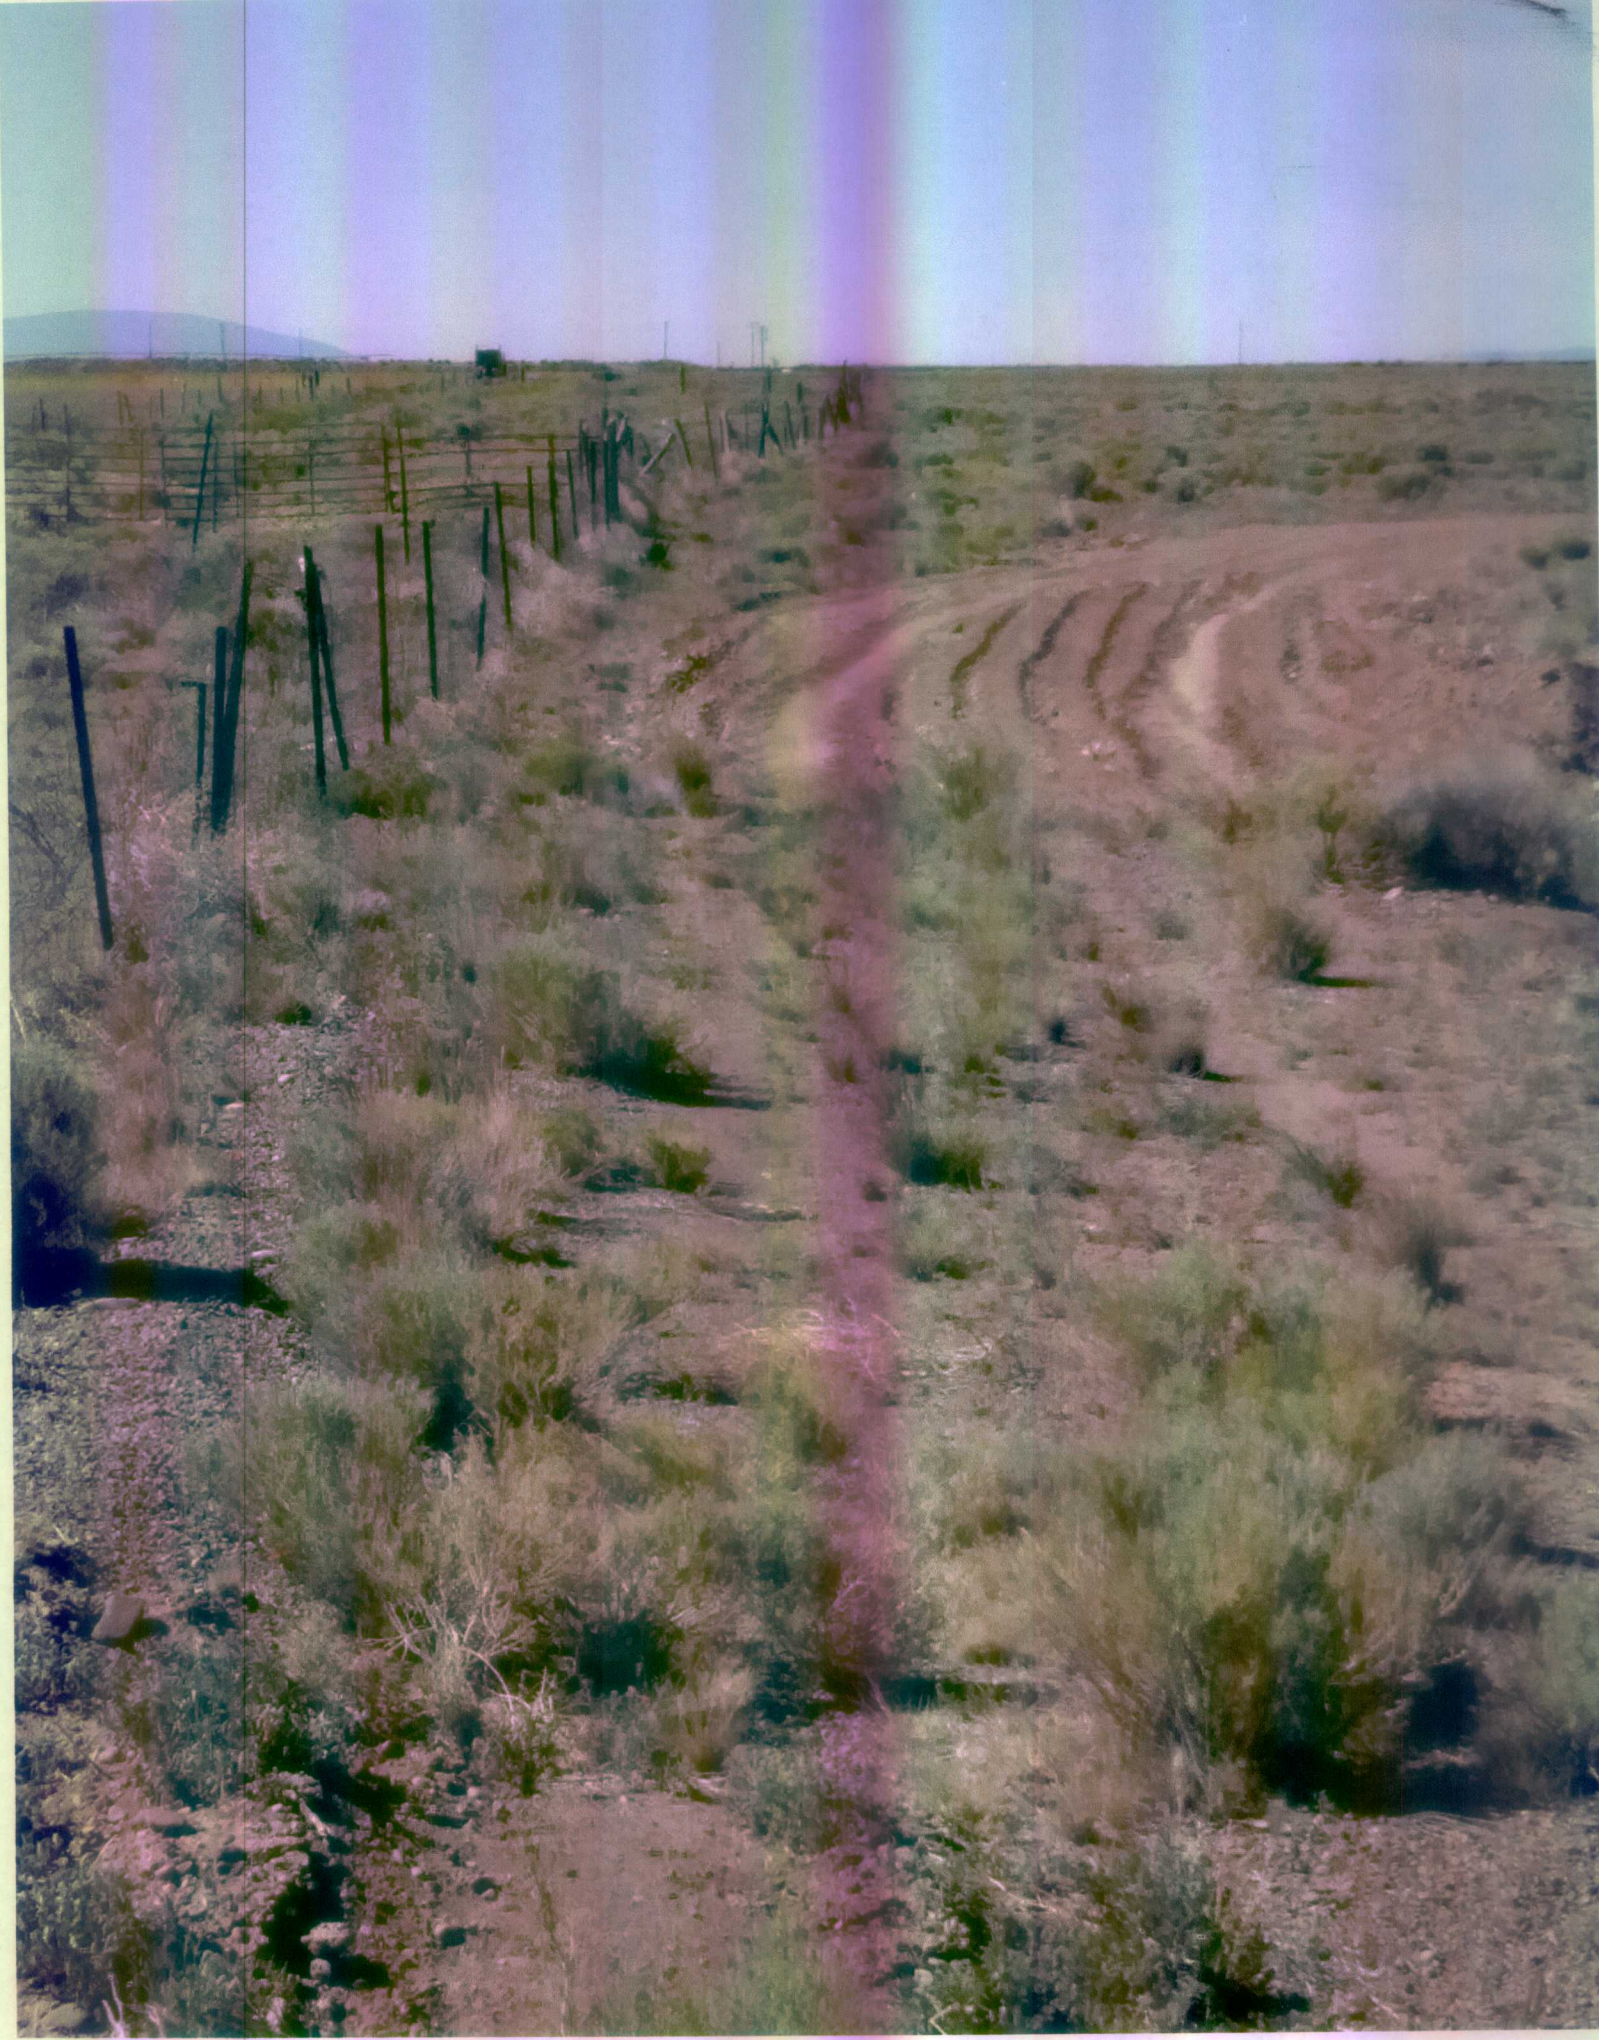
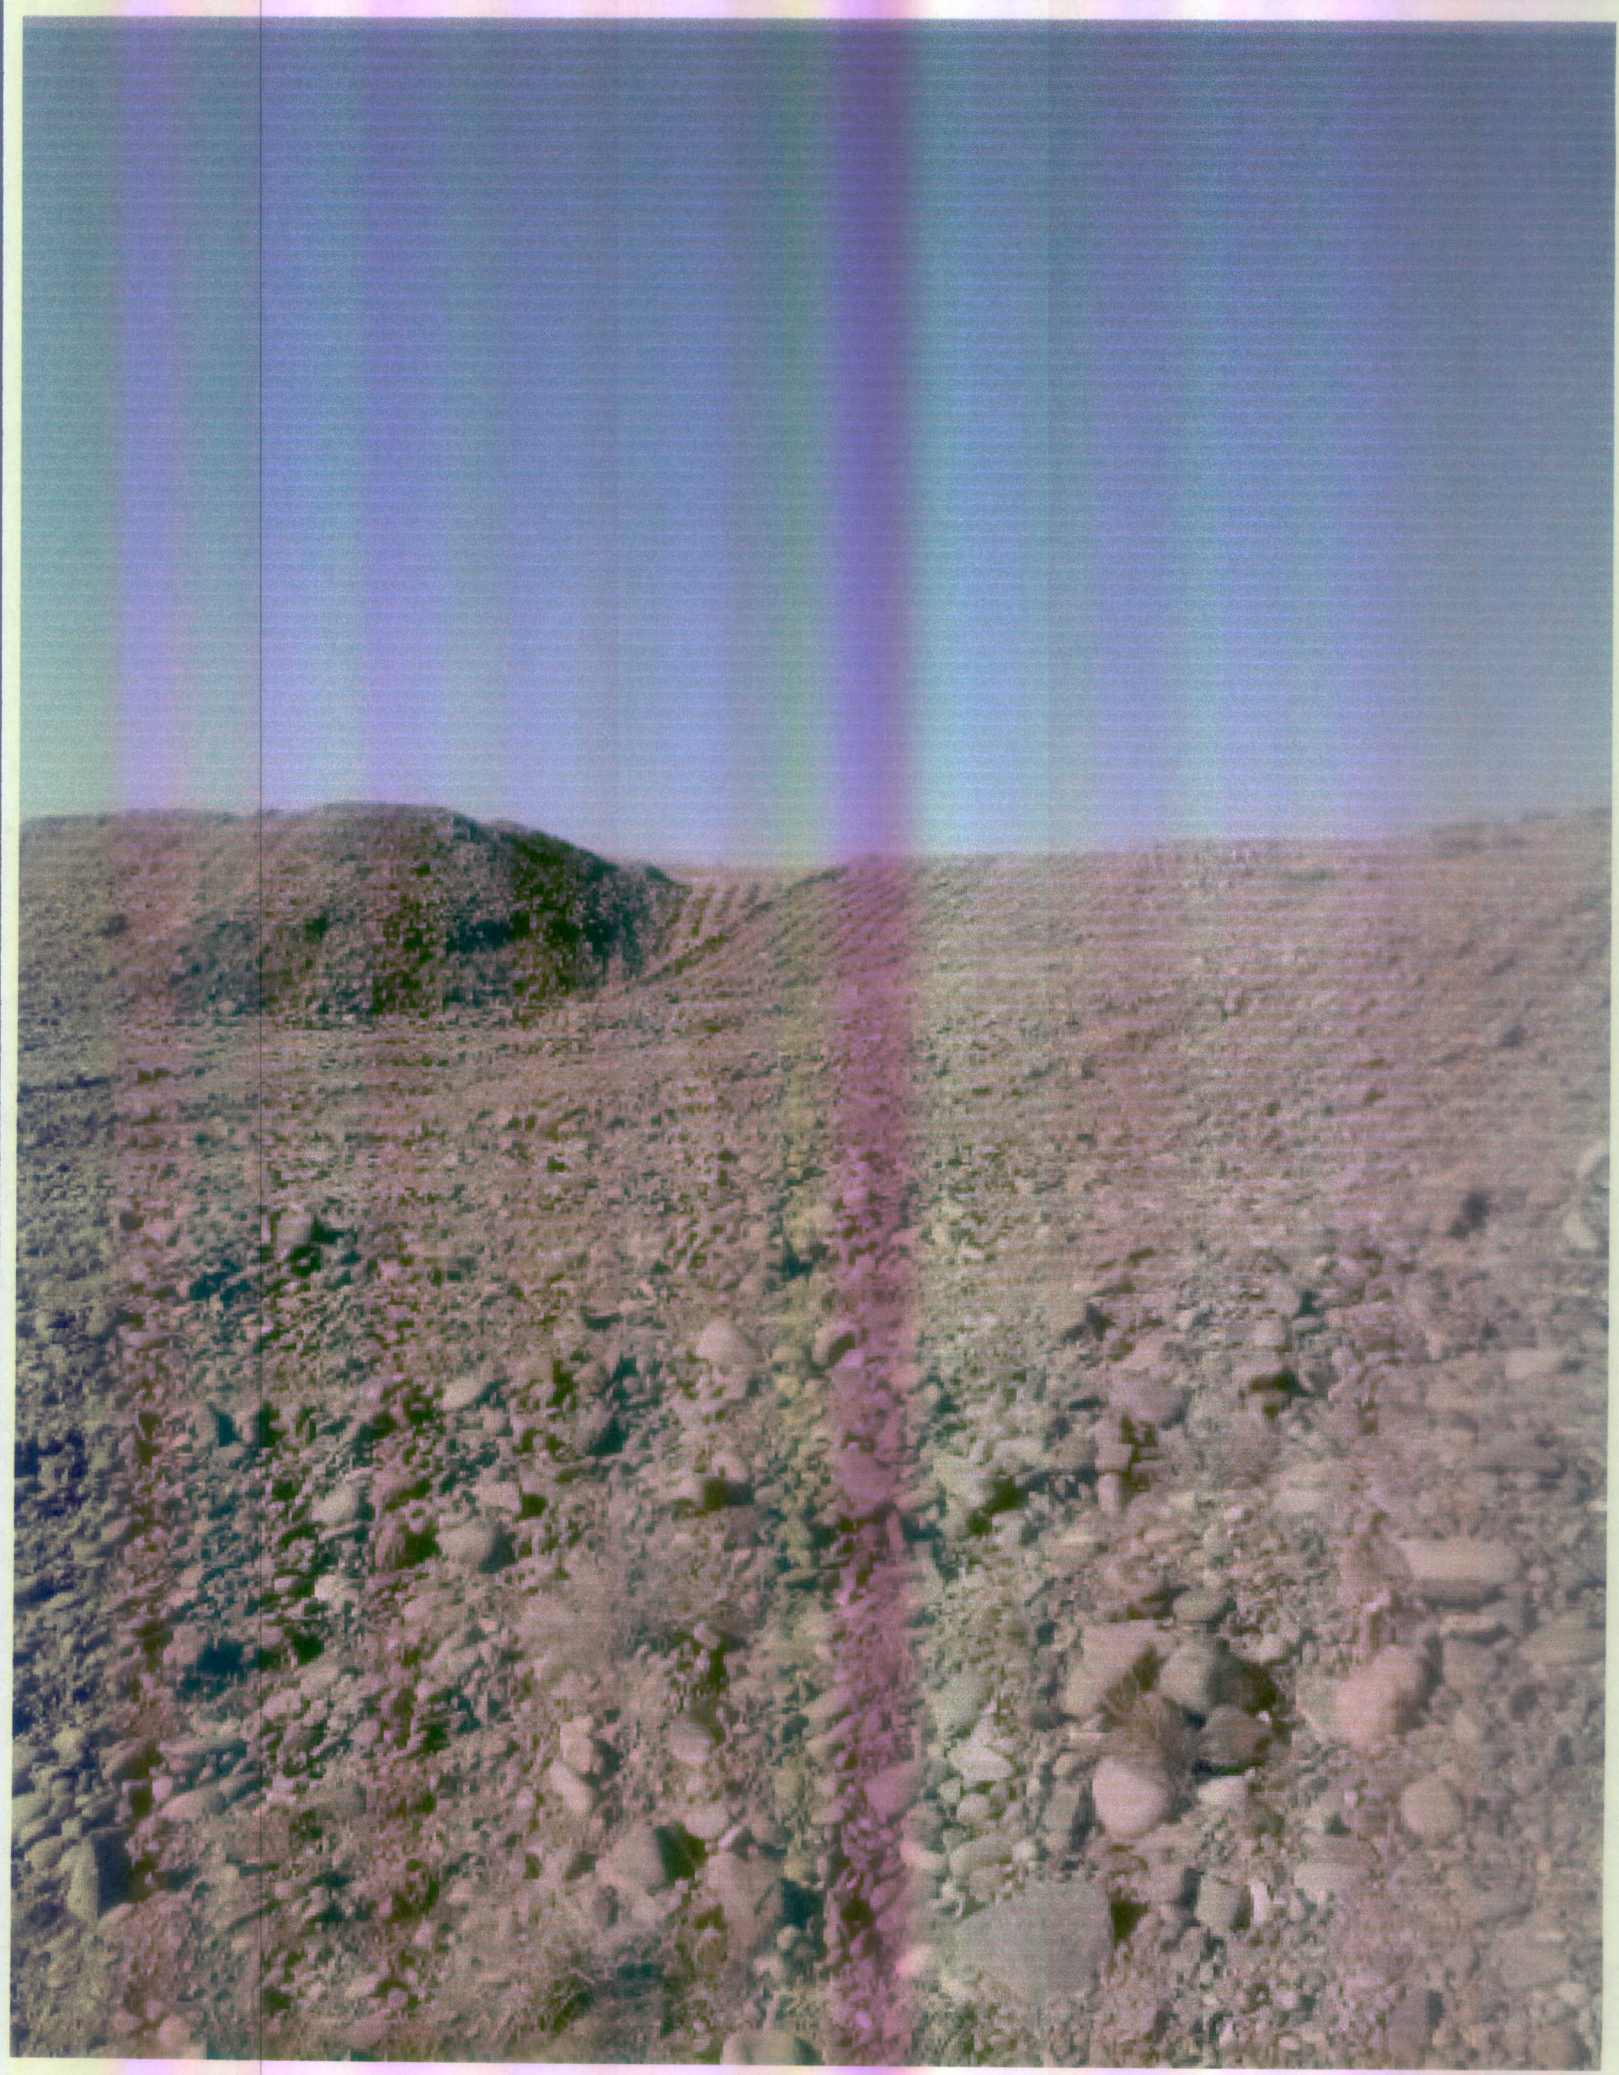
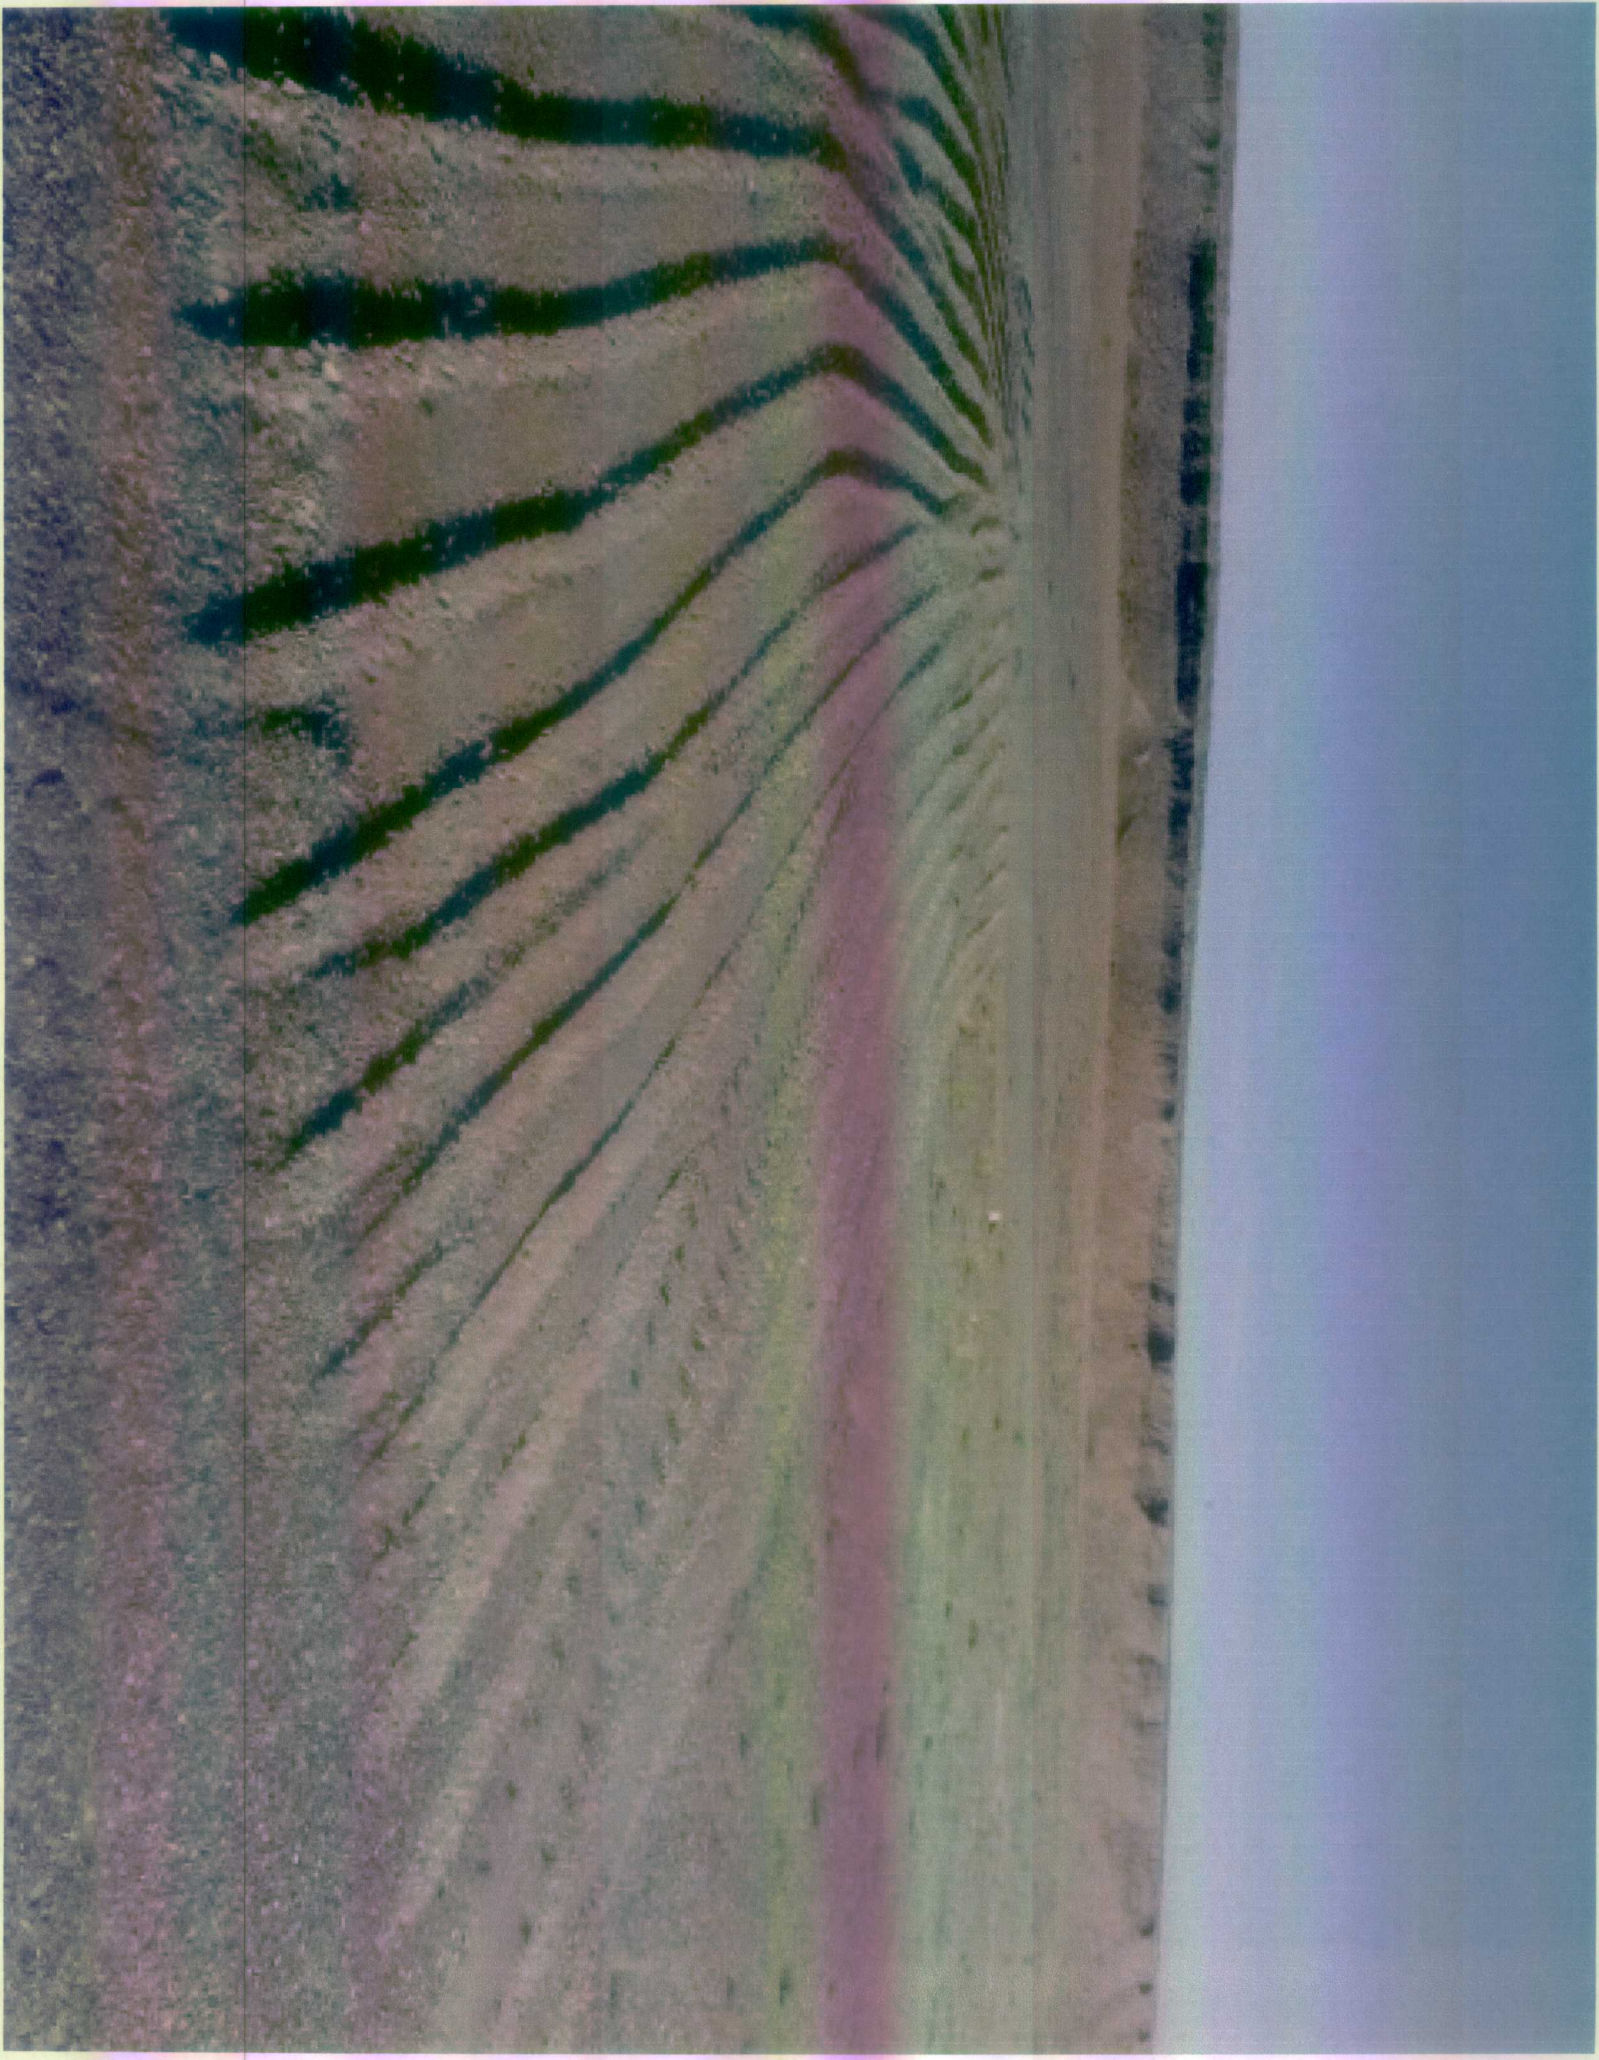
The following corrective actions have been completed with regard to the Inspection Topics for (1) Toxic Materials and (2) Erosion. We have removed the barrel and properly disposed of contaminated soil and also we have repaired the erosion gully and have reconstructed/stabilized the area(s) to prevent further erosion damage in the East and West Side of the pit. I am enclosing pictures of the areas involved to substantiate compliance with the corrective actions recommended by you Minerals Program Inspection Report dated 5/19/2017.
