MINERALS PROGRAM INSPECTION REPORT**PHONE: (303) 866-3567**

MINE NAME: Rudibaugh Pit	MINE/PROSPECTING ID#: M-1995-057	MINERAL: Sand and gravel	COUNTY: Gunnison
INSPECTION TYPE: Monitoring	INSPECTOR(S): Dustin M. Czapla	INSP. DATE: June 13, 2017	INSP. TIME: 11:30
OPERATOR: Deb Rudibaugh	OPERATOR REPRESENTATIVE: Deb Rudibaugh	TYPE OF OPERATION: 110c - Construction Limited Impact

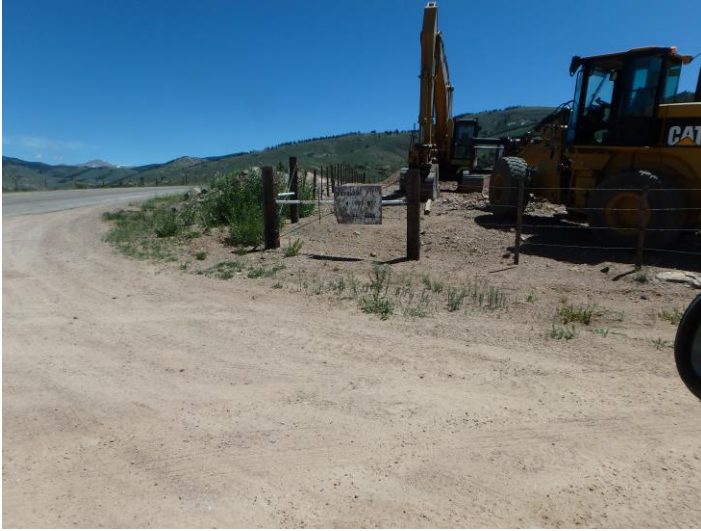
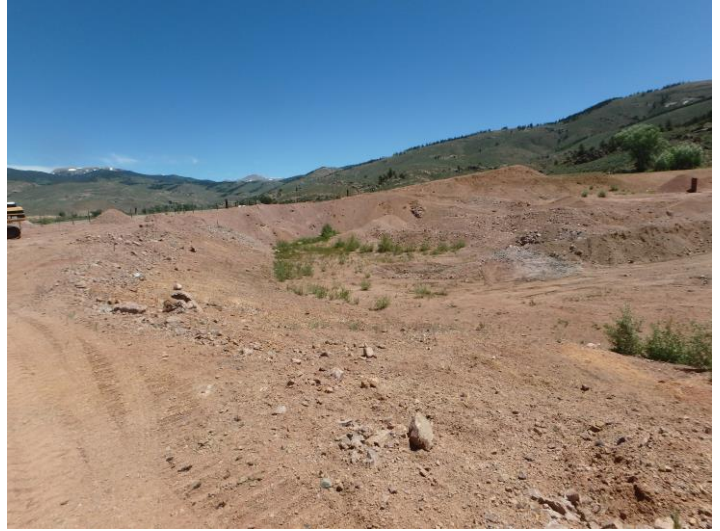
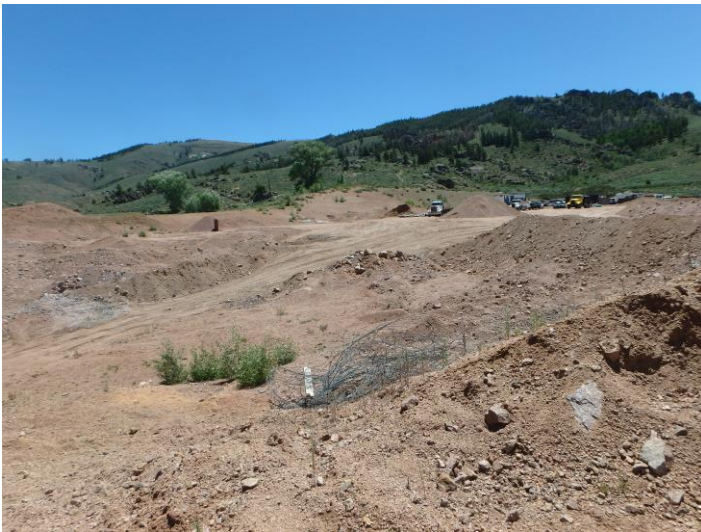
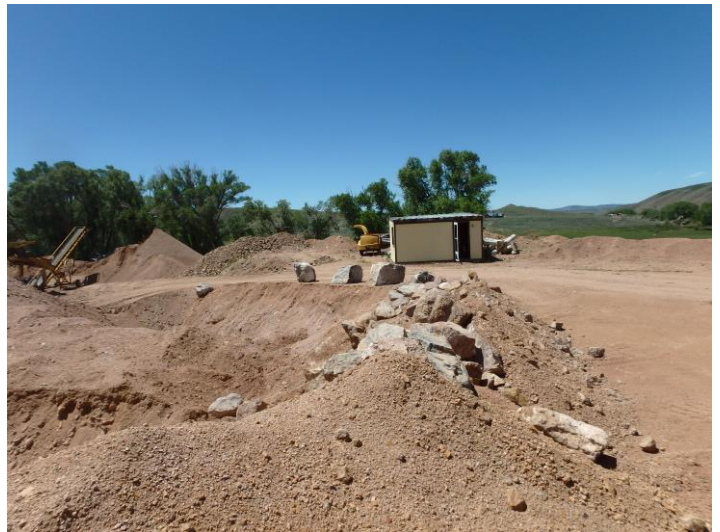
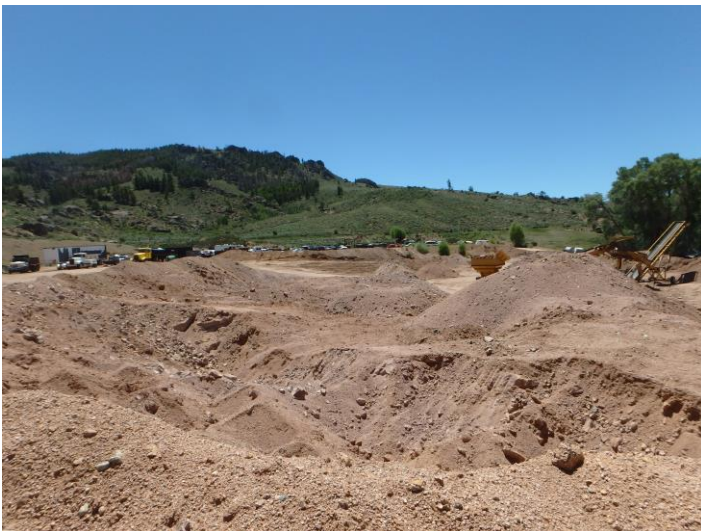
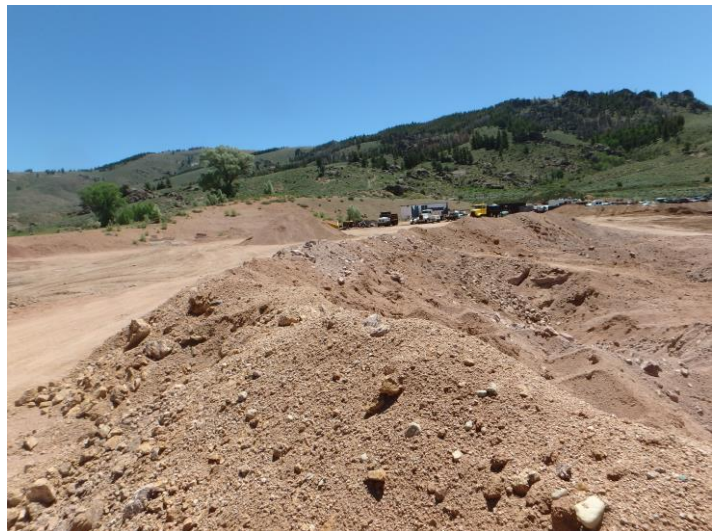
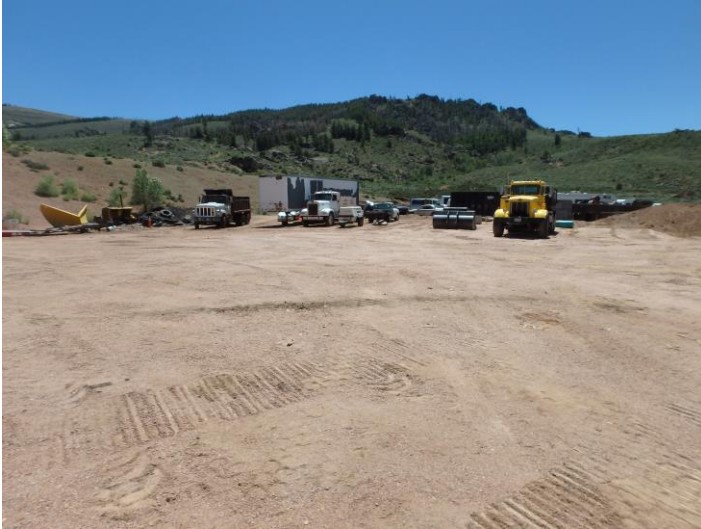
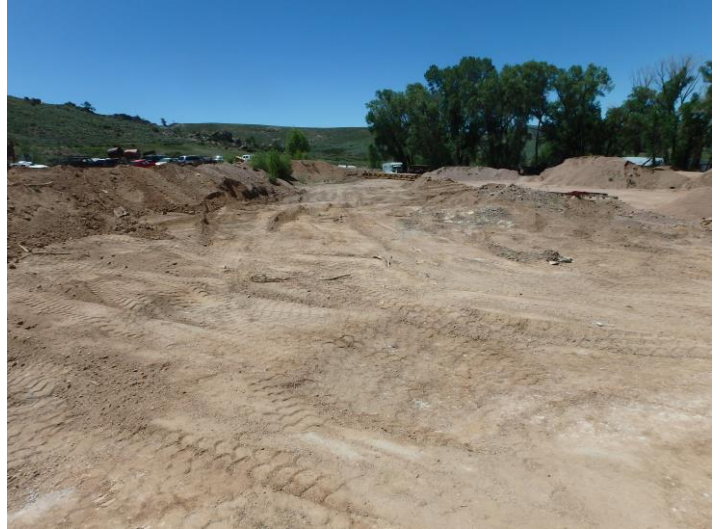
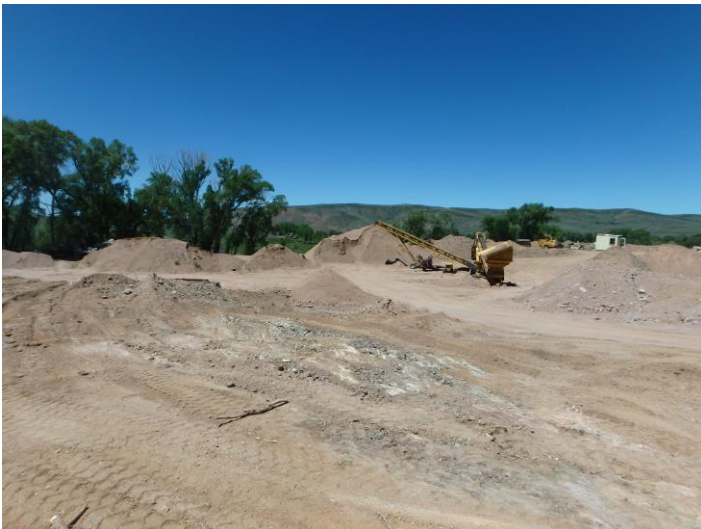
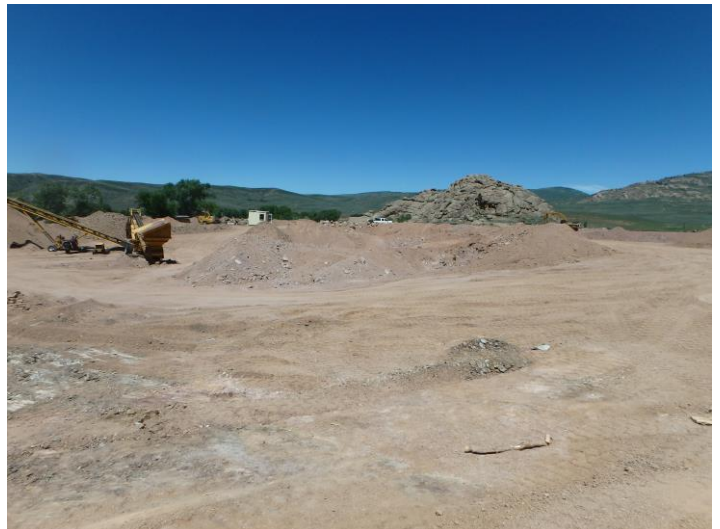
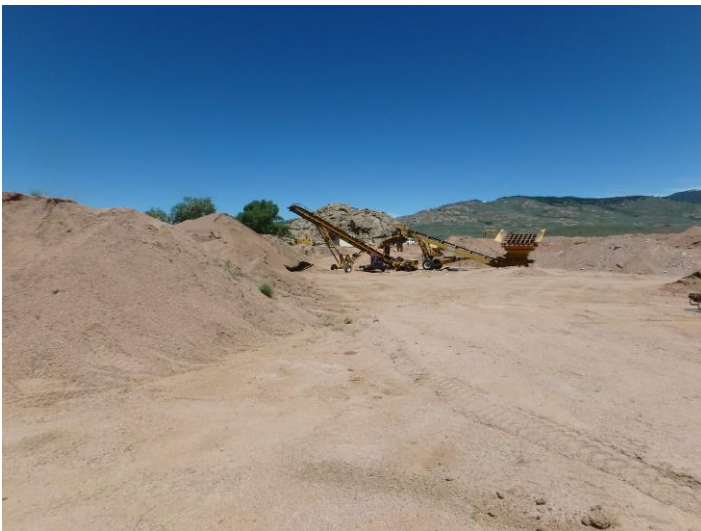
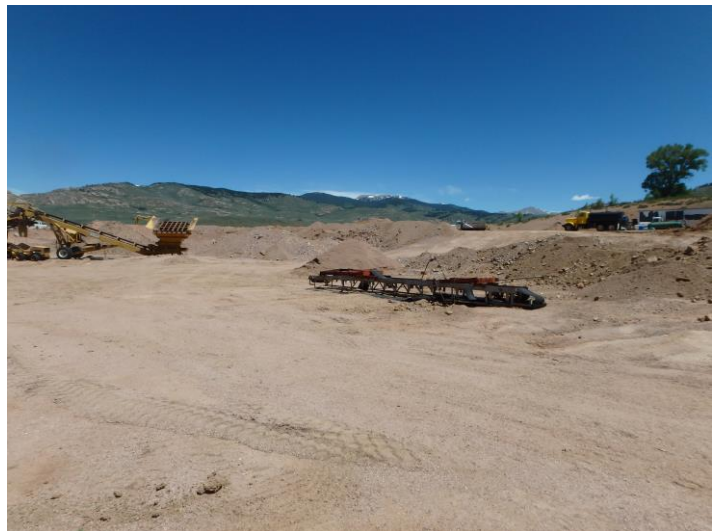
PROBLEM/POSSIBLE VIOLATION: Problem: Trash and refuse was noticed on the site. The south portion of the permit area is being used as a junkyard. Approximately fifty junk vehicles/equipment and various refuse are stored in this area. This is a problem at this time for failure to dispose of refuse in a manner that controls unsightliness or deleterious effects of such refuse pursuant to C.R.S. 34-32.5-116(4)(e).

PROBLEM/POSSIBLE VIOLATION: Problem: The mine identification sign posted at the entrance to the site is dilapidated and the required information is not legible. This is a problem for failure to post a mine identification sign as required by Section 3.1.12(1) of the rule.

A mine identification sign was posted at the entrance to the site, but it is dilapidated and some of the required information is illegible. The Operator must repair or replace the sign.

An earthen berm is constructed around the west side of the pit that controls stormwater runoff from the pit. The slope on the east side of the pit is graded to approximately 3H:1V and appears stable. Excavation is occurring in the north and central parts of the pit. There was no water observed in the pit. Slopes around the excavation are at an angle of repose, approximately 1H:1V. There was no fuel stored on site. A conveyor and screen were located in the central pit area.

CORRECTIVE ACTIONS: The operator shall submit a written notice to the Division with photo documentation, that the trash and junk vehicles have been removed from the site by the corrective action date, or alternatively, post additional financial warranty in an amount sufficient to cover removal costs.

CORRECTIVE ACTIONS: The operator shall, at the entrance of the mine site, post a sign which shall be clearly visible from the access road with the following: the name of the operator, a statement that a reclamation permit for the operation has been issued by the Colorado Mined Land Reclamation Board; and the permit number. The operator shall submit photo documentation that a proper sign has been posted by the corrective action date.
