COLORADO DIVISION OF RECLAMATION, MINING AND SAFETY
MINERALS PROGRAM INSPECTION REPORT
PHONE: (303) 866-3567

MINE NAME: Van 4 Shaft	MINE/PROSPECTING ID#: M-1997-032	MINERAL: Uranium and vanadium	COUNTY: Montrose
INSPECTION TYPE: Monitoring	INSPECTOR(S): Dustin M. Czapla	INSP. DATE: July 8, 2014	INSP. TIME: 16:00
OPERATOR: Energy Fuels Resources (USA) Inc.	OPERATOR REPRESENTATIVE: None	TYPE OF OPERATION: 110d - Designated Limited Impact

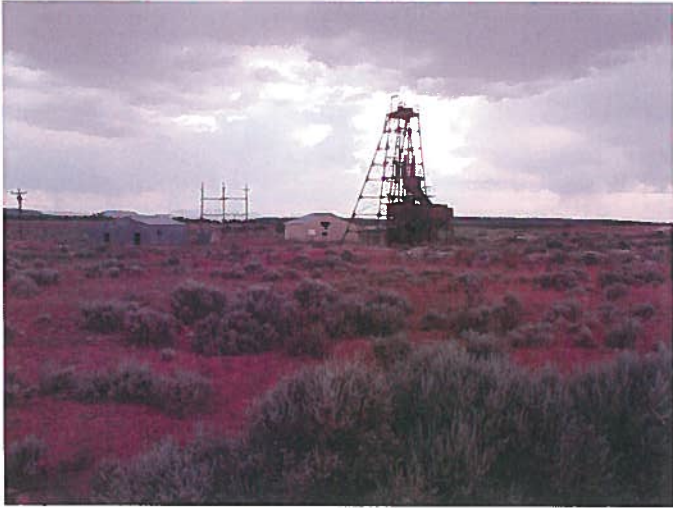
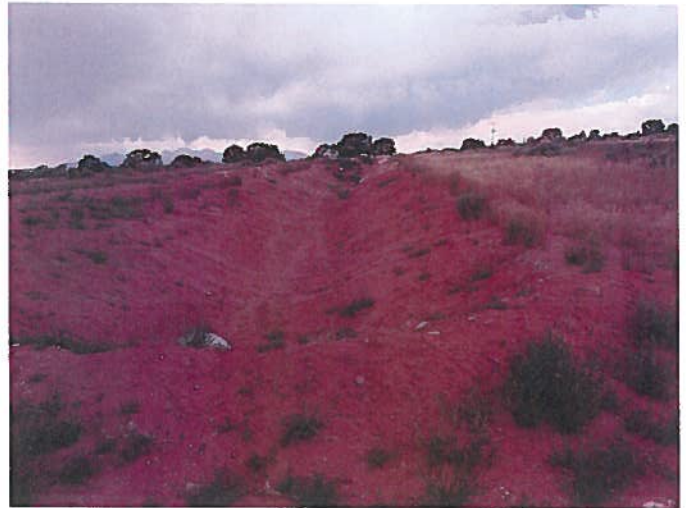
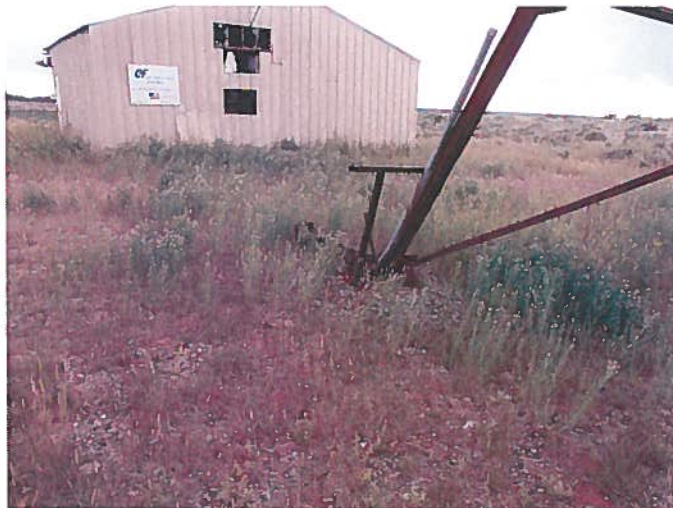
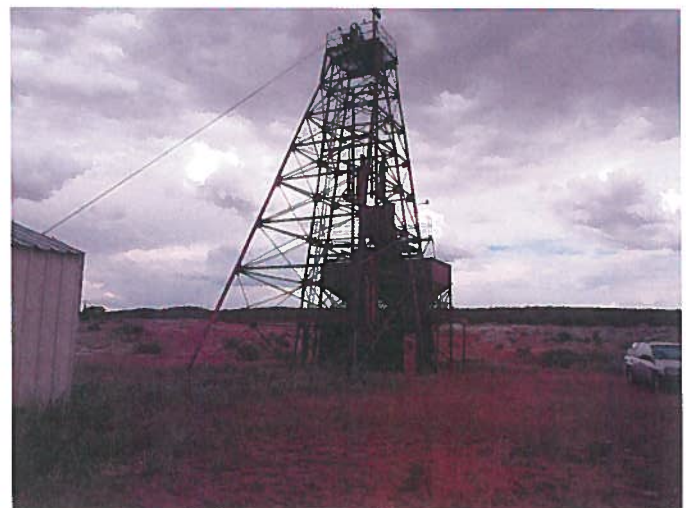
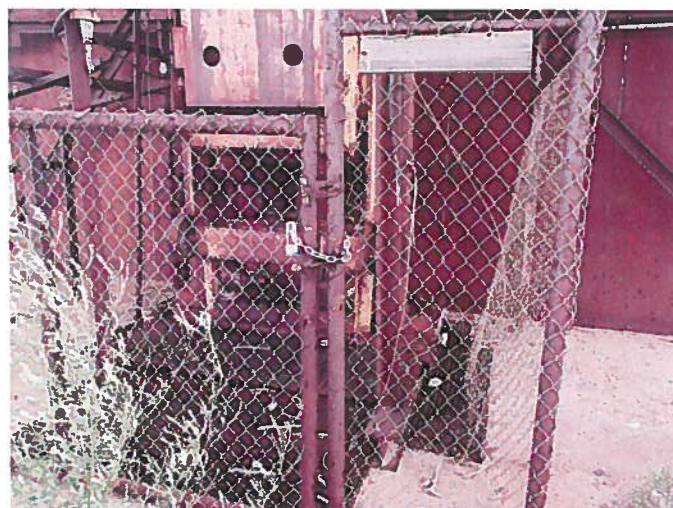
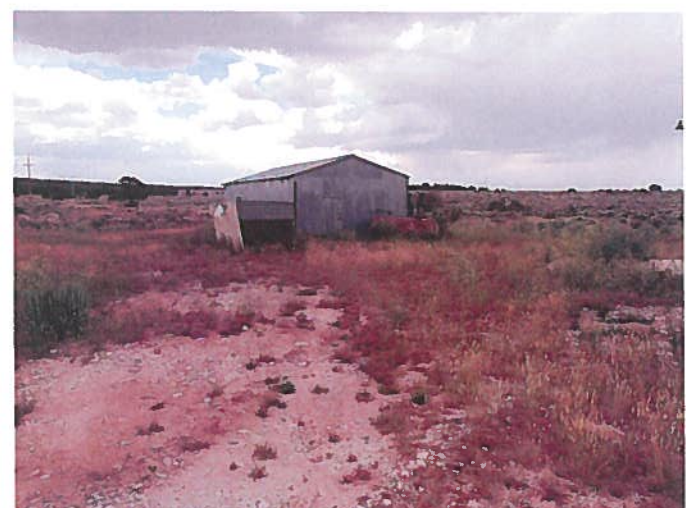
PHOTOGRAPHS

An infestation of Russian knapweed was noted between the hoist house and shaft. These noxious weeds should be treated as soon as possible.

CORRECTIVE ACTIONS: Implement approved weed control plan and provide proof to the Division that this has been done.
