MINERALS PROGRAM INSPECTION REPORT
PHONE: (303) 866-3567

MINE NAME: Van 4 Shaft	MINE/PROSPECTING ID#: M-1997-032	MINERAL: Uranium and vanadium	COUNTY: Montrose
INSPECTION TYPE: Monitoring	INSPECTOR(S): Dustin M. Czaplá	INSP. DATE: June 12, 2017	INSP. TIME: 10:30
OPERATOR: Pinon Ridge Mining LLC	OPERATOR REPRESENTATIVE:	TYPE OF OPERATION: 110d - Designated Limited Impact	
REASON FOR INSPECTION: Normal I&E Program	BOND CALCULATION TYPE: Complete Bond	BOND AMOUNT: \$75,057.00	
DATE OF COMPLAINT: NA	POST INSP. CONTACTS: None	JOINT INSP. AGENCY: U.S.BLM	
WEATHER: Windy	INSPECTOR'S SIGNATURE:

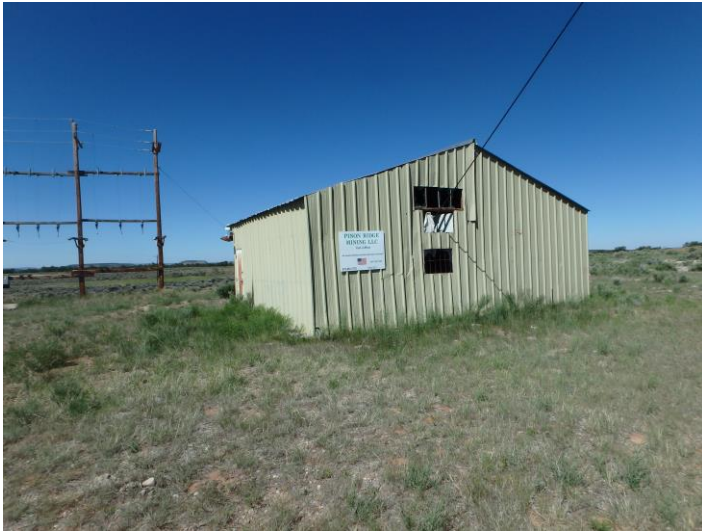
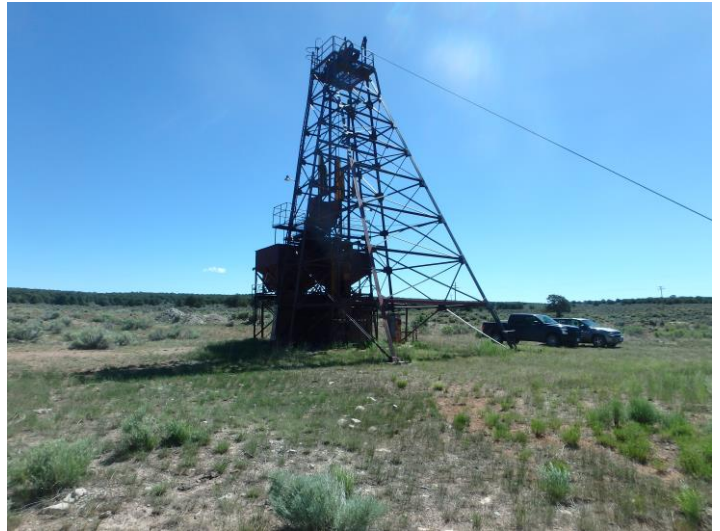
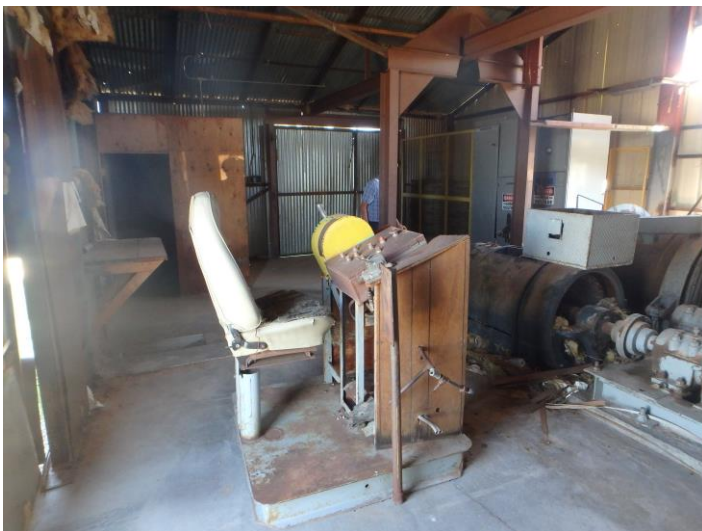
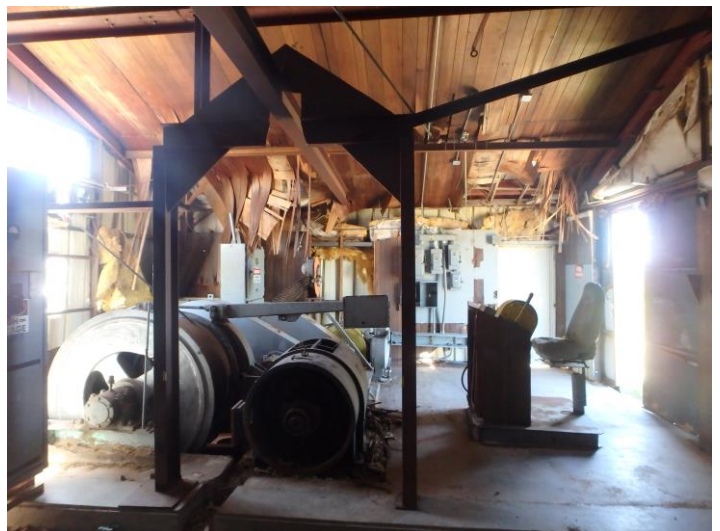
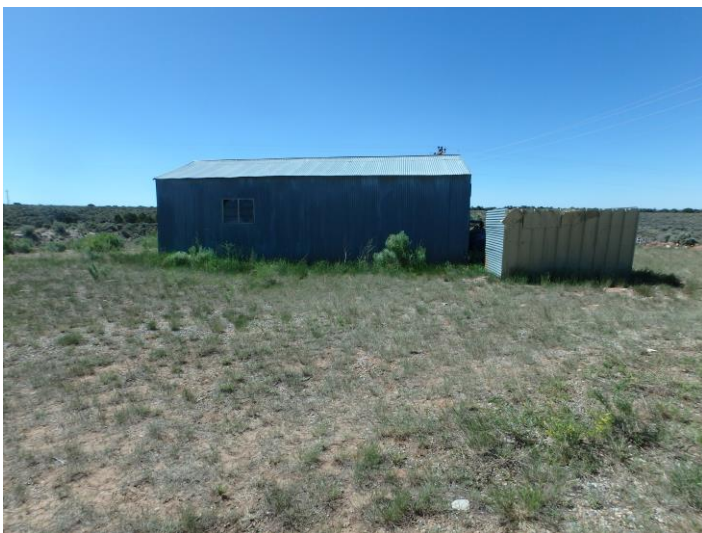
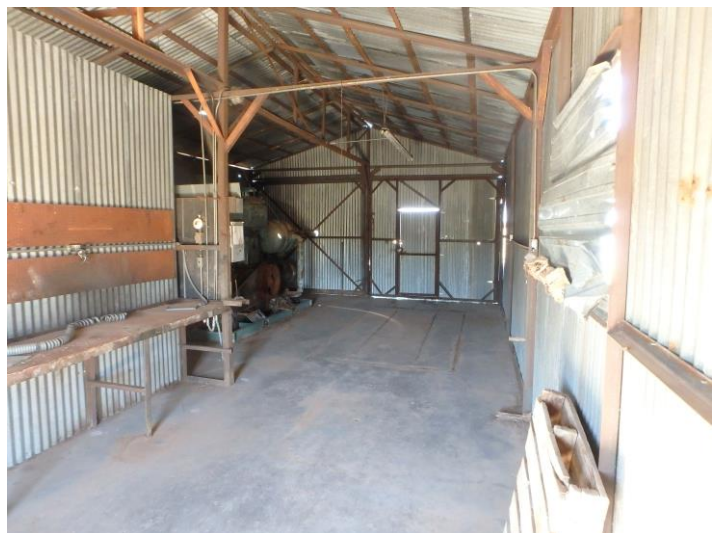
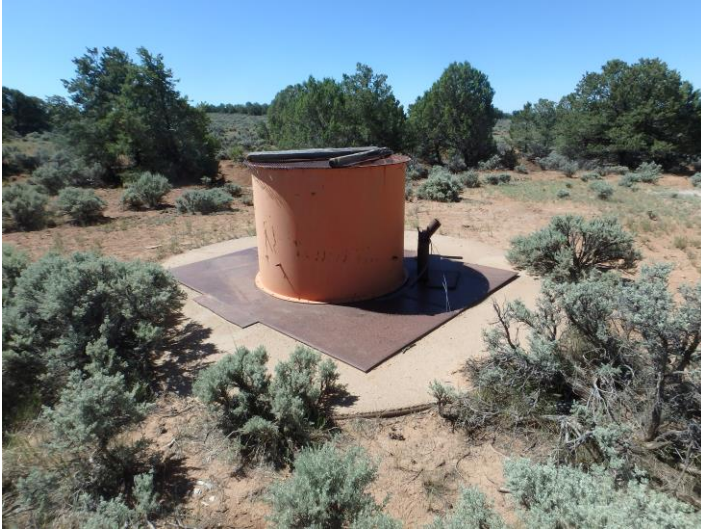
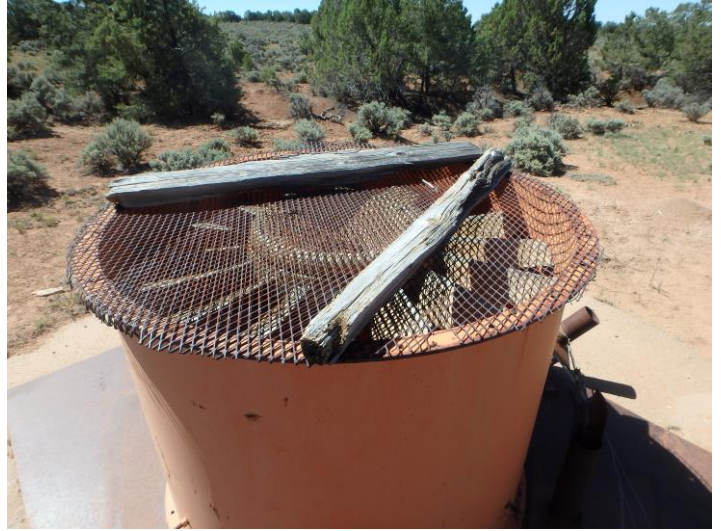
Adequate mine identification signage was noted on the hoist building, which is visible from the site entrance.

The permit was amended in 2012 to include an Environmental Protection Plan (EPP). The EPP included an improved stormwater management plan and control structures. The operator completed installation of the stormwater control structures in June 2012. Stormwater control structures appeared to be in good condition during this inspection. The site has been in Temporary Cessation since June 2012.

Two metal buildings remain at the site, a hoist house and shop. The buildings do not contain hazardous chemicals or ore. The buildings appeared to have recently been swept out, with most of the equipment removed from the buildings. The ceiling boards and insulation in the hoist house are rotting out and falling from the ceiling. The front windows of the hoist house are broken. The hoist assembly is still located in the hoist house, and a compressor is located in the shop building.

The shaft is secured with grating welded to the collar, and a welded gate at the base of the headframe. The headframe appears stable.

The vent hole on the east side of Dd19 is secured with grating welded onto the fan assembly.
