COLORADO DIVISION OF RECLAMATION, MINING AND SAFETY
MINERALS PROGRAM INSPECTION REPORT
PHONE: (303) 866-3567

MINE NAME: Monarch Quarry	MINE/PROSPECTING ID#: M-2000-098	MINERAL: Limestone (general)	COUNTY: Chaffee
INSPECTION TYPE: Monitoring	INSPECTOR(S): Dustin M. Czaplá	INSP. DATE: September 10, 2014	INSP. TIME: 11:30
OPERATOR: Colorado Lime Company	OPERATOR REPRESENTATIVE: Bob Beadle	TYPE OF OPERATION: 112c - Construction Regular Operation

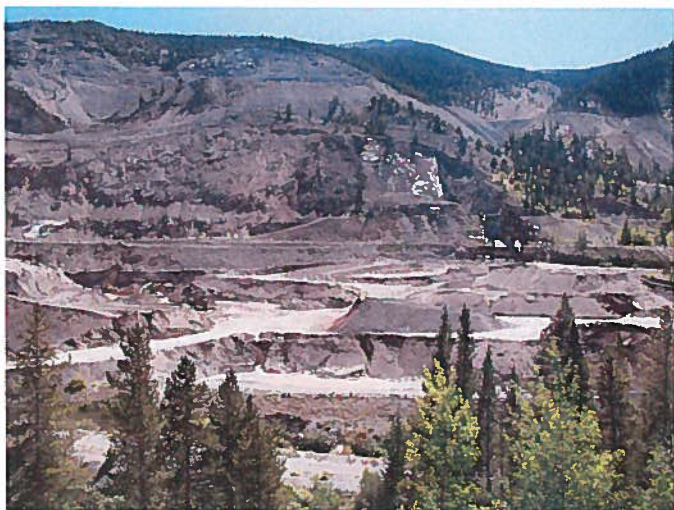
Figure 1: Overlooking site from Hwy 50

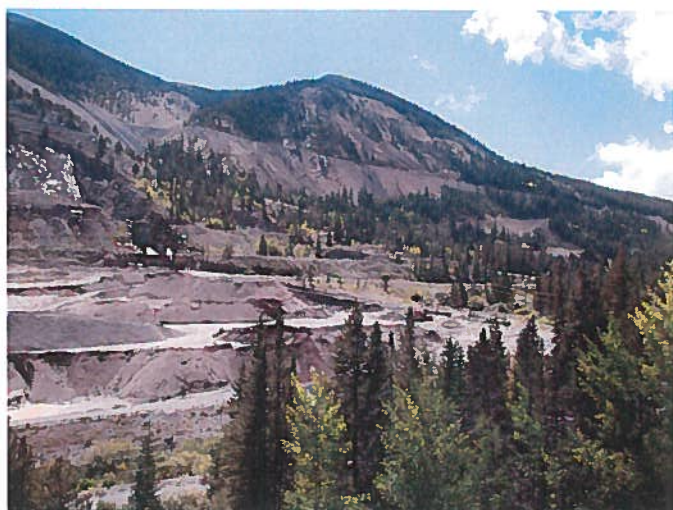
Figure 2: Overlooking site from Hwy 50

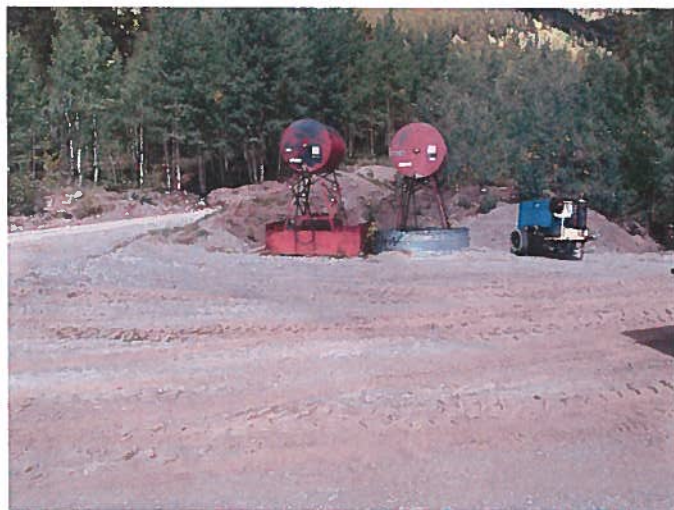
Fuel on site was stored in adequate secondary containment.

Figure 3: Fuel stored near site entrance

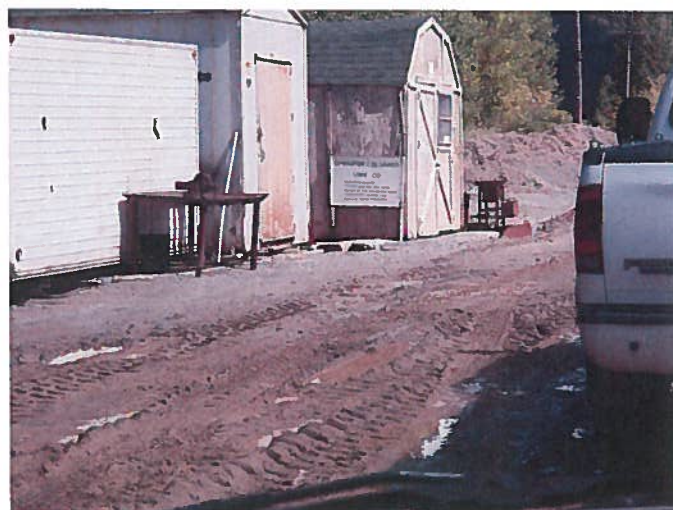
Figure 4: Equipment storage near site entrance

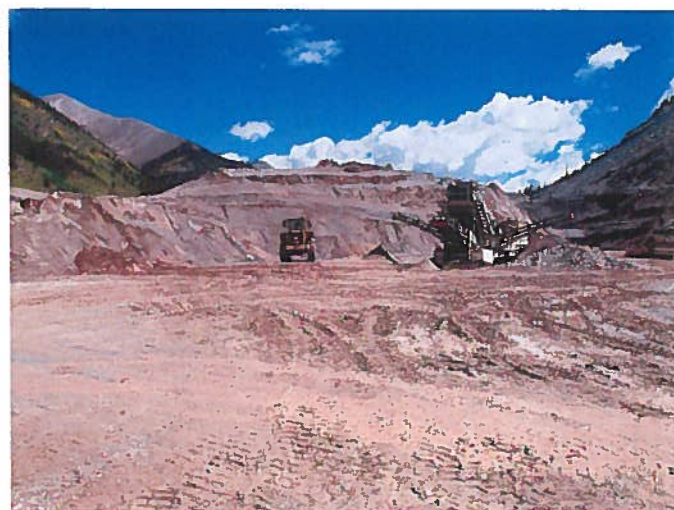
Mining at the site consists of removal of material from the existing limestone spoils piles left by CF&I. No quarrying is proposed for the foreseeable future.

Figure 5: Active mine area (lower dig face)

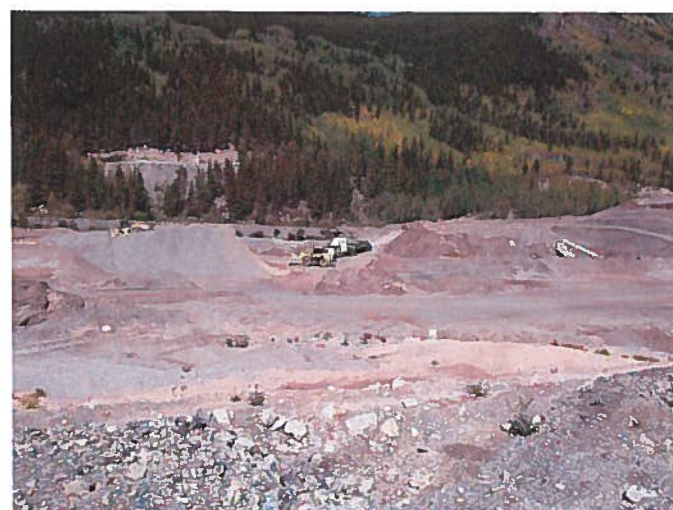
Figure 6: Overlooking mining area from scale

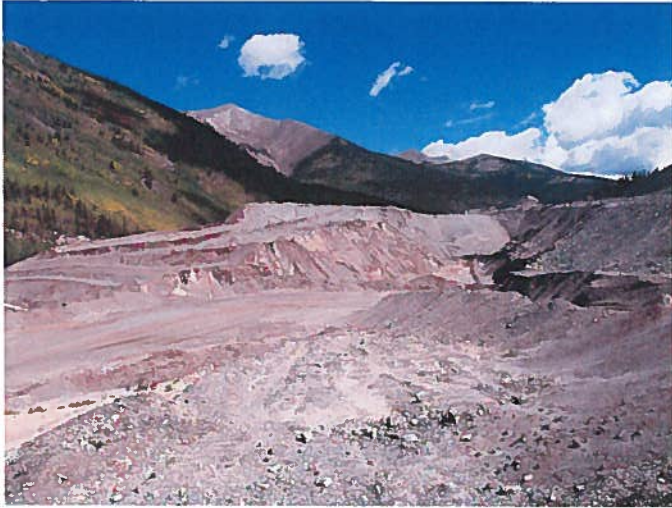
Figure 7: Overlooking mining area from scale

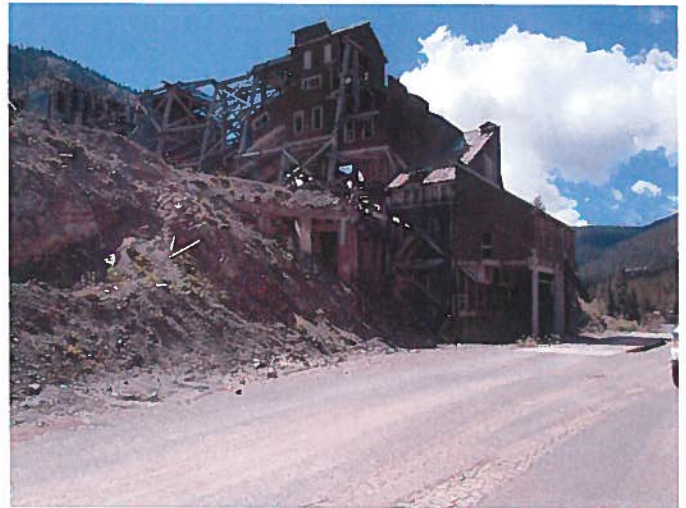
Figure 8: Scale located below historic mill facility
