**COLORADO**Division of Reclamation,
Mining and Safety

MINERALS PROGRAM INSPECTION REPORT**PHONE: (303) 866-3567**

MINE NAME: Upper Gold Links Portal	MINE/PROSPECTING ID#: P-2014-018	MINERAL: Gold and silver	COUNTY: Gunnison
INSPECTION TYPE: Monitoring	INSPECTOR(S): Dustin M. Czapla	INSP. DATE: June 13, 2017	INSP. TIME: 12:45
OPERATOR: Dunraven Mining, LLC	OPERATOR REPRESENTATIVE: Jake Wilkinson	TYPE OF OPERATION: MP - Mineral Prospecting	
REASON FOR INSPECTION: Normal I&e Program	BOND CALCULATION TYPE: Complete Bond	BOND AMOUNT: \$5,957.54	
DATE OF COMPLAINT: NA	POST INSP. CONTACTS: None	JOINT INSP. AGENCY: None	
WEATHER: Clear	INSPECTOR'S SIGNATURE:

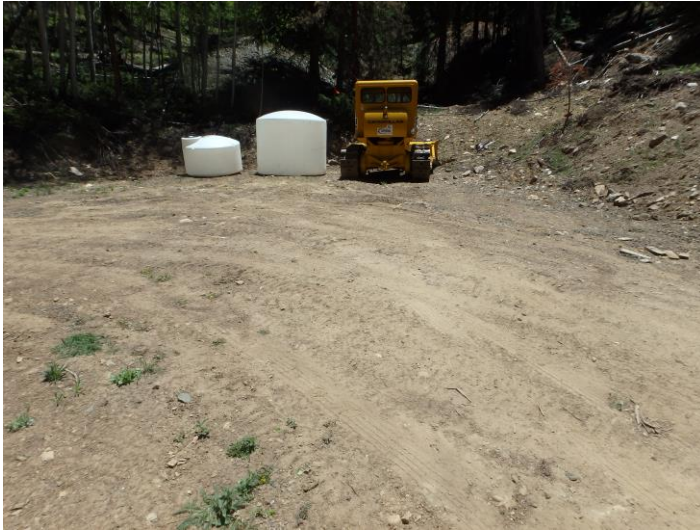
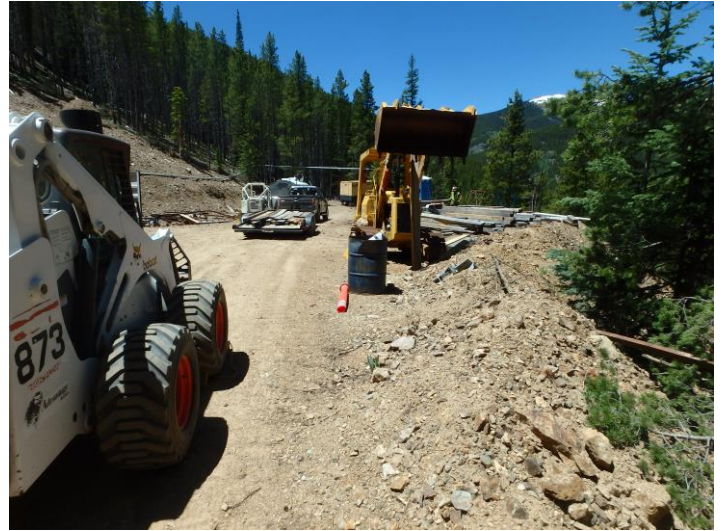
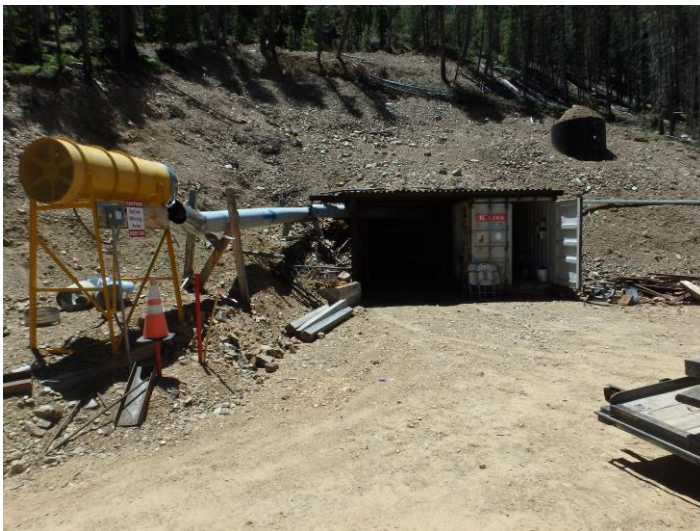
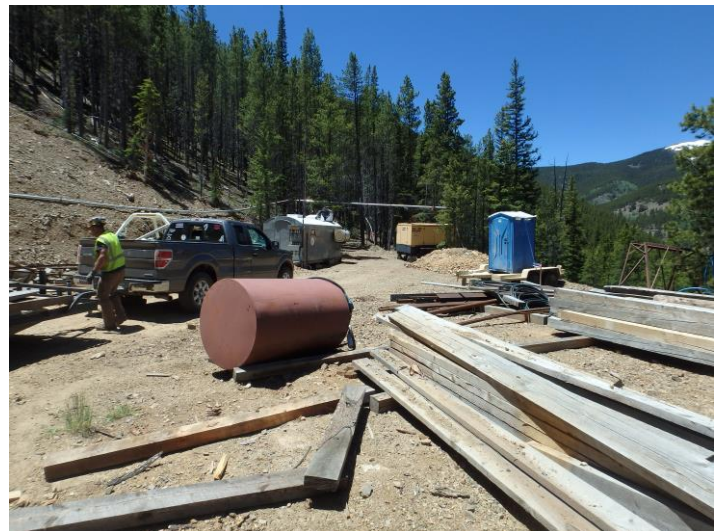
Work conducted under the NOI included reopening of an historic portal in order to obtain samples. The portal opening has been reinforced with a steel shipping container, steel beams and metal roofing. A ventilation system is installed outside the portal. The slope above the portal appeared stable. The site is dry and there was no discharge noted. The pad area is orderly and workers removing excess lumber from the site during this inspection.
