MINERALS PROGRAM INSPECTION REPORT
PHONE: (303) 866-3567

MINE NAME: San Luis Project	MINE/PROSPECTING ID#: M-1988-112	MINERAL: Gold and silver	COUNTY: Costilla
INSPECTION TYPE: Multi Person Inspection	INSPECTOR(S): Lucas J. West, Wallace Erickson, Russ Mea	INSP. DATE: June 16, 2017	INSP. TIME: 09:50
OPERATOR: Battle Mountain Resources, Inc.	OPERATOR REPRESENTATIVE: Larry Fiske	TYPE OF OPERATION: 112d-3 - Designated Mining Operation	
REASON FOR INSPECTION: Normal I&E Program	BOND CALCULATION TYPE: None	BOND AMOUNT: \$7,400,000.00	
DATE OF COMPLAINT: NA	POST INSP. CONTACTS: None	JOINT INSP. AGENCY: None	
WEATHER: Clear	INSPECTOR'S SIGNATURE:

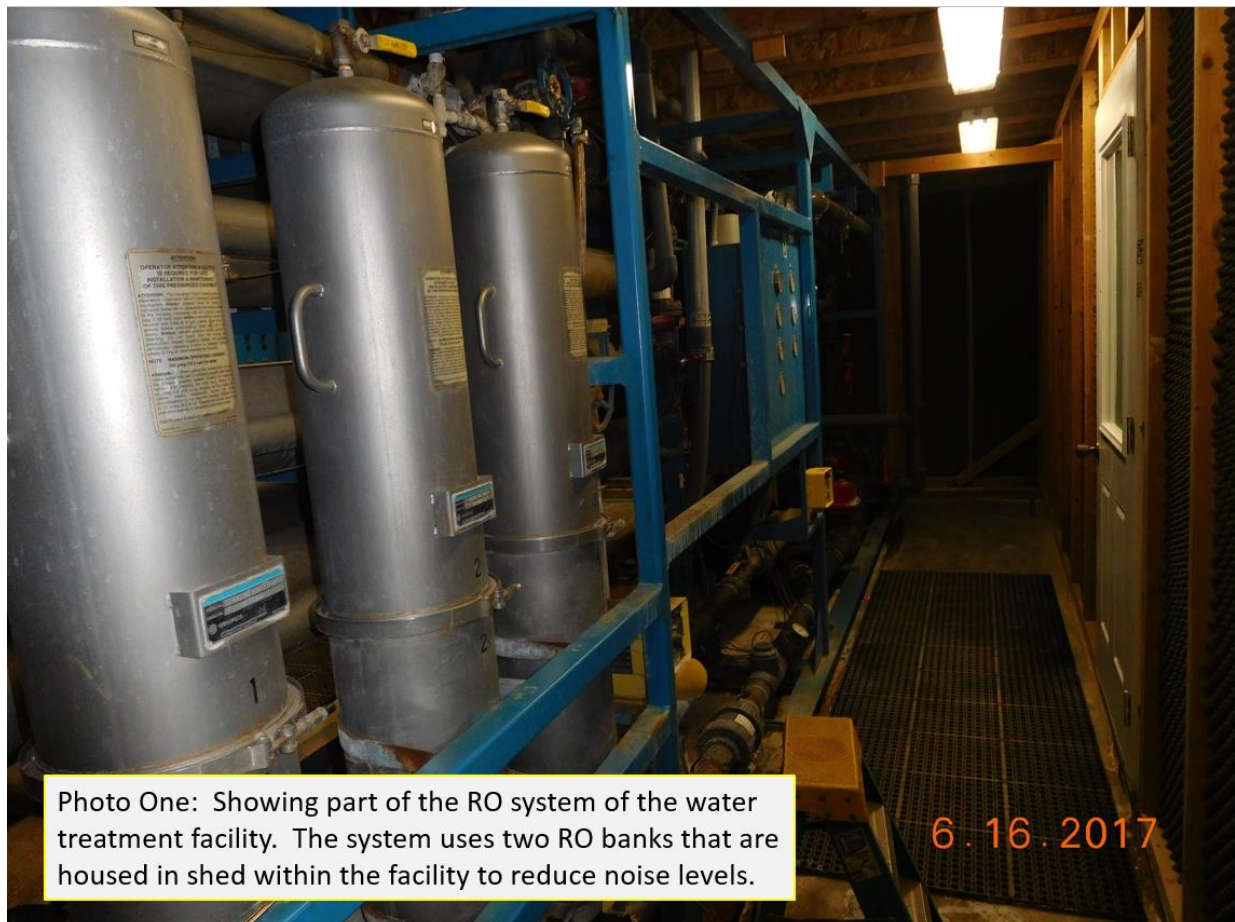
Photo One: Showing part of the RO system of the water treatment facility. The system uses two RO banks that are housed in shed within the facility to reduce noise levels.

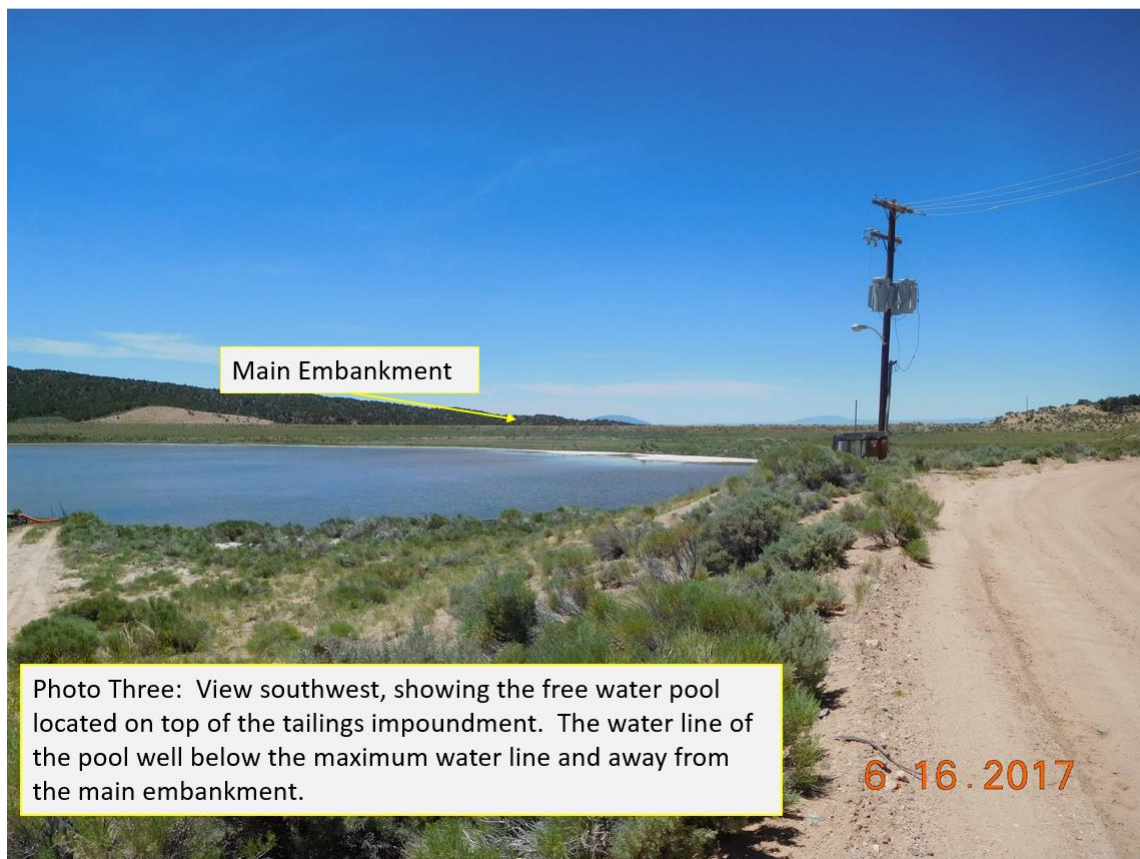
The tailings impoundment area appeared to be stable and in good condition. The free water pool located on top of the impoundment was observed, and the water levels are far below the maximum waterline that is outlined in the permit conditions. Photo Three shows the free water pool and surrounding vegetation. The other areas of the tailings impoundment are very well vegetated and appear to meet or exceed the conditions of the adjacent undisturbed areas. The maximum water line is designed to protect the main embankment from saturation which could lead to stability issues. The main embankment is well vegetated, appears to be stable and in good condition as seen in Photo Four. Also visible in photo Four is the underdrain system and collection pond located at the base of the main embankment. The operator has recently repaired a section on the north side of embankment that was experiencing some erosion issues. The repairs were completed successfully and no signs of significant erosion of the main embankment was noted during the inspection. The tailings impoundment is a lined facility, complete with under drains and an HDPE Liner that extends from under the impoundment and the main embankment to the collection pond immediately down gradient. The underdrains convey water that has percolated through the tailings impoundment down to the collection pond, where it is then recirculated back to the free water pool. The under drain was observed discharging water into the collection pond, which indicates the liner, and all of its components are functioning as designed.
